[Docket No. FAA–2018–1046; Product Identifier 2018–CE–049–AD]

Airworthiness Directives; Piper Aircraft, Inc. Airplanes

ACTION: Notice of proposed rulemaking (NPRM).

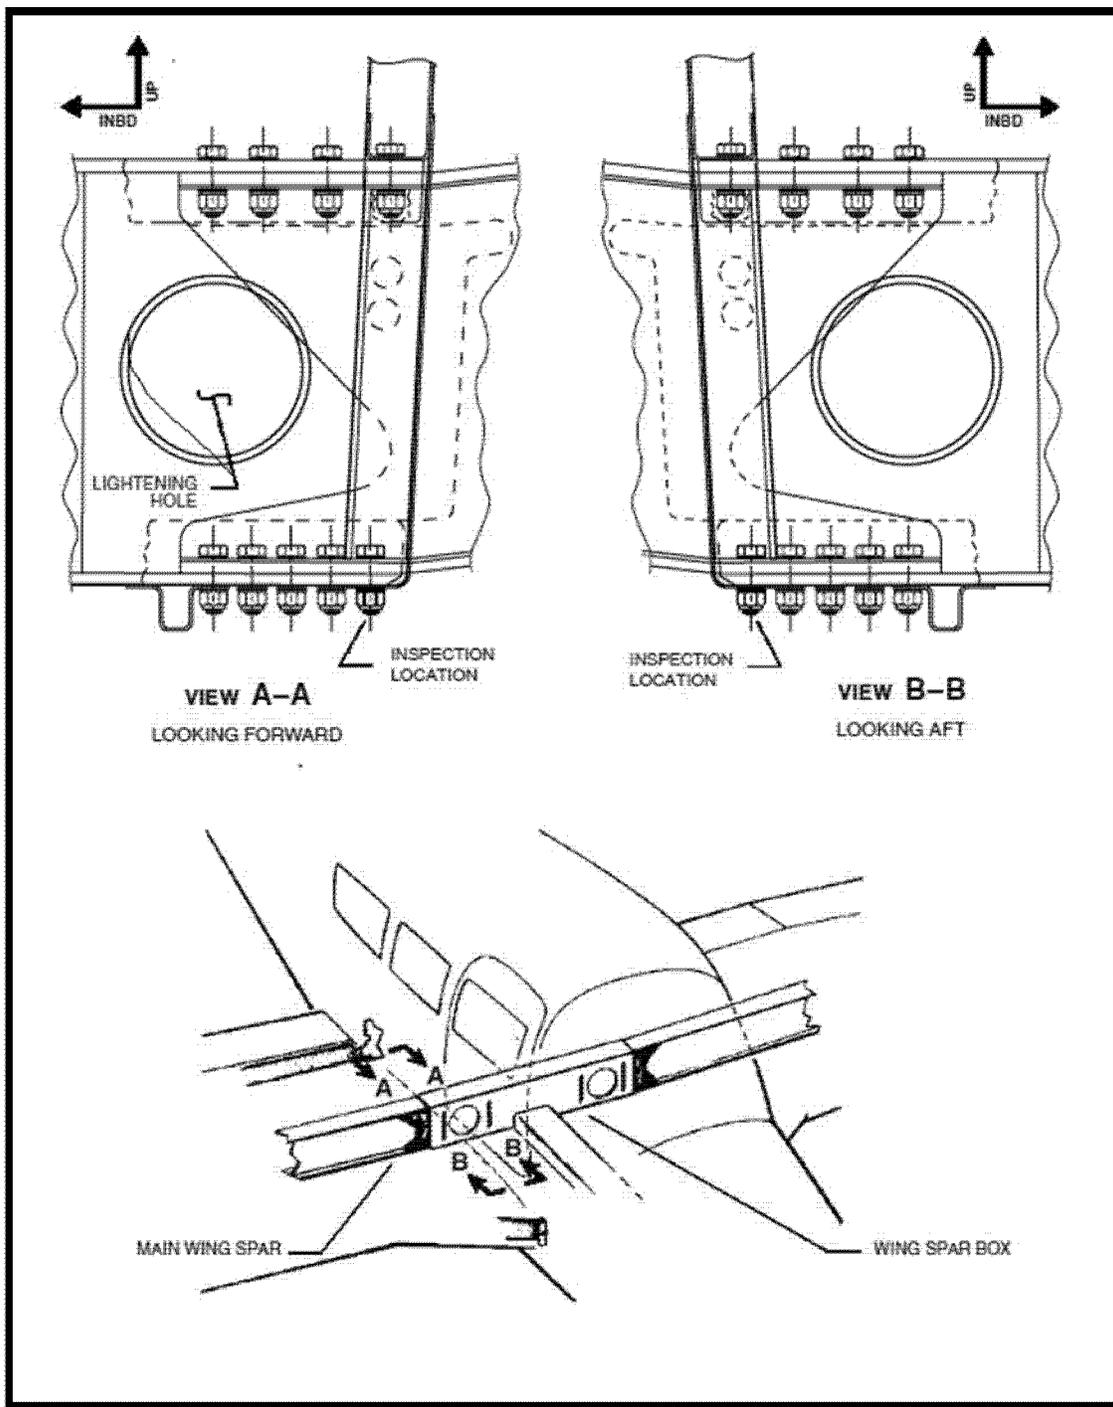
Figure 1. Main Spar Attach Bolt Locations (RH Side Shown)

This AD was prompted by a report of a fatigue crack found in a visually inaccessible area of the lower main wing spar cap. We are issuing this AD to detect and correct fatigue cracks in the lower main wing spar cap bolt holes. The unsafe condition, if not addressed, could result in the wing separating from the fuselage in flight.

(1) Locate the two (2) lower outboard main spar attach bolts, as shown in Figure 1 of Appendix 1, installed on the lower cap of the main spar, on the forward and aft sides of the spar web.

further flight, replace the main wing spar with a new (zero hours TIS) main wing spar or with a main wing spar that has been inspected as specified in appendix 1 of this AD and no cracks were found.

(3) Use eddy current surface and bolt hole examinations to detect surface and shallow subsurface cracking and discontinuities on the left and right lower outboard spar bolt holes. Use SAE ARP4402, "Eddy Current Inspection of Open Fastener Holes in Aluminum Aircraft Structure," or another FAA-approved eddy current inspection method to do these inspections.

A crack or crack-like indication with an amplitude equal to or greater than 50 percent of the reference level signal must be rejected and documented. Such an amplitude reading indicates that the spar does not meet type design.
