14 CFR Part 39

[Docket No. 93-CE-54-AD]

Airworthiness Directives; Cessna Aircraft Company Engine Oil Filter Adapter Assemblies Installed on Aircraft

ACTION: Supplemental notice of proposed rulemaking (NPRM); Reopening of the comment period.

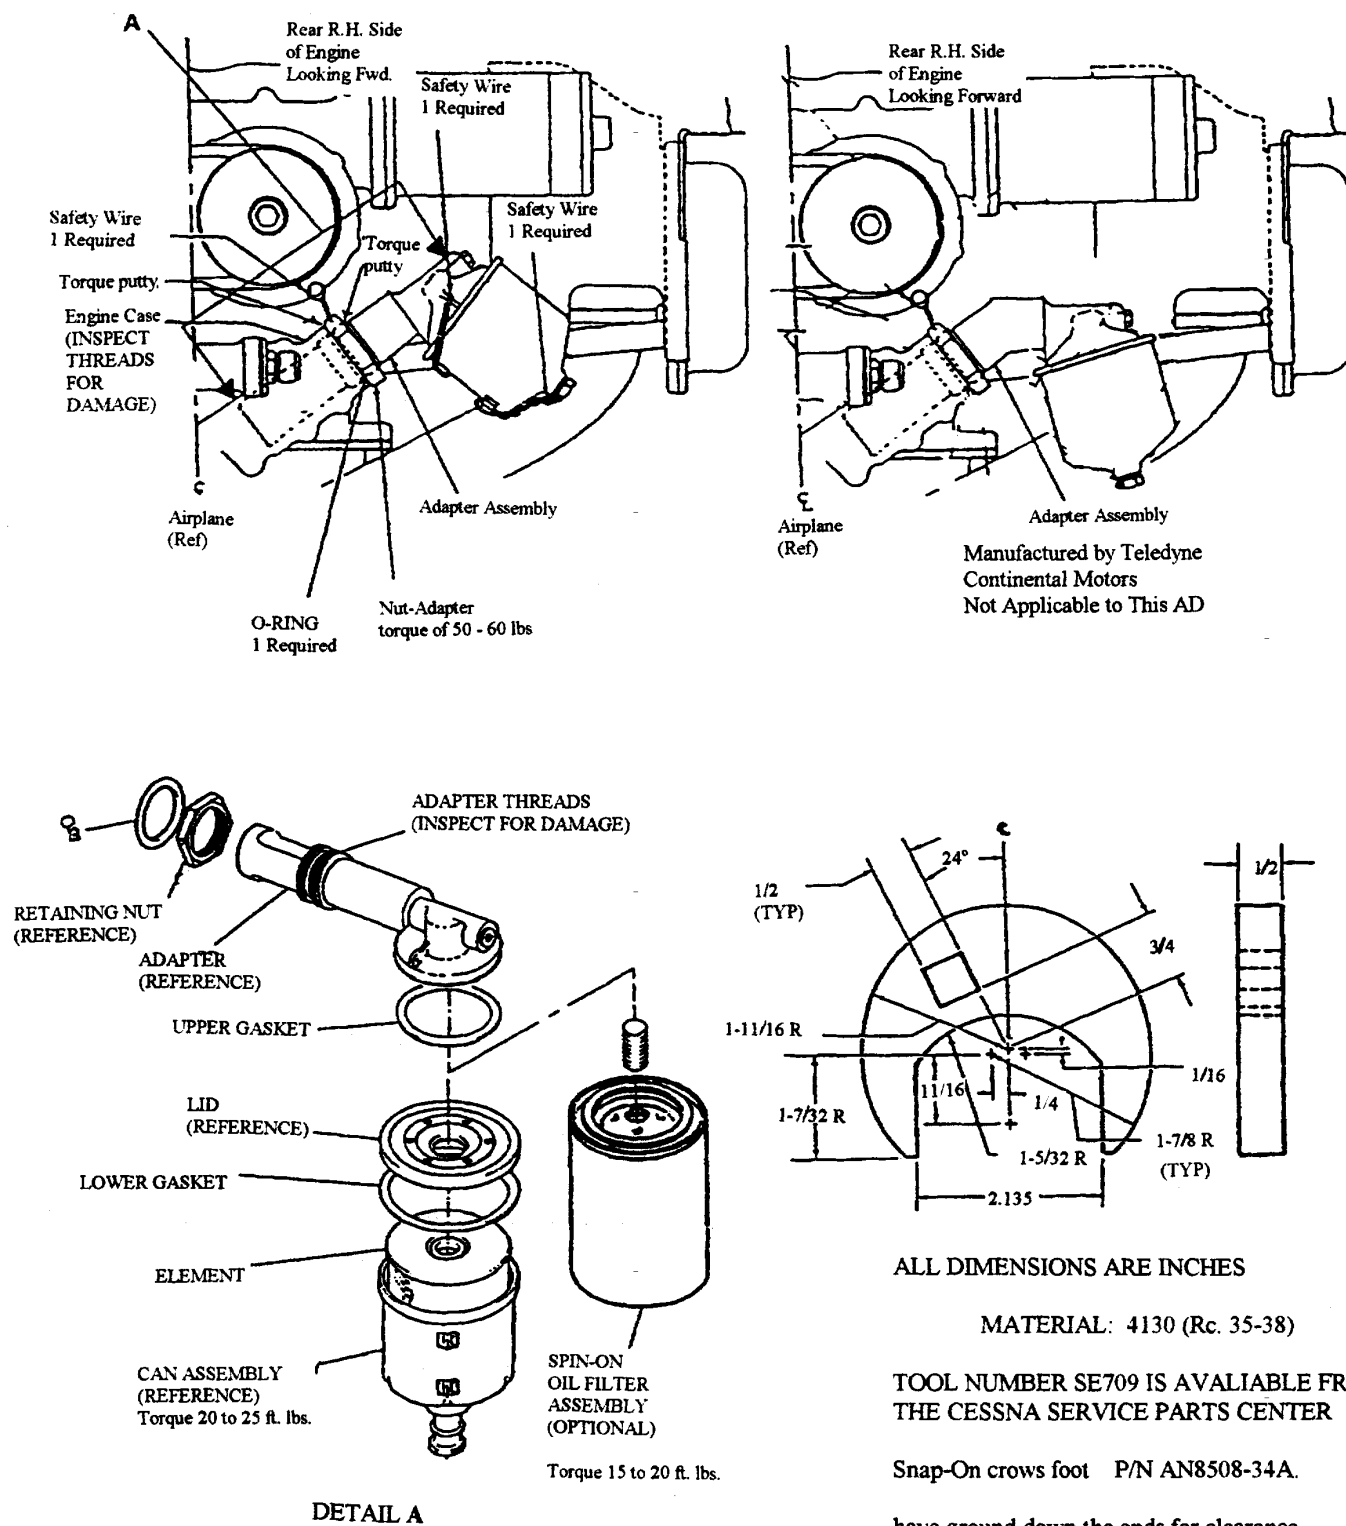
Figure 1. Oil Filter Adapter Installation

Note 2: This AD does not apply to engine oil filter adapter assemblies manufactured by Teledyne Continental Motors (See Figure 1 of this AD).

(b) For airplanes with torque putty between the engine filter adapter assembly, nut, and oil pump housing, inspect the torque putty for misalignment, evidence of oil leakage, or cracks.

(4) Apply torque putty between the engine filter adapter assembly, nut, and oil pump housing as specified in Figure 1 of this AD.

(1) If any misalignment, evidence of oil leakage, or torque putty cracks are found, prior to further flight, accomplish the requirements specified in paragraph (a) of this AD, including all subparagraphs.

(2) If no misalignment, evidence of oil leakage, or torque putty cracks are found, reinspect at intervals not to exceed 100 hours TIS until the engine oil filter is removed.
