[Docket No. 98-SW-11-AD; Amendment 39-10633; AD 98-06-04]

Airworthiness Directives; Eurocopter France Model AS332C, L, and L1 and Model SA330F, G, and J Helicopters

98-06-04 Eurocopter France: Amendment 39-10633. Docket No. 98-SW-11-AD.

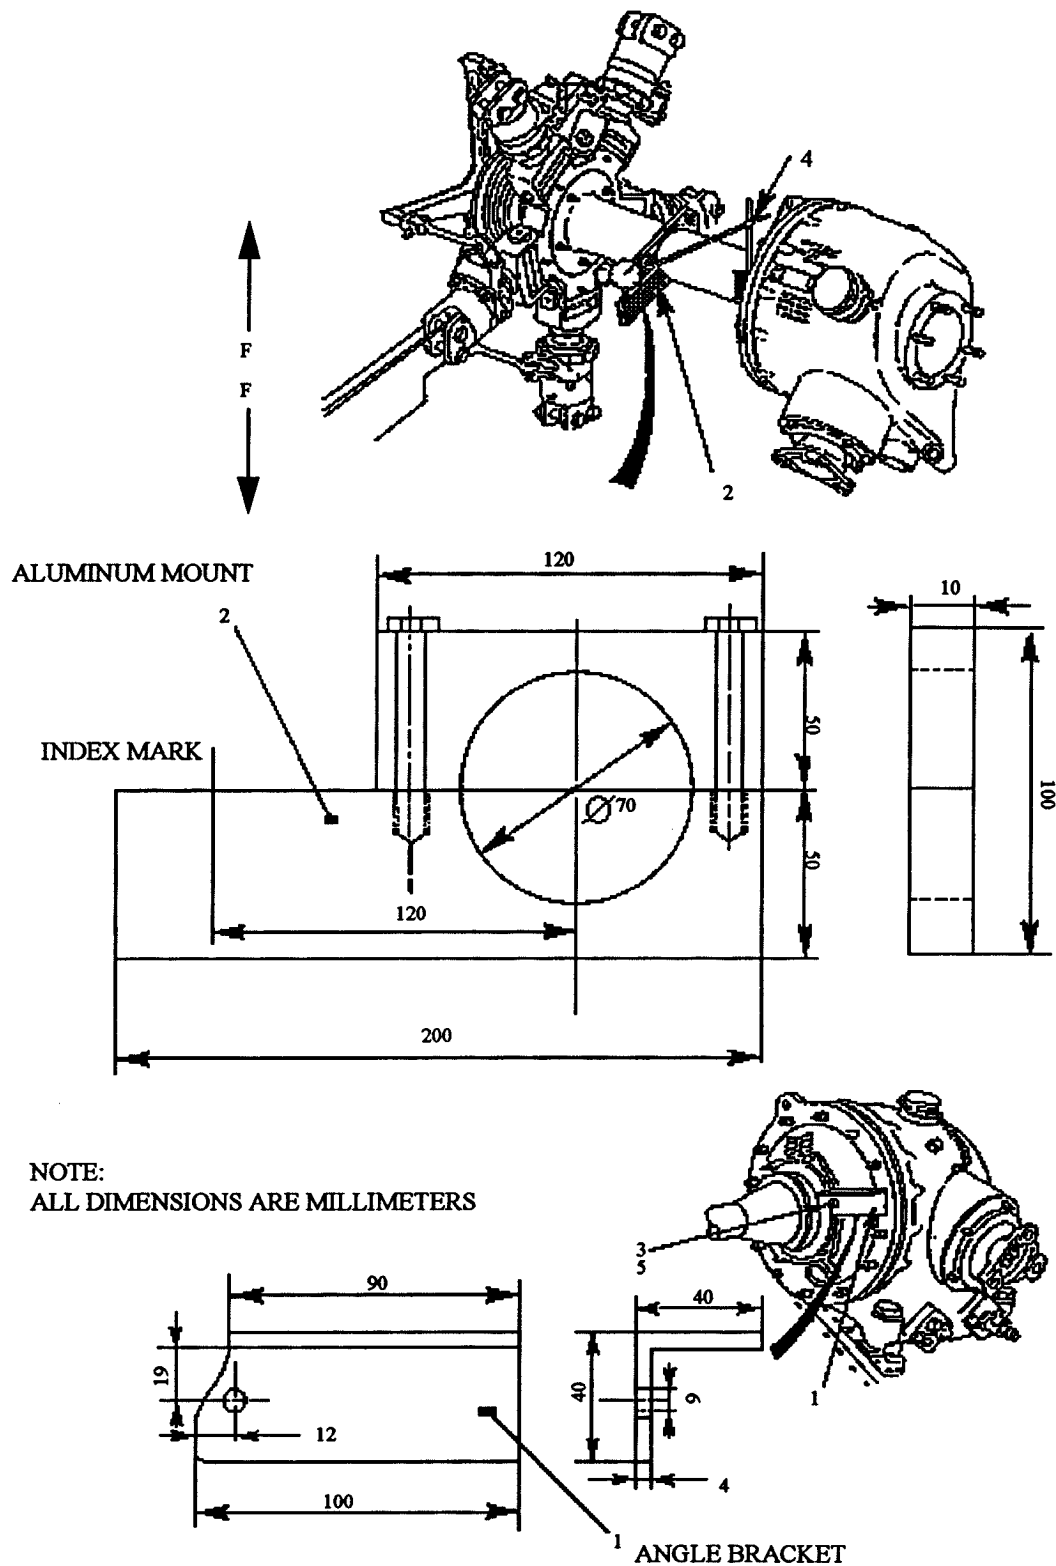
FIGURE 1

To detect excessive play between the splines of the TGB bevel gear and the bevel wheel and to prevent failure of the TGB, which could result in loss of tail rotor drive and subsequent loss of control of the helicopter, accomplish the following:

(a) For TGB that are not equipped with a tail rotor blade deicing system as shown in Figure 1, fabricate a steel angle bracket (angle bracket) (No. 1 of Figure 1) and an aluminum mount (No. 2 of Figure 1).

(1) Place a tail rotor blade in the horizontal position with the blade's tip facing forward.

(2) Immobilize the TGB input flange by placing a wooden block between the TGB input flange and the deck.

(3) Secure the angle bracket on the TGB output casing with a nut (No. 3 of Figure 1) and a washer (No. 5 of Figure 1).

(4) Secure the mount on the rotor shaft.

(5) Secure the dial indicator gage (No. 4 of Figure 1) on the angle bracket.

(6) Install the feeler of the dial indicator on the mount at the index mark which is 120 mm from the rotor shaft center line.

(7) Using a dynamometer, apply a 1 daN (2.25 lbs.) load in both directions (indicated by letter "F" in Figure 1), 30 mm from the blade tip, to measure the total play.

(1) If the play is 0.37 mm or less, comply with paragraphs (a) or (b) of this AD, as applicable, at intervals not to exceed 520 hours TIS.

(2) If the play is greater than 0.37 mm and less than 0.52 mm, comply with paragraphs (a) or (b) of this AD, as applicable, at intervals not to exceed 100 hours TIS.

(3) If the play is equal to or greater than 0.52 mm, remove the TGB and replace it with an airworthy TGB.
