[Docket No. 98-CE-01-AD; Amendment 39-10669; AD 98-15-18]

#### **Airworthiness Directives; Maule Aerospace Technology Corp. M-4, M-5, M-6, M-7, MX-7, and MXT-7 Series Airplanes and Models MT-7-235 and M-8-235 Airplanes**

**98-15-18 Maule Aerospace Technology Corp.:** Amendment 39-10669; Docket No. 98-CE-01-AD; Supersedes AD 95-26-18, Amendment 39-9476.

#### **Appendix to AD 98-15-18—Procedures and Requirements for Ultrasonic Inspection of Maule Wing Lift Struts**

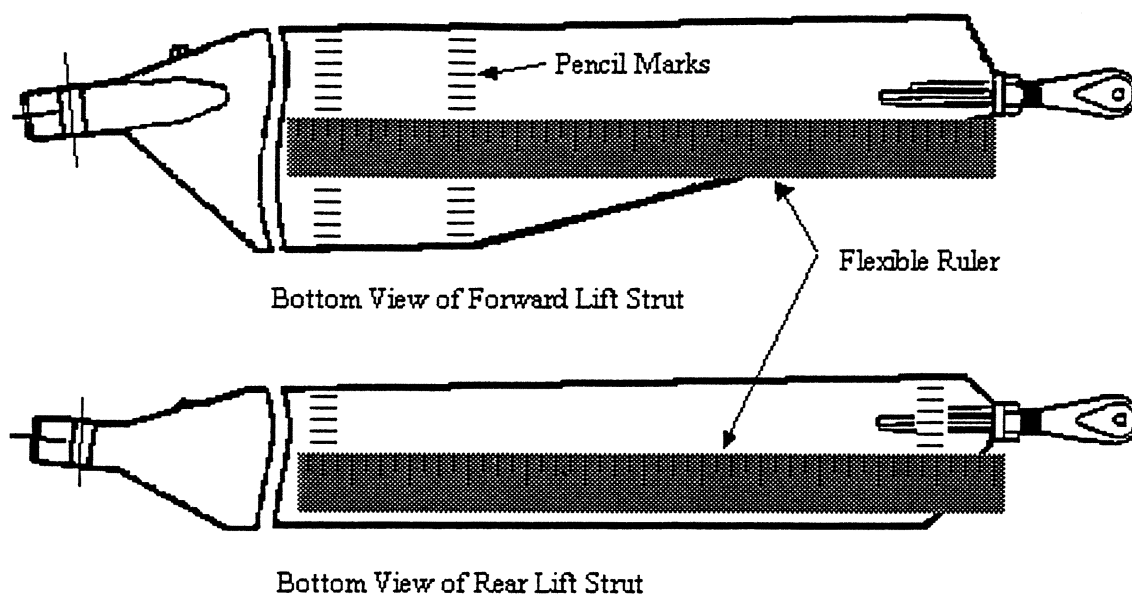
**Figure 1**

2. Using a flexible ruler, draw a  $\frac{1}{4}$ -inch grid on the surface of the first 11 inches from the lower end of the strut as shown in Piper Service Bulletin No. 528D or 910A, as applicable. This can be done using a soft (#2) pencil and should be done on both faces of the strut. As an alternative to drawing a complete grid, make two rows of marks spaced every  $\frac{1}{4}$  inch across the width of the strut. One row of marks should be about 11 inches from the lower end of the strut, and the second row should be several inches away where the strut starts to narrow. Lay the flexible ruler between respective tick marks of the two rows and use tape or a rubber band to keep the ruler in place. See Figure 1.
