Airworthiness Directives; McDonnell Douglas Helicopter Systems Model 369A, 369D, 369E, 369F, 369FF, 369H, 369HE, 369HM, 369HS, 500N, 600N, and OH-6A Helicopters

AD 98-15-26 McDonnell Douglas

Helicopter Systems: Amendment 39-10675. Docket No. 98-SW-22-AD. Supersedes Priority Letter AD 98-08-15, Docket No. 98-SW-06-AD.

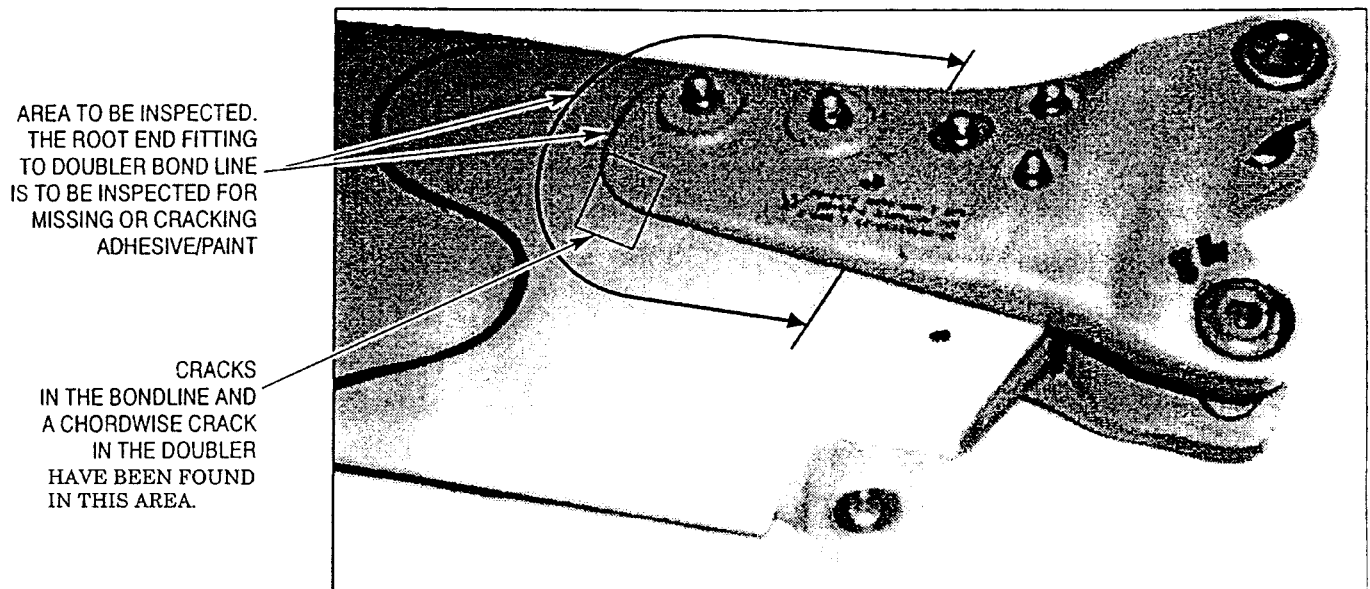
Figure 1

been caused by residual stresses induced by nonconforming doublers used to construct the blade. A fatigue crack in a blade creates an unsafe condition. That condition, if not detected, could result in failure of the blade and subsequent loss of control of the helicopter.

(1) With each blade lifted off the droop stop, using a 10X or higher magnifying glass, visually inspect the blade for any chordwise cracking starting at the root fitting edge on the blade lower surface doubler and skin or cracks on the doubler adjacent to the root end fitting (Figure 1). If any cracking is discovered, remove the blade and replace it with an airworthy blade.

(2) With each blade lifted off the droop stop, inspect the lower surface for missing or cracked adhesive or paint at the root end fitting-to-doubler bond line (Figure 1). If any missing or cracked adhesive or paint is discovered, remove and inspect the blade in accordance with paragraph 3E of Part II of the Accomplishment Instructions in McDonnell Douglas Helicopter Systems Service Information Notice No. HN-239, DN-188, EN-81, FN-67, NN-008, dated October 27, 1995. If there is any disbonding in excess of the allowable margins specified in paragraph 3E of Part II of the service information notice, replace the blade with an airworthy blade.

Main Rotor Blade Lower Surface Root Fitting and Doubler Inspection
