DEPARTMENT OF TRANSPORTATION

National Highway Traffic Safety Administration

[Docket No. NHTSA-98-4008; Notice 1]

Application for Decision of Inconsequential Noncompliance

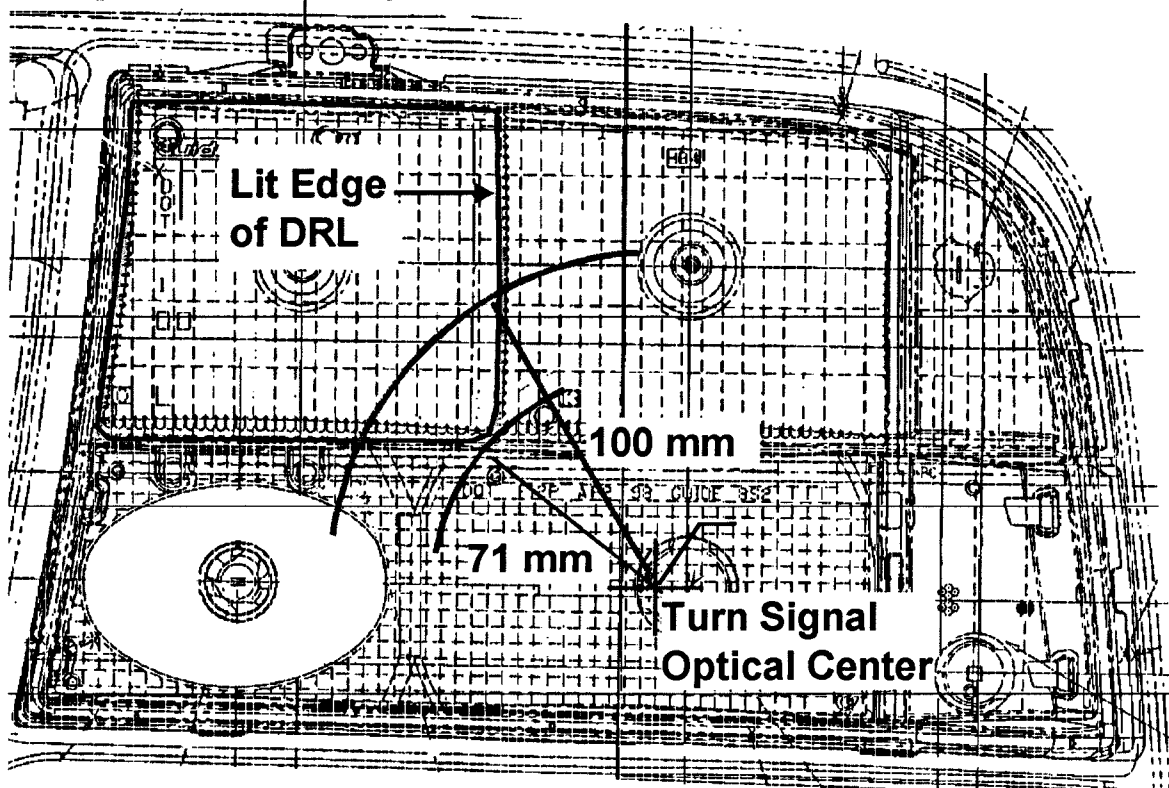
Figure 1: Jimmy, Sonoma, Bravada Lamp Asm.

conditions, they would comply with the spacing requirements of FMVSS 108 (see S5.5.11(a)(4)(iv))). In this case, the 122,455 vehicles involved provide less than the requisite 100 mm clearance between the DRL and the turn signal. As a result, they fail to meet the requirements of FMVSS 108.

4. Regardless of the whether the distance is within 15 percent or 30 percent of the 100 mm requirement, the turn signal and the DRL diagonal to each other. Therefore, the closest lighted edge of the DRL is the corner of the lamp (see figure 1). This portion of the lamp does not significantly contribute to the DRL beam pattern, and therefore does not have a significant potential to mask the turn signal.

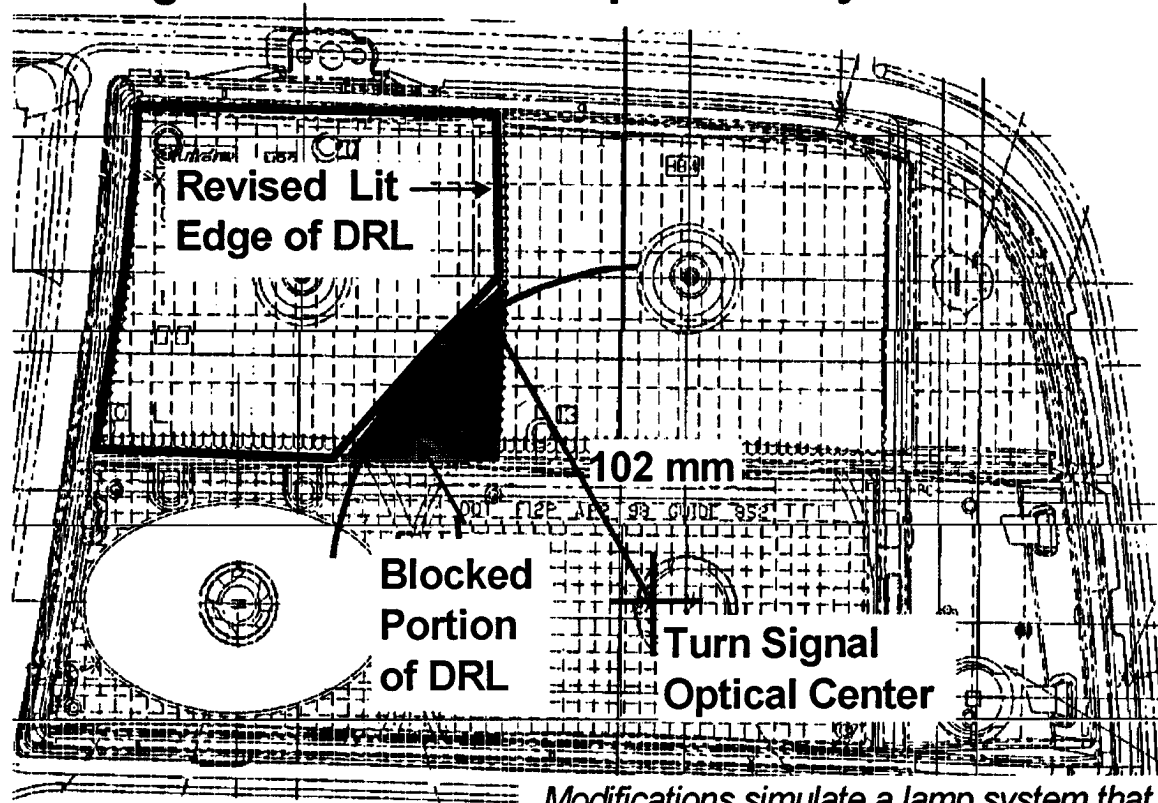
Figure 2: Modified Lamp Assembly

signal output were made using a video-based photometer (digital CCD camera system). First, the photometric output of the turn signal was measured with the DRL activated. Then a portion of the DRL was blocked, as shown in Figure 2, and the output of the turn signal was re-measured with the modified DRL activated. The zonal values of the turn signal changed an average of just 12.7 percent. The largest difference in turn signal output was found in zone 5, closest to the DRL, and it only changed 17.5 percent.

Modifications simulate a lamp system that meets the requirements in FMVSS 108

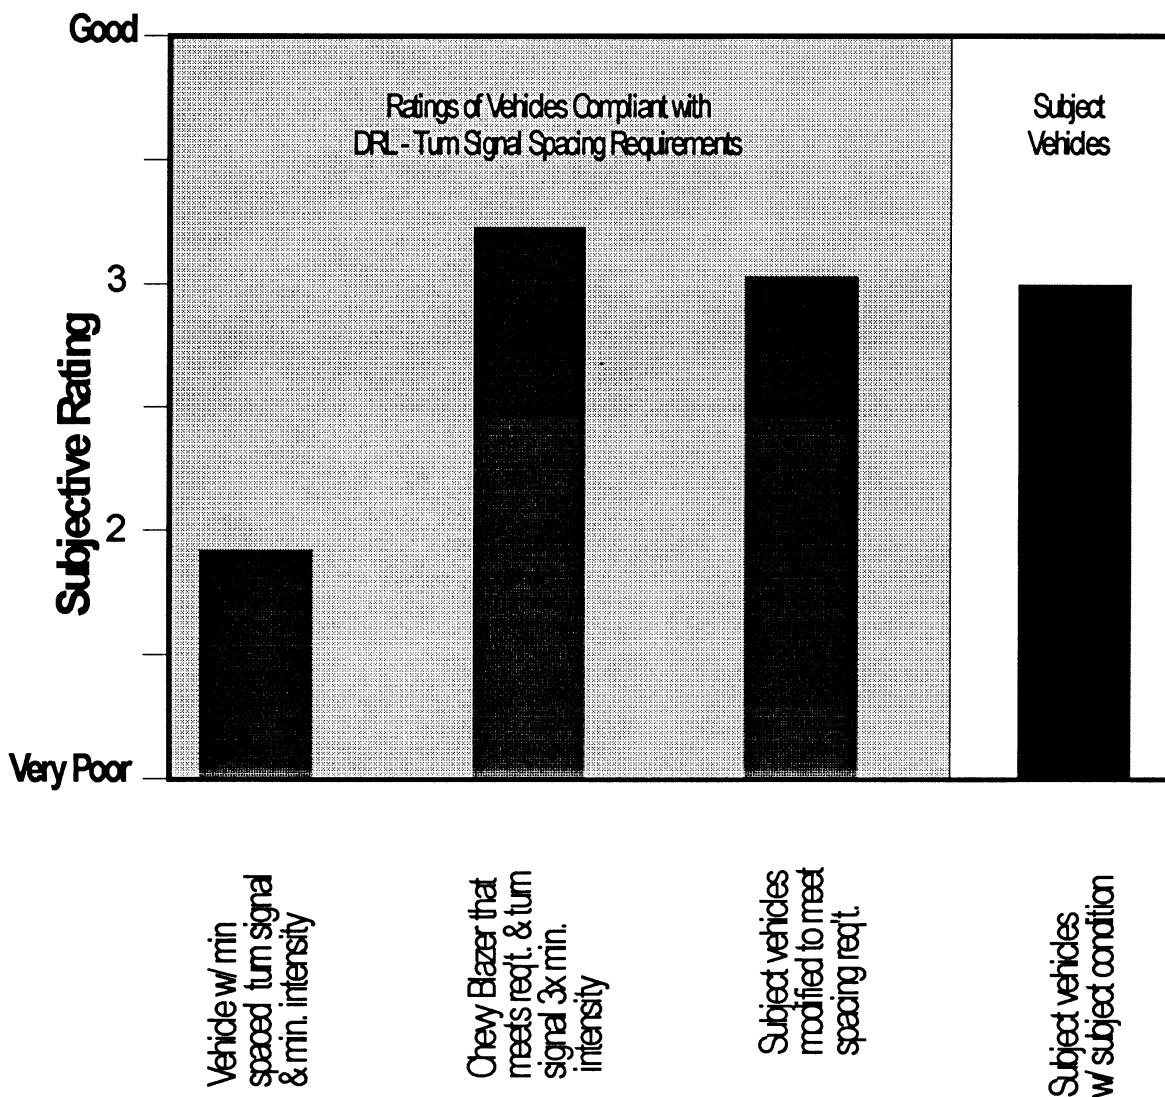
Figure 3: Subjective Evaluation of Turn Signal Visibility

6. Subjective evaluations were run using GM personnel whose jobs do not involve vehicle lighting. They were asked to rate the relative visibility of turn signals on the subject vehicles and other vehicles that meet the FMVSS 108 spacing requirement. The results, shown in figure 3, indicate the visibility of subject turn signals is substantially better than vehicles that just meet the minimum requirement. In addition, the turn signals are rated nearly identical to vehicles modified to be fully compliant to the requirements, and preferred only slightly less than turn signals on the Chevrolet Blazer (which is a similar vehicle whose turn signal/DRL spacing meets the requirements of FMVSS 108). A copy of the report *Subjective*
