[Docket No. 98-NM-236-AD; Amendment 39-10767; AD 98-20-01]

Airworthiness Directives; Bombardier Model CL-600-2B19 (Regional Jet Series 100) Series Airplanes

98-20-01 Bombardier, Inc.: Amendment 39-10767. Docket 98-NM-236-AD.

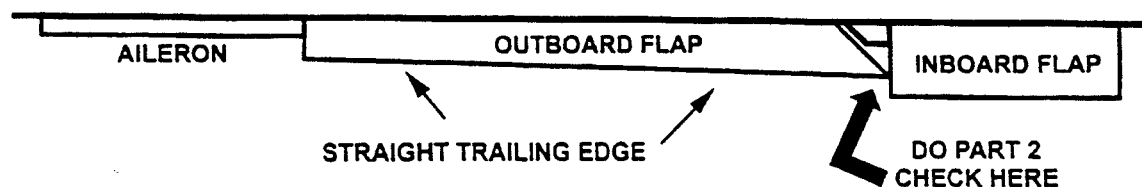
Figure 1. Normal/Abnormal Outboard Flap Configuration in Take-off Position

NORMAL/ABNORMAL OUTBOARD FLAP CONFIGURATION IN TAKE-OFF POSITION

NOTE: View looking forward on left wing trailing edge (right side opposite).

1. NORMAL

A normal outboard flap has a straight trailing edge, and the inboard corner is slightly above (i.e. higher) than the inboard flap.

2. ABNORMAL

The following are indications of an outboard flap with a twist, skew or abnormal deformation:

- Noticeable curve in the trailing edge
- Buckled top or bottom surface
- Higher than normal position of the inboard trailing edge corner

(b) An external visual check must be accomplished to detect any twisting, skewing, or abnormal deformation of the flaps, using the information given in Figures 1 and 2.

2. Carry out an external visual check of each outboard flap for evidence of twisting, skewing, or abnormal deformation. (Reference Figures 1 and 2.)

2. If there is evidence of twisting, skewing, or abnormal deformation, replace both actuators and any discrepant flap panel with new or serviceable components. In addition,

inspect flexible shaft(s) inboard of the most outboard actuator removed for discrepancies, and replace any discrepant flexible shaft with a new or serviceable flexible shaft.

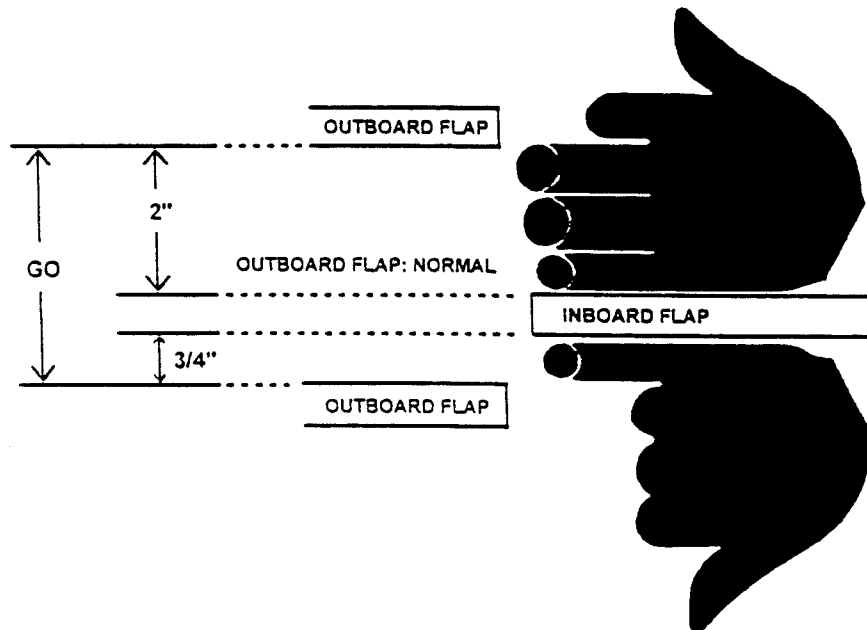
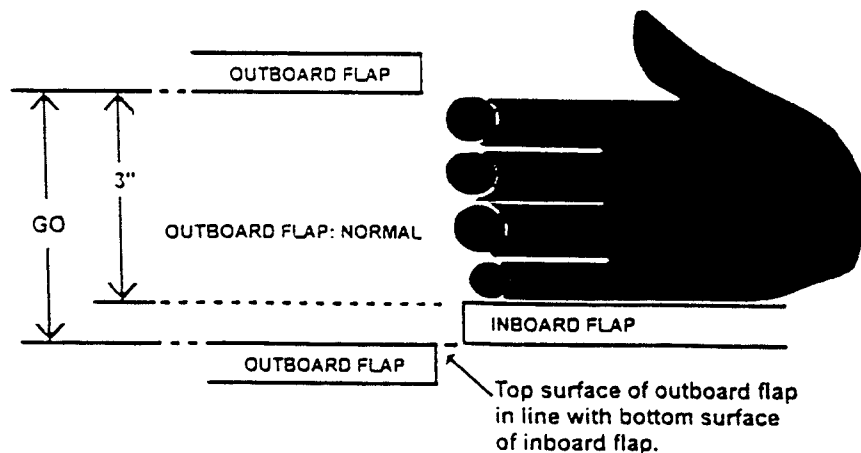
Figure 2. Outboard Flap Go/No-Go Criteria in Take-off Position

OUTBOARD FLAP GO/NO-GO CRITERIA IN TAKE-OFF POSITION

- NOTES: 1. These criteria are applicable for any size of hand.
2. View looking forward on left wing trailing edge (right side opposite).

If the outboard flap position is outside the "GO" range as shown below, further flight is prohibited.

1. FLAPS AT 8 DEGREES

**2. FLAPS AT 20 DEGREES**

IMPORTANT: If the outboard flap position is outside the "GO" range, as shown in figure 2., further flight is prohibited until required maintenance actions have been accomplished.

Whenever the outboard flap position indicator is outside the "GO" range as shown in Figure 2, or whenever directed to do so by the Maintenance Procedure above, perform the following procedures:

A. Interrogate the flap electronic control unit (FECU) per Fault Isolation Manual, Section 27-50-00, Flaps Fault Isolation, and rectify as applicable.

B. Visually check each flap for evidence of twisting, skewing, or abnormal deformation.

1. If there is no evidence of twisting, skewing, or abnormal deformation, manually isolate any jammed, disconnected, or dragging component; and rectify all discrepant conditions.
