[Docket No. 98-SW-05-AD; Amendment 39-10918; AD 98-24-32]

Airworthiness Directives; Eurocopter France Model AS-365N2, SA-360C, SA-365C, C1, C2, N, N1, and SA-366G1 Helicopters

AD 98-24-32 Eurocopter France:

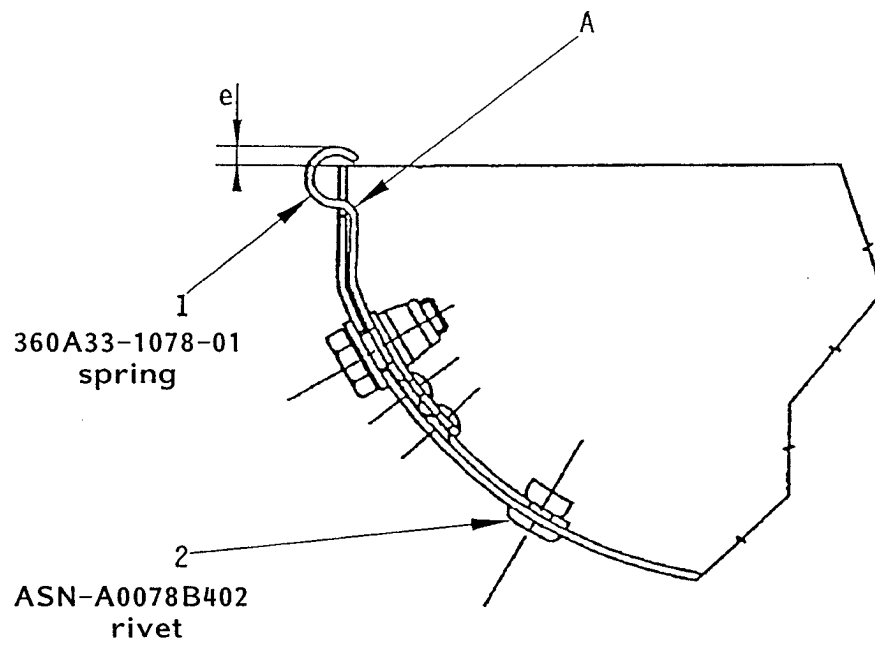
FIGURE 1
CORRECT INSTALLATION

(2) Inspect for broken springs, especially in the rounded sections at the rotor hub groove (Point A, Figure 1).

(6) Measure the outward axial protrusion (Dimension e, Figure 1), for each spring. If the protrusion dimension obtained from the measurement required by paragraph (a)(6) of this AD is less than 1mm (0.039-inches), or greater than 2.7mm (0.106 inches), either

(3) If any broken springs are discovered, replace them with airworthy springs using the procedure specified in paragraph (b) of this AD.

(i) replace the spring with an airworthy spring before further flight or,

(ii) inspect the out-of-tolerance spring(s) in accordance with paragraph (a)(2) before the first flight of each day until each spring is replaced with an airworthy spring. Any out-of-tolerance spring must be replaced with an airworthy spring within 25 hours time-in-service (TIS).

(2) Temporarily install an airworthy spring, P/N 360A33-1078-01, and verify that the axial protrusion (Dimension e, Figure 1) is within tolerance and that no interference (see Figure 2) exists.

(3) Permanently secure the new spring to the fairing with one ASN-A0078B402 rivet, coated with Mastinox 6856KD150-2, and installed with the rivet head on the outside of the fairing (see Figure 1).

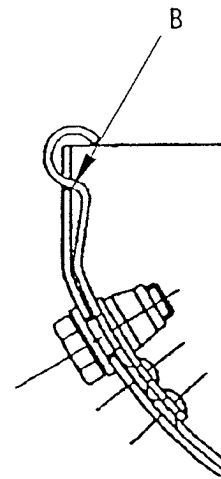
FIGURE 2
INCORRECT INSTALLATION

(5) Inspect for interference between the spring and the fairing (Point B, Figure 2), and replace any spring that exhibits such interference in accordance with the procedure specified in paragraph (b) of this AD.
