Airworthiness Directives; BFGoodrich Avionics Systems, Inc. SKYWATCH SKY497 Installations with a Top-Mounted Antenna

98-25-02 BFGoodrich Avionics Systems, Inc.: Amendment 39-10924, Docket No. 98-CE-107-AD.

**APPENDIX TO AD 98-25-02;
AMENDMENT 39-10924; DOCKET NO. 98-CE-107-AD.**

**POWER-UP PROCEDURES FOR SKYWATCH SKY497
INSTALLATIONS WITH A TOP-MOUNTED ANTENNA**

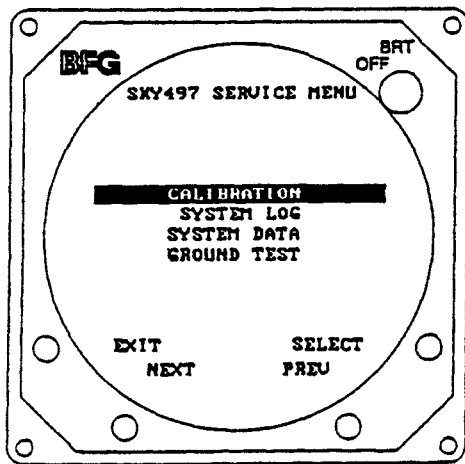
Figure 1.

1. If a WX-1000 is installed with the SKYWATCH, ensure that the STORMSCOPE/CWS switch is in the CWS position.
2. At the SKYWATCH display, access the service menu by holding the left two buttons depressed and switch the system on. Hold the buttons until the Service Menu is displayed. The Service Menu is shown in figure 1.

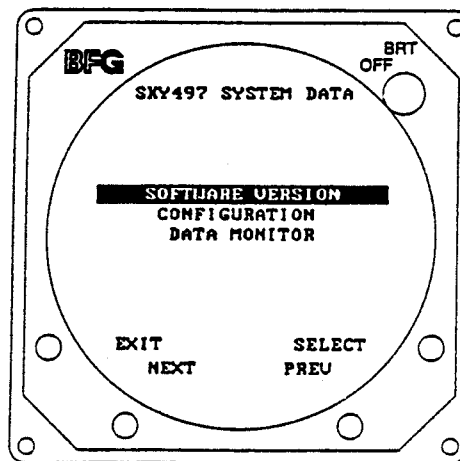
Figure 2.

3. Highlight SYSTEM DATA (press NEXT button two times) and then press SELECT. The SYSTEM DATA screen, as shown in figure 2 will be displayed.
4. Highlight CONFIGURATION by pressing the NEXT button and then press SELECT. The configuration display consists of 4 pages. Advance to Page 3 of 4 (see figure 3) by pressing the NEXT button two times.
5. Verify that the antenna position is configured for TOP mount (i.e., as shown in figure 3).

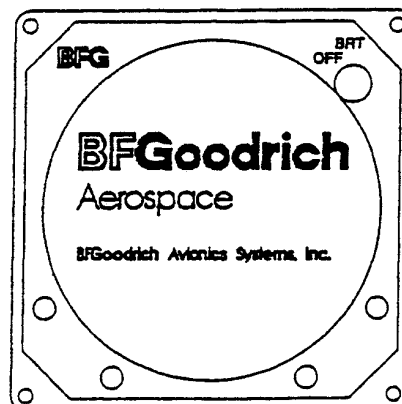
Figure 4.

6. If the antenna configuration is correct, press EXIT until the start-up screen (see figure 4) is displayed.
