[Docket No. 97-SW-60-AD]

Airworthiness Directives; Sikorsky Aircraft-Manufactured Model CH-54A Helicopters

ACTION: Notice of proposed rulemaking (NPRM).

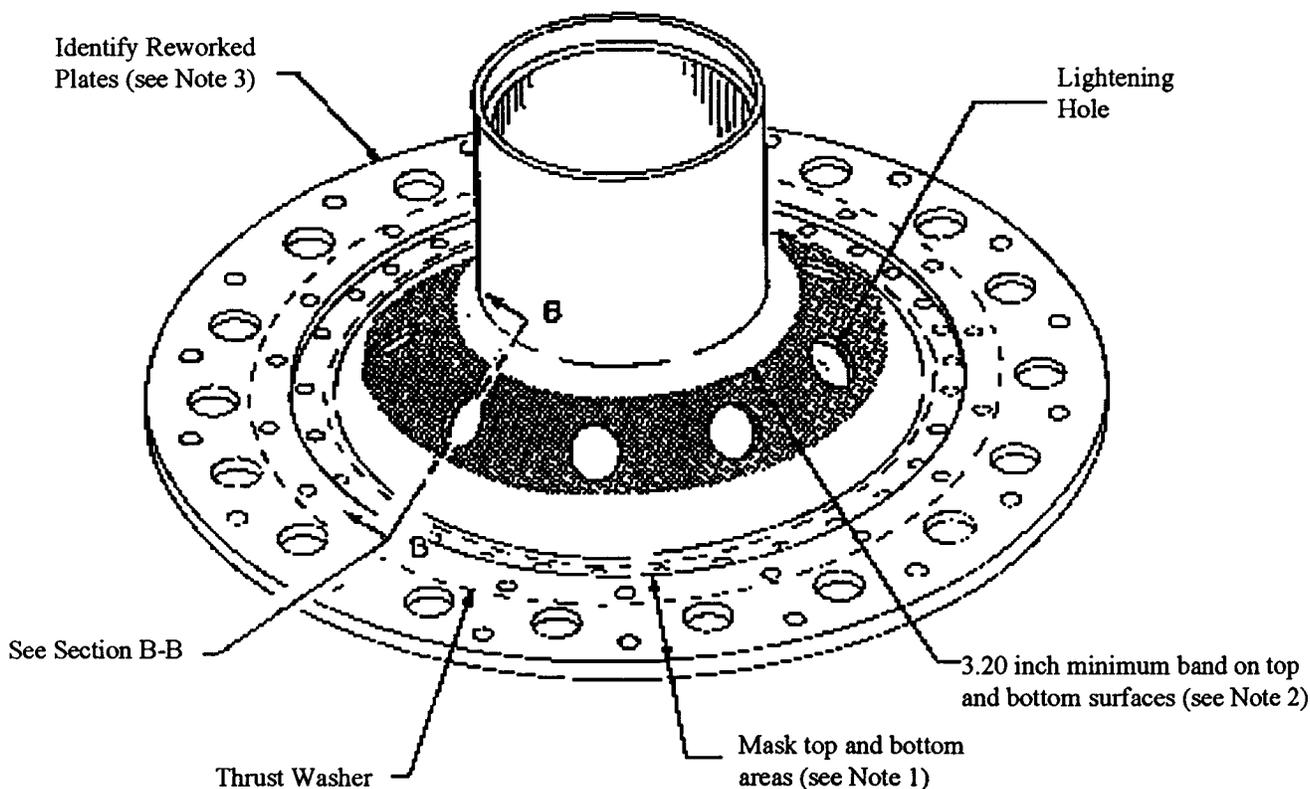
Rework of Second Stage
Lower Planetary Plate (6435-20229-102)
Figure 1

(a) On or before accumulating 1,300 hours time-in-service (TIS) conduct a fluorescent magnetic particle inspection of the plate, P/N 6435-20229-102, in the circumferential and longitudinal directions using the wet continuous method. Pay particular attention to the area around the 9 lightening holes.

1. Mask top and bottom areas to protect from liquid air-grit and shot peen.
2. Shaded area to be liquid air-grit blasted and shot peened includes plate top and bottom surfaces and I.D. of all lightening holes. Feather shot peened surface edges.
3. Use low-stress depth controlled impression-stamp with full fillet depth of no more than 0.003 inch.
4. Reworked machined surface roughness shall not exceed 63 microinches AA rating.

Section B-B

(Typical Nine Places)

(i) Locate the center of each 1.750 inch-diameter lightning hole and machine holes 0.015 to 0.020 oversize on a side (0.030 to 0.040 diameter oversize). Machined surface roughness must not exceed 63 microinches AA rating (see Figure 1).

(ii) Radius each hole 0.030 to 0.050 inches on each edge as shown in Figure 1.

(iii) Mask the top and bottom surfaces of the plate to expose 3.20 inch minimum width circumferential band as shown in Figure 1.

(v) Shot peen exposed surfaces and inside and edges of lightening holes to 0.008—0.012A intensity. Use cast steel shot, size 170; two hundred percent coverage is required. Use the tracer dye inspection method to ensure the required coverage. Also, visually inspect the shot peened surfaces for correct shot peen coverage. Inspect the intensity of the shot by performing an Almen strip height measurement.

(viii) Identify the reworked plate by adding "TS-107" after the part number using a low-stress depth-controlled impression-stamp with a full fillet depth of not more than 0.003 inch (see Figure 1).

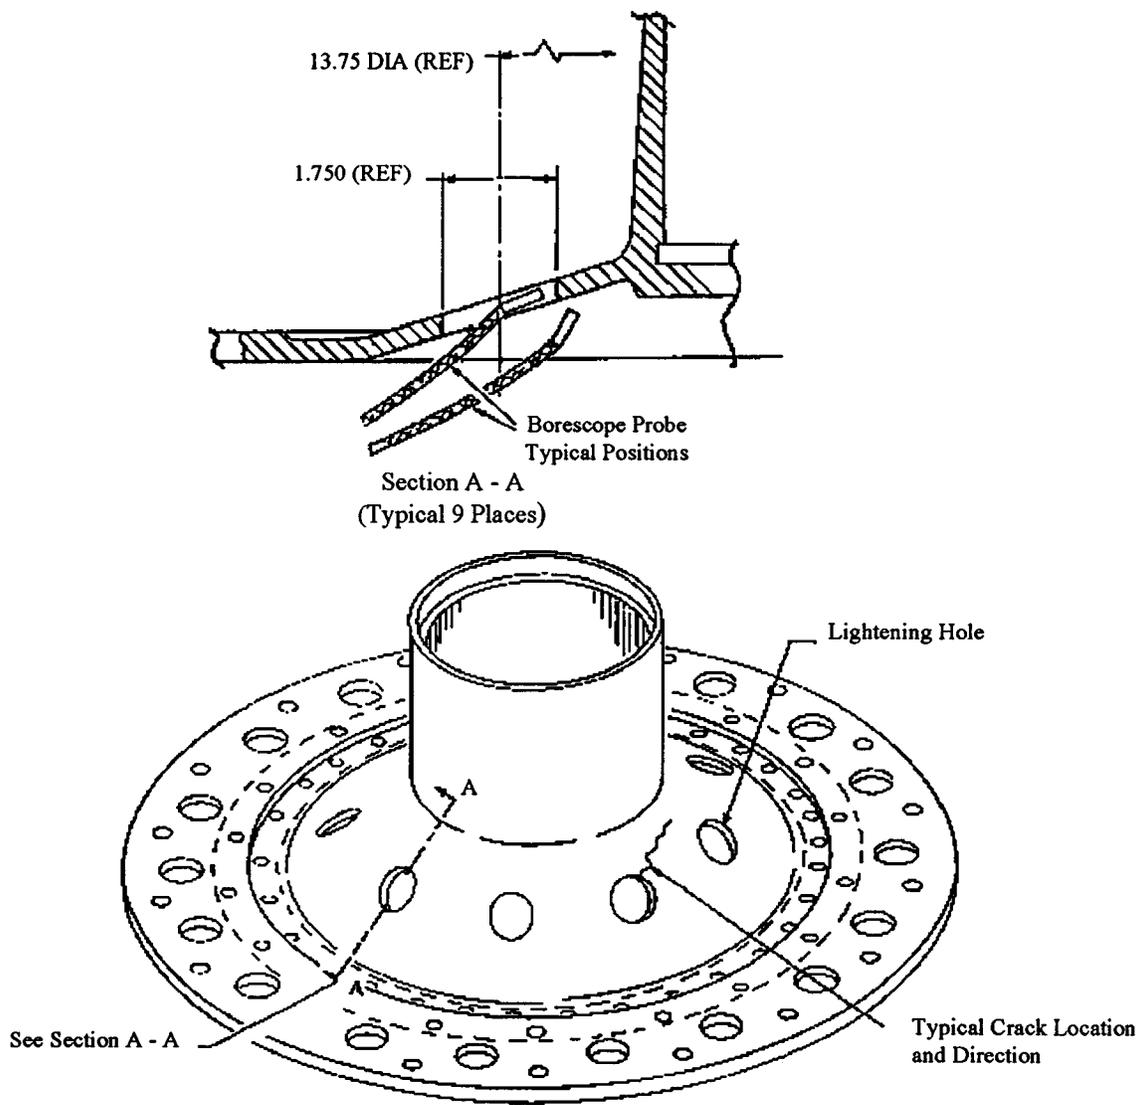
Borescope Inspection of
Second Stage Lower Planetary Plate
Figure 2

not to exceed 70 hours TIS, accomplish the following:
(1) Inspect the plate for a crack in the area around all nine lightening holes using a

Borescope or equivalent inspection method (see Figure 2).
(2) If a crack is found, replace the plate with an airworthy plate.
