[Docket No. 98-SW-33-AD; Amendment 39-10936; AD 98-25-10]

#### Airworthiness Directives; Aircraft Belts, Inc. Model CS, CT, FM, FN, GK, GL, JD, JE, JT, JU, MD, ME, MM, MN, NB, PM, PN, RG, and RH Seat Restraint Systems

#### **AD 98-25-10 Aircraft Belts, Inc.:**

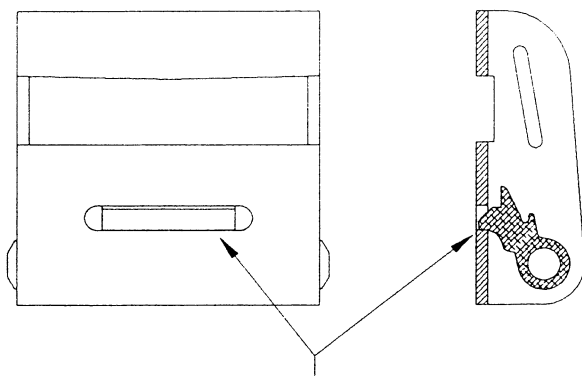
RIGHT

(3) After the lever is completely closed, examine the slot in the bottom of the buckle. The locking mechanism should be firmly seated against the edge of the slot as shown in Figure 1.

THE LEDGE OF THE LOCKING MECHANISM MUST BE FIRMLY SEATED ON THE BOTTOM EDGE AS SHOWN.

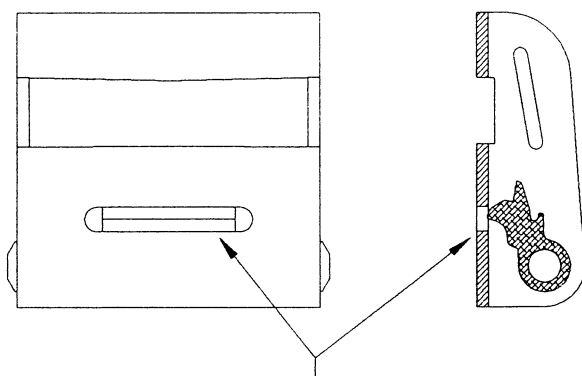
WRONG

To prevent failure of the seat restraint system due to the buckle assembly (buckle) locking mechanism not engaging properly, which could result in the seat restraint system failing to properly secure the occupant during turbulence or landing, accomplish the following:

THE LEDGE OF THE LOCKING MECHANISM IS NOT FIRMLY SEATED ON THE BOTTOM EDGE.

(b) If the locking mechanism does not seat properly, replace the buckle with an airworthy buckle.
