[Docket No. 2000-SW-38-AD]

Airworthiness Directives; Marathon Power Technologies Company

ACTION: Notice of proposed rulemaking (NPRM).

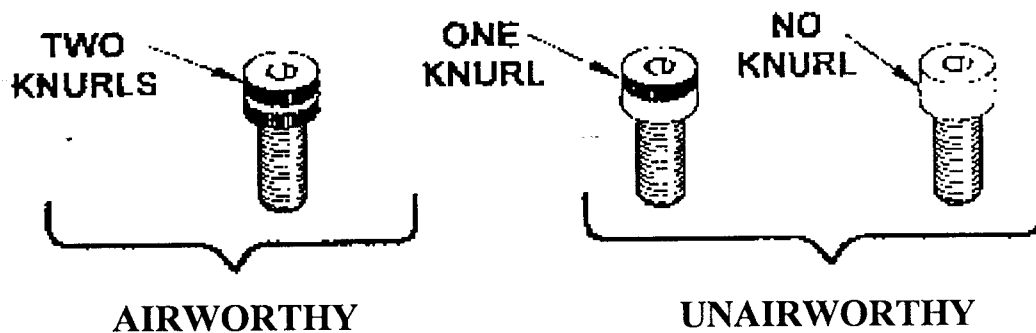
Figure 1

prompted by an explosion of a G.E./Saft battery during routine maintenance on a McDonnell Douglas DC-9 aircraft. Marathon battery, P/N 27183-001, is similar to the GE/Saft battery that exploded. A battery cell screw head broke off causing an electrical short circuit between the internal battery cell positive and negative posts. This resulted in a rapid discharge of energy, heat, and gases. Investigation revealed unapproved screws were installed, and maintenance procedures did not comply with the manufacturer's recommendations. Metallurgical tests cited chloride as a factor in causing the heads of the failed screws to shear and the eventual explosion of the battery. The actions specified by the proposed AD are intended to prevent an explosion of a battery, structural damage, and subsequent loss of power to the electrical systems.

(a) Visually inspect each #10-32 screw in the battery at the terminals to verify that each screw has two (2) rows of straight knurls (see Figure 1). If a screw is found with only one knurl or no knurl (see Figure 1), before further flight, fully discharge the battery, remove the unairworthy screw and replace it with an airworthy screw, P/N 10488-020.

replacing any unairworthy screw with an airworthy screw, P/N 10488-020.
