[Docket No. 2001-SW-13-AD; Amendment 39-12408; AD 2001-17-17]

Airworthiness Directives; Bell Helicopter Textron, Inc. Model 47B, 47B-3, 47D, 47D-1, 47G, 47G-2, 47G2A, 47G-2A-1, 47G-3, 47G-3B, 47G-3B-1, 47G-3B-2, 47G-3B-2A, 47G-4, 47G-4A, 47G-5, 47G-5A, 47H-1, 47J, 47J-2, 47J-2A, and 47K Helicopters

ACTION: Final rule.

2001-17-17 Bell Helicopter Textron, Inc.:
Amendment 39-12408. Docket No. 2001-SW-13-AD. Supersedes AD 2000-18-51, Amendment 39-11983, Docket No. 2000-SW-35-AD.

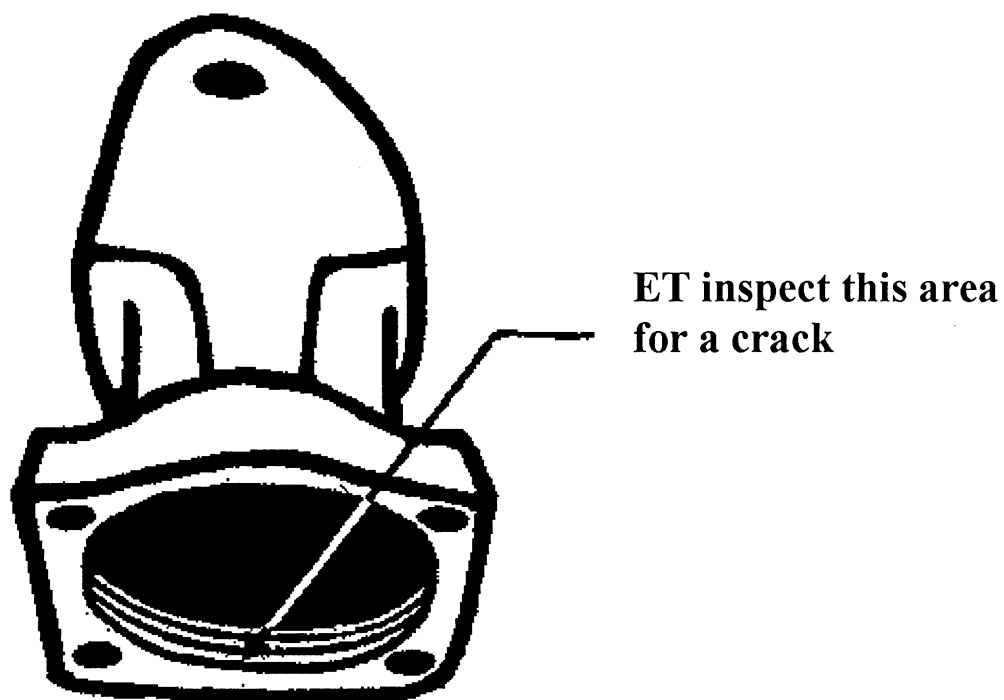
Figure 1, Appendix 1

1.1 The inboard inside diameter machined threads (reference figure 1).

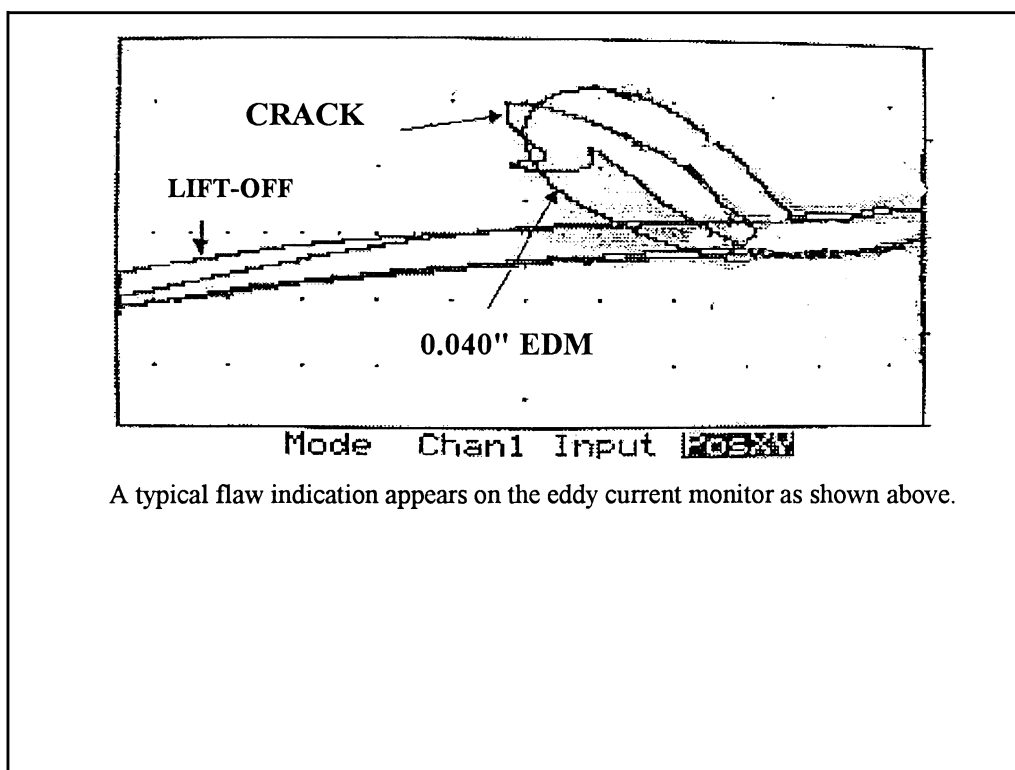
Figure 2, Appendix 1

6.1 Place the probe into the threaded area and slide it in the same direction as was done on the standard while monitoring the screen for root cracks. Moving the probe in the same direction produces a repeatable display that allows for more accurate flaw size determination. Scan the probe along each individual thread until all the threads are inspected. (See Figures 2 and 3.)

A special eddy current probe shaped to fit the thread and containing a coil positioned so that its ferrite core is contiguous with the root of the thread.

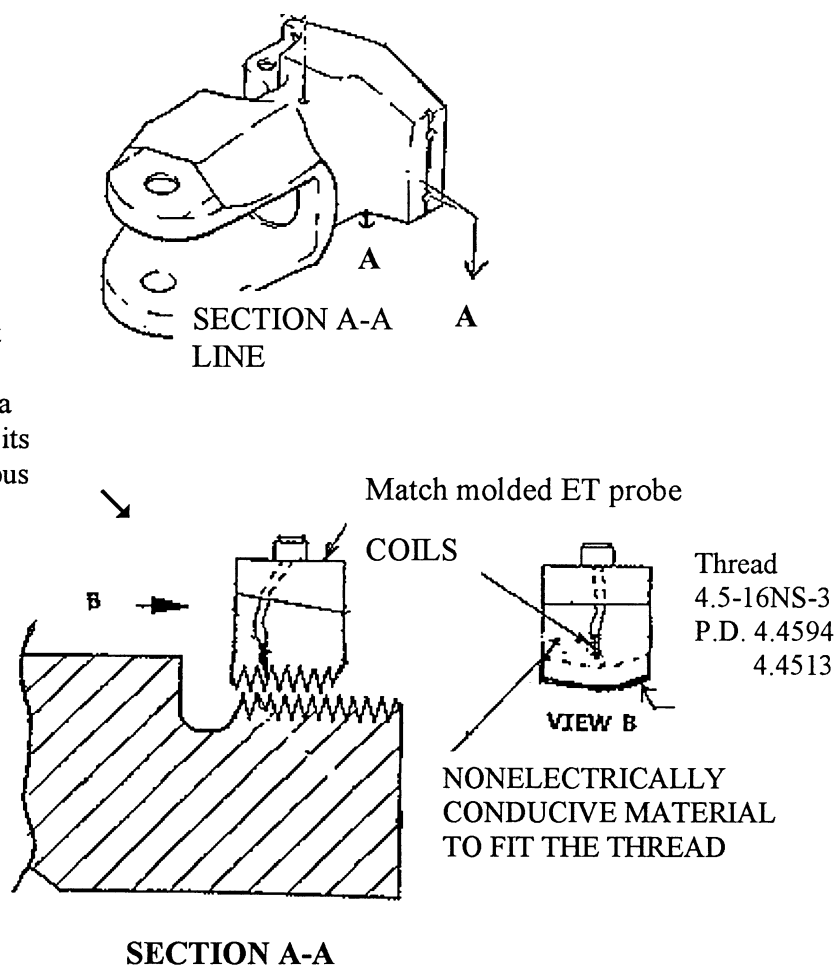
Figure 3, Appendix 1

2.2 Match molded ET probe SPC-193 (100kHz) or equivalent. (See Figure 3.)

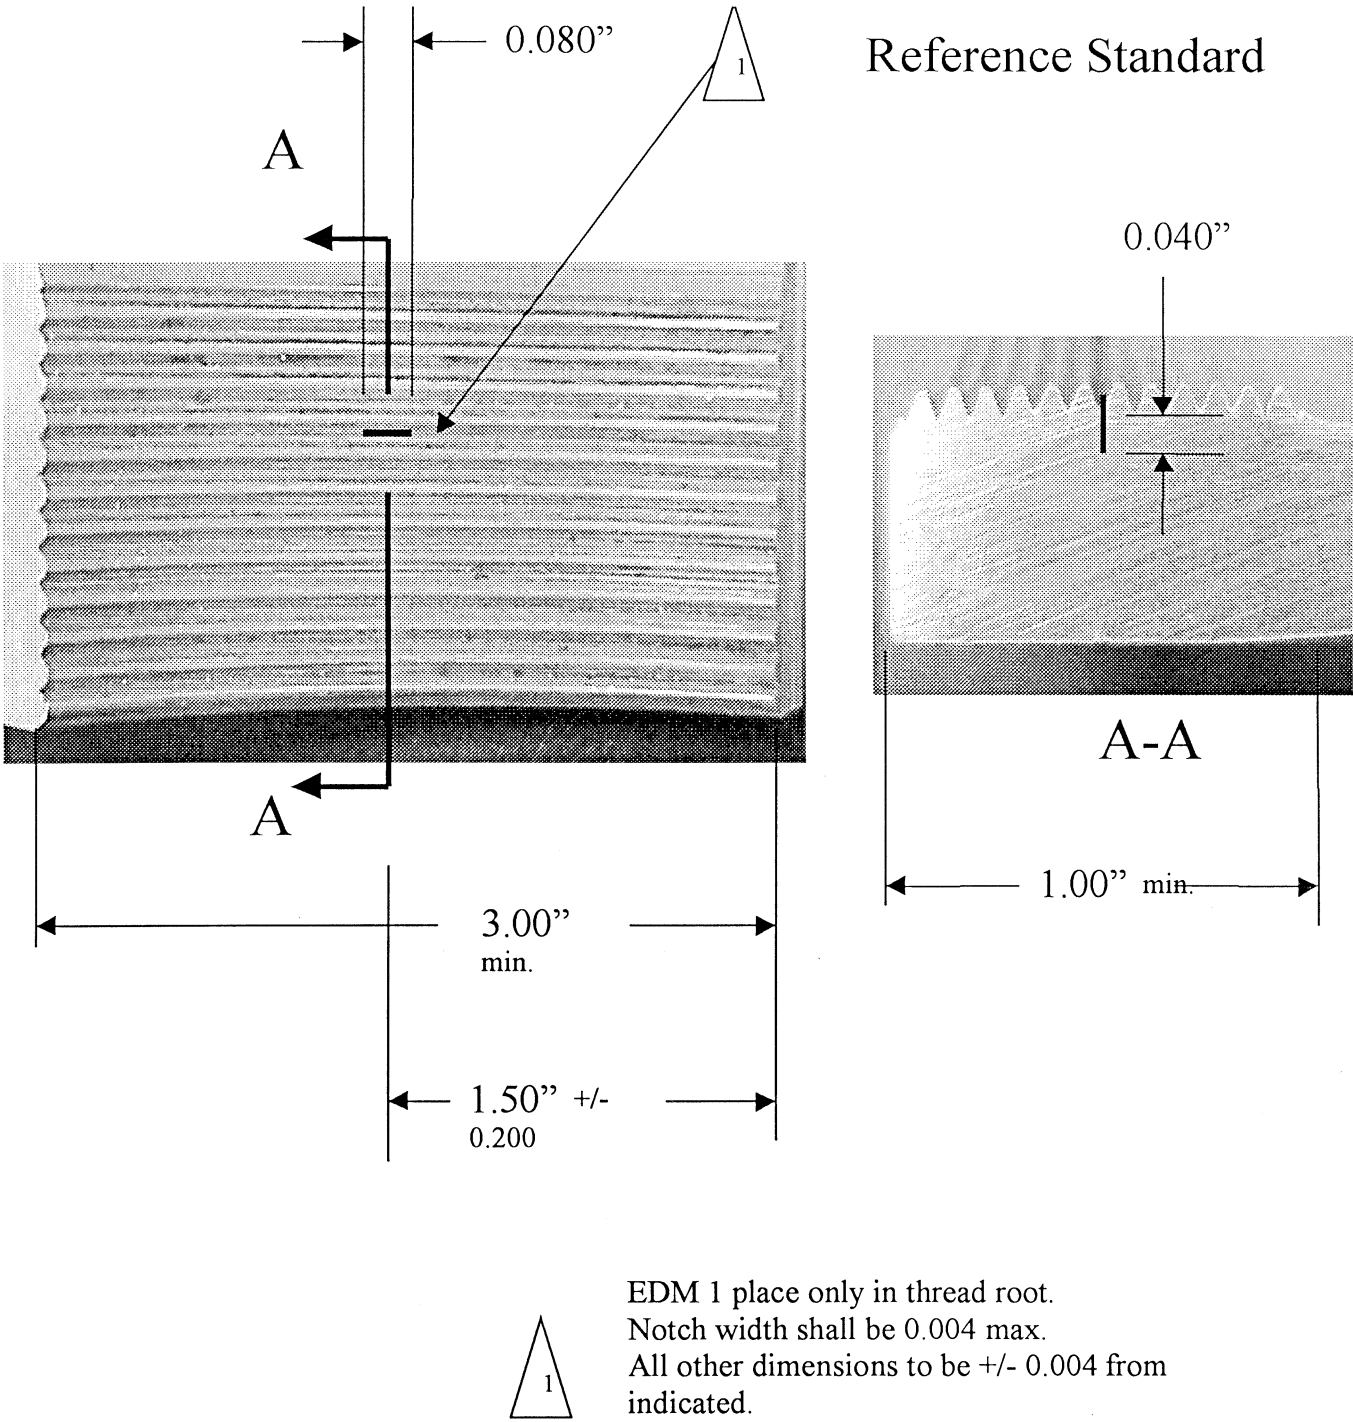
Figure 4, Appendix 1

2.3 Reference standard EC-010-021, or equivalent. (See Figures 4 and 5.)
