## DEPARTMENT OF TRANSPORTATION

[Docket No. 2000–SW–37–AD; Amendment 39–12449; AD 2001–20–03]

#### **Airworthiness Directives; Bell Helicopter Textron Canada Model 206L–4 Helicopters**

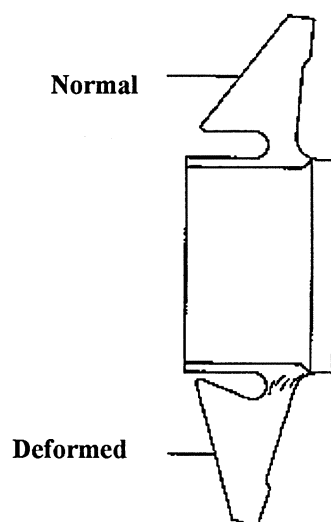
**Figure 1**

(b) Before each engine start, check the indicator for damage in accordance with Figure 1 of this AD. If damage is found, before further flight, replace the damaged indicator with an airworthy indicator, and replace the tail rotor yoke, P/N 406-012-102-107, with an airworthy tail rotor yoke.

**Normal and Deformed (damaged) Indications of the  
High Altitude Tail Rotor Static Stop Yield Indicator (P/N 206-011-752-101)**
