DEPARTMENT OF TRANSPORTATION**Federal Aviation Administration****14 CFR Part 39**

[Docket No. 2002–SW–46–AD; Amendment 39–12910; AD 2002–21–04]

Airworthiness Directives; Agusta S.p.A. Model A119 Helicopters

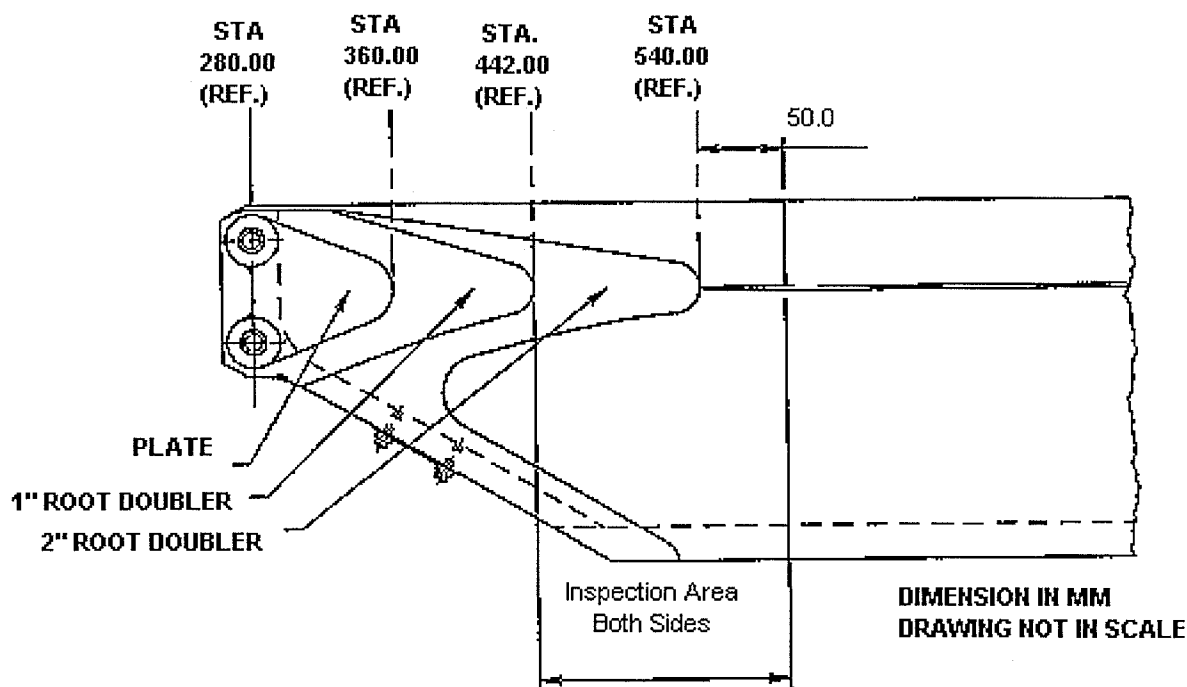
FIGURE 1

(b) Before each start of the helicopter engine, visually check both sides of each tail rotor blade for a crack in the area depicted in Figure 1 of this AD. An owner/operator (pilot) holding at least a private pilot certificate may perform this visual check and must enter compliance with this paragraph into the aircraft maintenance records in accordance with 14 CFR 43.11 and 91.417(a)(2)(v). See Figure 1:

Part Number 109-8132-01-111 Tail Rotor Blade

Note 2: Paint irregularities on the tail rotor blade may be due to a crack.

(c) Within 25 hours time-in-service (TIS), and thereafter at intervals not to exceed 25 hours TIS, and any time an increase in vibration levels occur, using a 5x or higher magnifying glass, visually inspect each tail rotor blade for a crack in accordance with the Compliance Instructions, Part III, paragraphs 1. through 5., of the BT. Reporting to Agusta Service Engineering is not required. If you are unable to determine by the visual inspection whether there is a crack, dye penetrant inspect the tail rotor blade for a crack in accordance with the Compliance Instructions, Part III, paragraph 6., of the BT.

(d) Replace any cracked tail rotor blade with an airworthy blade before further flight.
