[Docket No. FAA-2011-1115; Directorate Identifier 2010-SW-011-AD; Amendment 39-17017; AD 2012-08-01]

Airworthiness Directives; Sikorsky Aircraft Corporation Helicopters

2012-08-01 Sikorsky Aircraft Corporation:

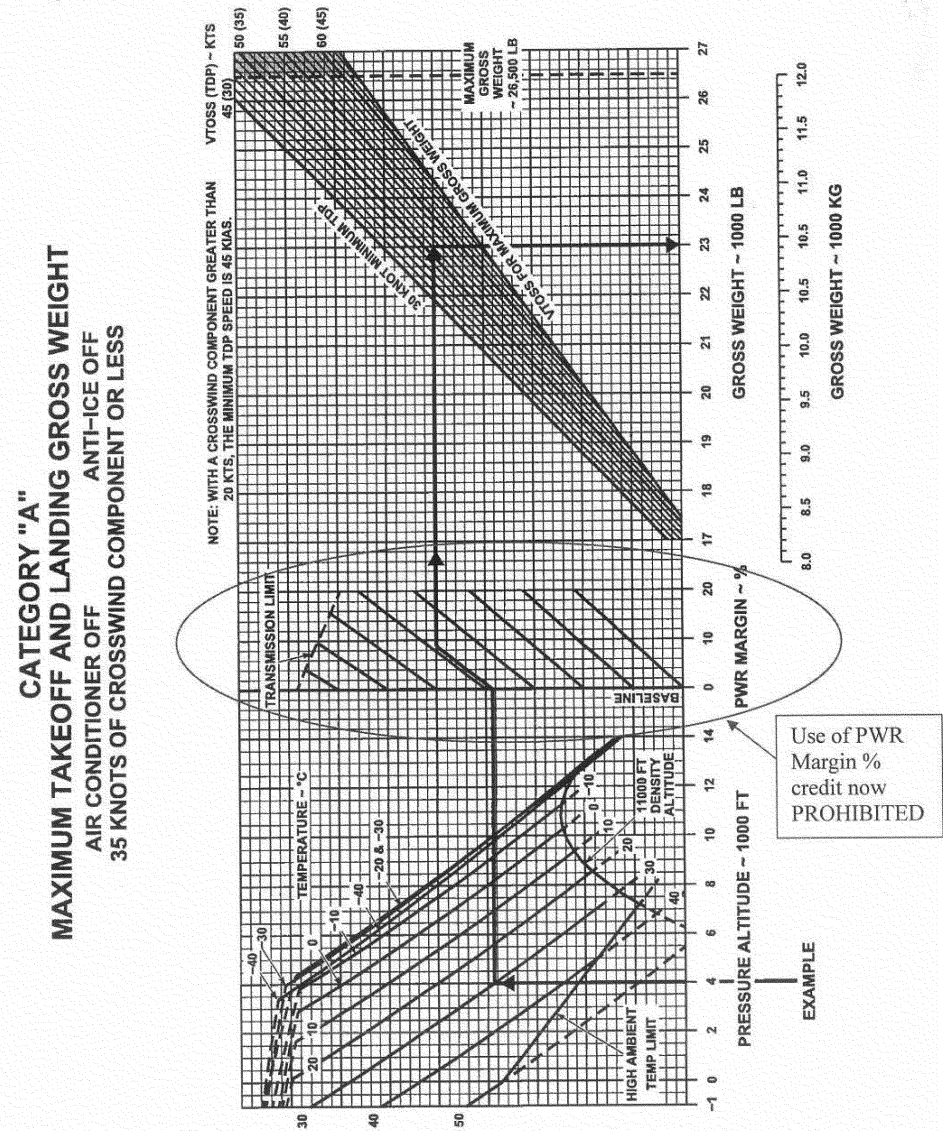
Figure 1. Cat 'A' Takeoff and Landing Gross Weight

(2) If the RFM already contains the revisions appropriate for your helicopter as listed in the following Table 1, all dated April 9, 2008, with the correct performance charts, without the performance credit as depicted in the circled area of Figure 1 of this AD, the operating limitation required by paragraph (1) of this AD does not need to be inserted into the RFM.

Note to paragraph (e)(2) of this AD:
Previous RFM revisions allowed for the use of above-specification engine power margin as depicted in the circled area of Figure 1 of this AD.

(1) By making pen and ink changes, insert into the Operating Limitations section, Part 1, Section 1, Weight Limits, of Rotorcraft Flight Manuals (RFMs) SA S92A-RFM-002, -003, -004, -005, and -006 the following limitation “Performance credit for above specification engine power margin is prohibited.”
