Airworthiness Directives; Eurocopter France Helicopters

SUMMARY: We are adopting a new airworthiness directive (AD) for Eurocopter France (Eurocopter) Model EC225 helicopters with certain epicyclic modules installed. This AD requires inspecting the epicyclic module for the presence of a through-hole upstream of the magnetic plug. This AD is prompted by a report of a missing through-hole between the integrated collector and the magnetic plug, which would prevent the flow of chips from the integrated collector to the magnetic plug. This could result in the chip-detector system failing to detect deterioration of the main rotor mast lift bearing (lift bearing). These actions are intended to detect a missing through-hole and prevent lift bearing failure and subsequent loss of control of the helicopter.

2012-21-09 Eurocopter France:
Amendment 39-17225; Docket No. FAA-2012-1128; Directorate Identifier 2012-SW-064-AD.

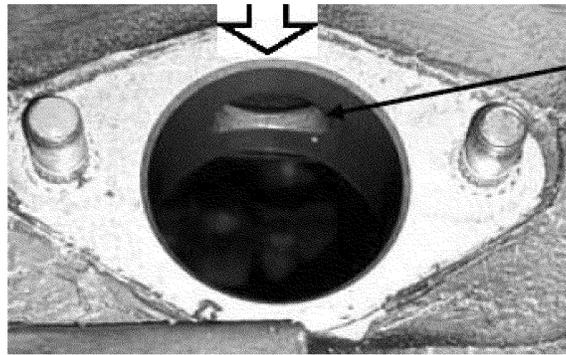
Figure 1 to paragraph (e)(1)(ii)

This AD defines the unsafe condition as a missing through-hole, joining the integrated collector to the magnetic plug. This condition could result in failure of the chip-detector system to detect deterioration of the main rotor mast lift bearing, failure of the lift bearing, and subsequent loss of control of the helicopter.

(ii) Determine if the hole above the magnetic plug is a through-hole as shown in figures 1 and 2 to paragraph (e)(1)(ii) of this AD.

(2) If the hole above the magnetic plug is not a through-hole, before further flight,

replace the epicyclic module with an airworthy epicyclic module.
