Airworthiness Directives; Eurocopter Deutschland GmbH Helicopters

2012–10–53 Eurocopter Deutschland GMBH (ECD): Amendment 39–17254; Docket No. FAA–2012–1188; Directorate Identifier 2012–SW-049–AD.

This AD defines the unsafe condition as a crack in the MRH shaft flange, which could result in failure of the MRH shaft and subsequent loss of control of the helicopter.

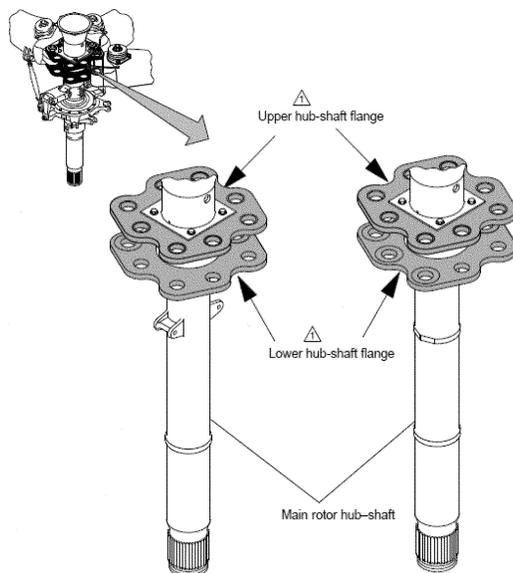
- (i) Remove rotor-hub cap.
- (ii) Clean the upper and lower MRH shaft flange as depicted in Figure 3 to Paragraph

(f)(2)(ii) of this AD and visually inspect for a crack.

△ Check visible area of the upper and lower hub-shaft flange.

(3) If there is a crack in the upper or lower MRH shaft flange, before further flight, replace the MRH shaft. Replacing the MRH shaft with an MRH shaft having a part number listed in the applicability of this AD does not constitute terminating action for the requirements of this AD.

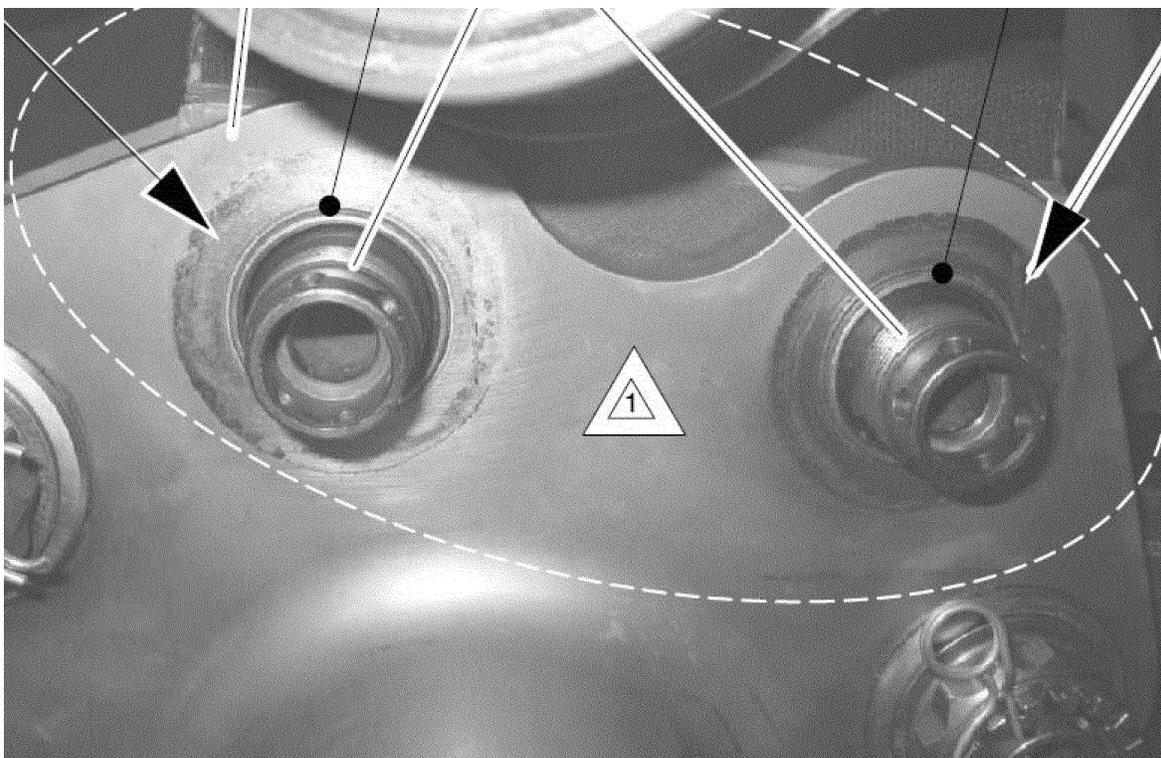
(iv) Clean the blade bolt attachment area.
 (v) Using a 10X or higher power magnification, inspect all lower MRH shaft

flange blade bolt attachment areas for a crack as shown in Figure 4 to Paragraph (f)(2)(v) of this AD.
