[Docket No. **FAA-2012-0630**; Directorate Identifier **2011-SW-010-AD**; Amendment **39-17409**; AD **2013-07-05**]

Airworthiness Directives; Eurocopter France Helicopters

ACTION: Final rule.

2013-07-05 Eurocopter France:

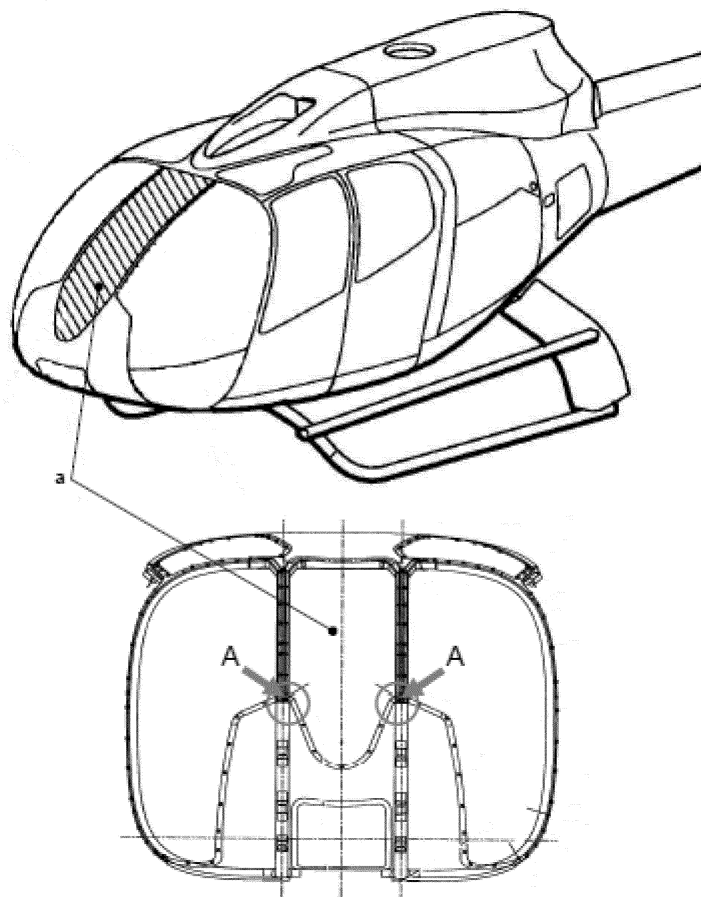
Figure 1 to Paragraph (e)(1)

This AD defines the unsafe condition as a crack in the blending radii of the center windscreen, which could lead to failure of the center windscreen, injury to the flight crew, and subsequent loss of control of the helicopter.

(1) Until the center windscreen is replaced with center windscreen P/N 350A25-9045-20, before each flight, visually check the center windscreen for a crack in the area of the blending radii where the front-lower part of the center windscreen joins the front fuselage as depicted in Figure 1 to paragraph (e)(1) of this AD. This visual check may be performed by the owner/operator (pilot) holding at least a private pilot certificate, and must be entered into the aircraft records showing compliance with this AD in accordance with Title 14 Code of Federal Regulations (14 CFR) 43.9 (a)(1)-(4) and 14 CFR 91.417(a)(2)(v). The record must be maintained as required by 14 CFR 91.417, 121.380, or 135.439.

(2) If there is a crack or if a pilot indicates that the center windscreen distorted during flight, before further flight, replace the center windscreen with an airworthy center windscreen, P/N 350A25-9045-20, in accordance with the Accomplishment Instructions, paragraphs 2.B.2.b. through 2.B.2.b.4., of Eurocopter Service Bulletin No. 56-003, Revision 0, dated November 16, 2010.

(3) Within 12 months, replace the center windscreen with an airworthy center windscreen, P/N 350A25-9045-20, in accordance with the instructions contained in paragraph (e)(2) of this AD.

(4) Replacing the center windscreen with center windscreen, P/N 350A25-9045-20, constitutes terminating action for the requirements of this AD.
