[Docket No. FAA-2013-0019; Directorate Identifier 2010-SW-051-AD; Amendment 39-17485; AD 2013-12-07]

Airworthiness Directives; Bell Helicopter Textron Canada Helicopters

2013-12-07 Bell Helicopter Textron

Canada (BHTC): Amendment 39-17485; Docket No. FAA-2013-0019; Directorate Identifier 2010-SW-051-AD.

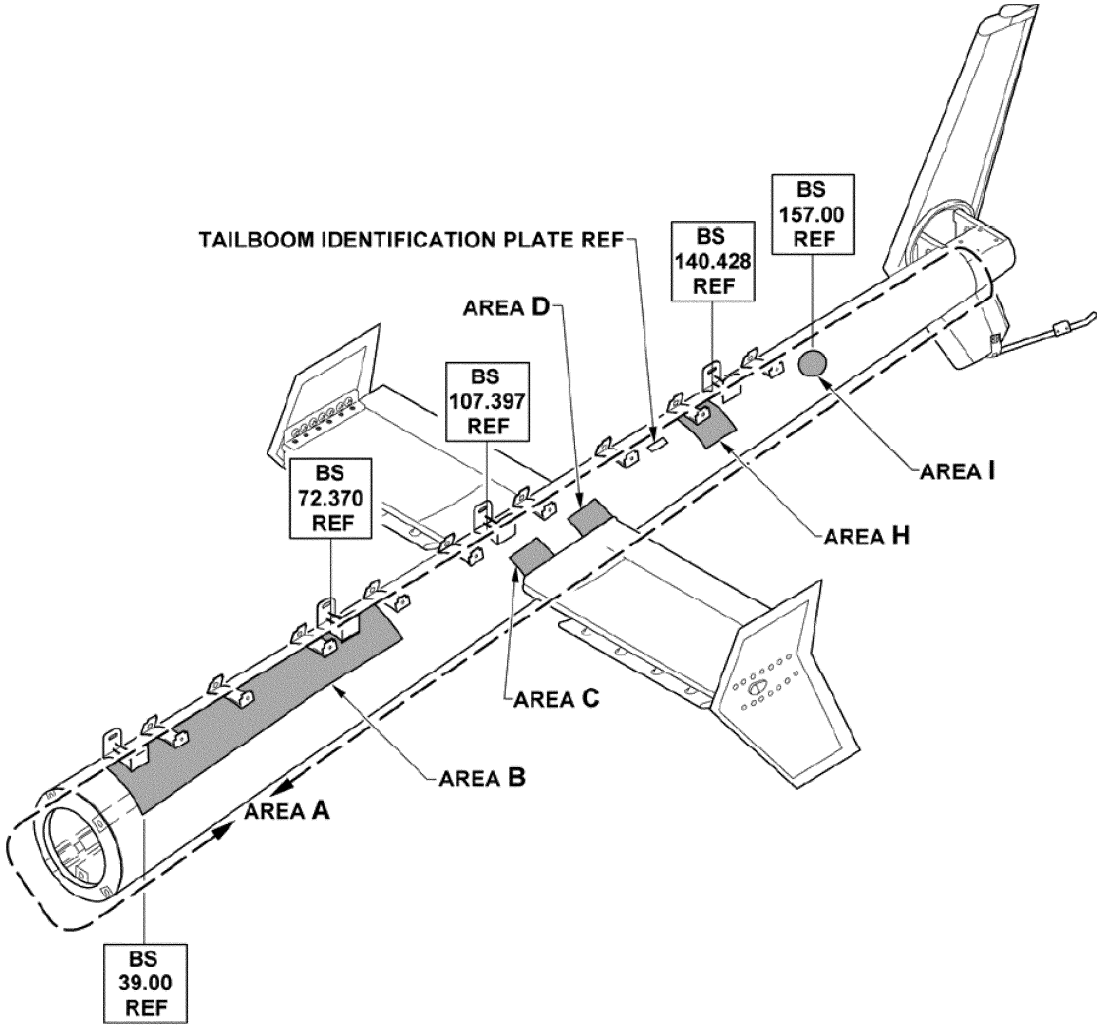
Figure 1 to Paragraph (e)

This AD defines the unsafe condition as high-stress-concentration areas in the tailboom skin that are at risk of cracking. This condition could result in a crack in the tailboom assembly, failure of the tailboom, and subsequent loss of helicopter control.

(A) Before the first flight of each day, visually check for a crack in the "C" and "D" areas depicted in Figures 1 and 2 to Paragraph (e) of this AD. The actions required by this paragraph may be performed by the owner/operator (pilot) holding at least a private pilot certificate, and must be entered into the aircraft records showing compliance with this AD in accordance with 14 CFR 43.9 (a)(1)–(4) and 14 CFR § 91.417(a)(2)(v). The record must be maintained as required by 14 CFR 91.417, 121.380, or 135.439; or

(5) If there is a crack in the tailboom assembly, before further flight, replace it with an airworthy tailboom assembly.

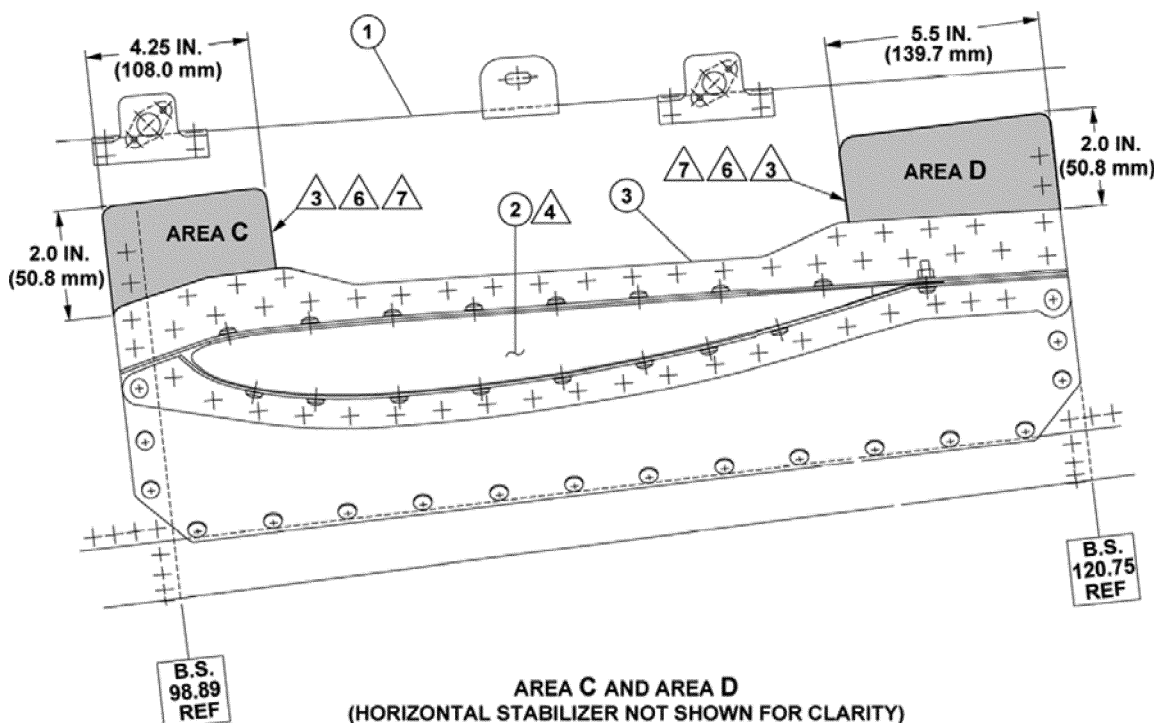
(B) Within 25 hours TIS, or 30 days, whichever comes first, and thereafter at intervals not to exceed 50 hours TIS, clean and inspect for a crack around each fastener and just above the edge of the upper stabilizer support in the "C" and "D" areas on the left side of the tailboom assembly, as depicted in Figure 2 to Paragraph (e) of this AD, using a 10X or higher power magnifying glass.
