[Docket No. FAA-2013-0695; Directorate
Identifier 2011-NM-264-AD]

Airworthiness Directives; Saab AB, Saab Aerosystems Airplanes

ACTION: Notice of proposed rulemaking
(NPRM).

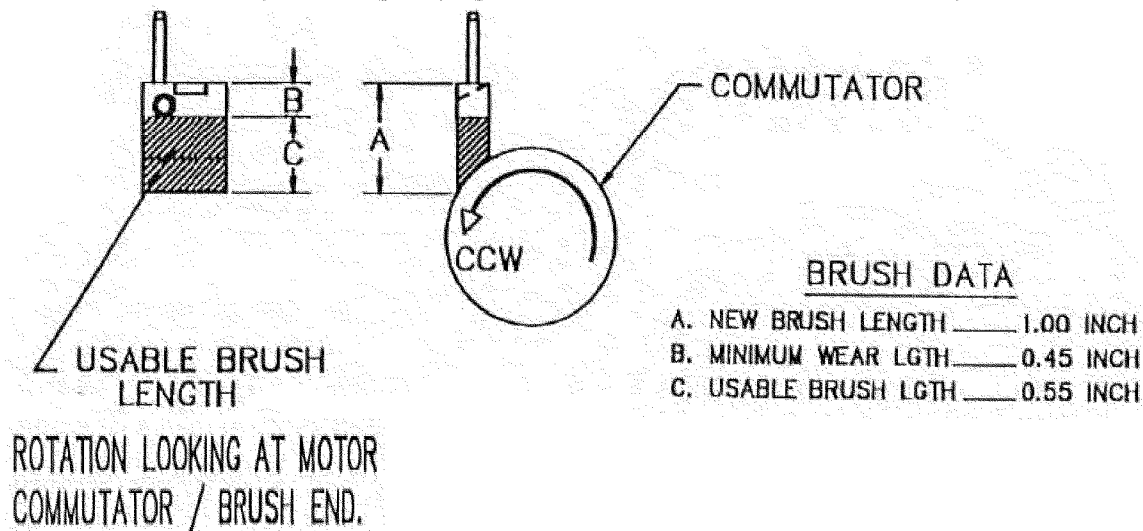
Figure 1 to paragraph (m)(2)(vii) of this AD – Measuring the Brush

(vii) Measure each brush as shown in figure below and record values.

(viii) Using the brush with the shortest measured length calculate the wear by subtracting the measured value from 1.000 inch.

(ix) Replace brushes in accordance with the instructions specified in paragraphs (j)(9) through (j)(23) of this AD.
