Federal Register

[Docket No. FAA-2012-0807; Directorate Identifier 2011-NM-191-AD; Amendment 39-17888; AD 2014-13-12]

Airworthiness Directives; Airbus Airplanes

2014–13–12 Airbus: Amendment 39–17888. Docket No. FAA–2012–0807; Directorate Identifier 2011–NM–191–AD.

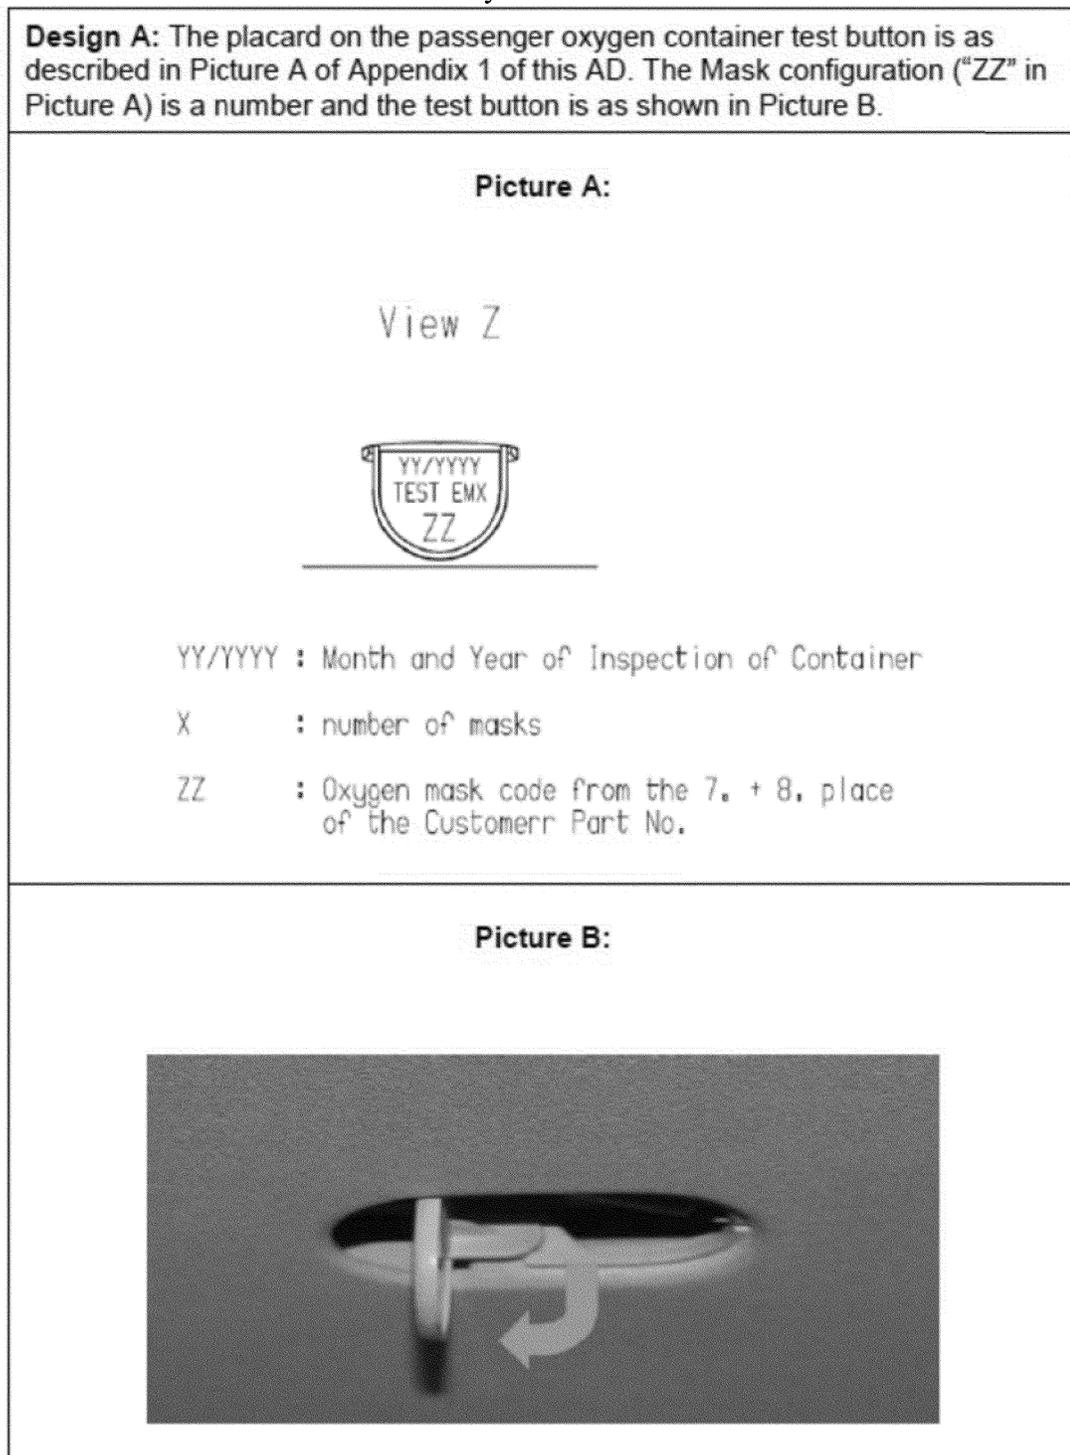
Figure 1 to paragraph (i)(7) of this AD – Design A of the Passenger Oxygen Containers Affected by this AD

(7) The requirements of paragraphs (g) and (h) of this AD apply only to passenger oxygen containers that are Design A, as defined in figure 1 to paragraph (i)(7) of this AD.
