[Docket No. FAA–2014–0337; Directorate Identifier 2013–SW–029–AD; Amendment 39–18008; AD 2014–22–03]

Airworthiness Directives; Various Restricted Category Helicopters

SUMMARY: We are superseding Airworthiness Directive (AD) 2012–14–11 for Arrow Falcon Exporters, Inc. (AFE), Rotorcraft Development

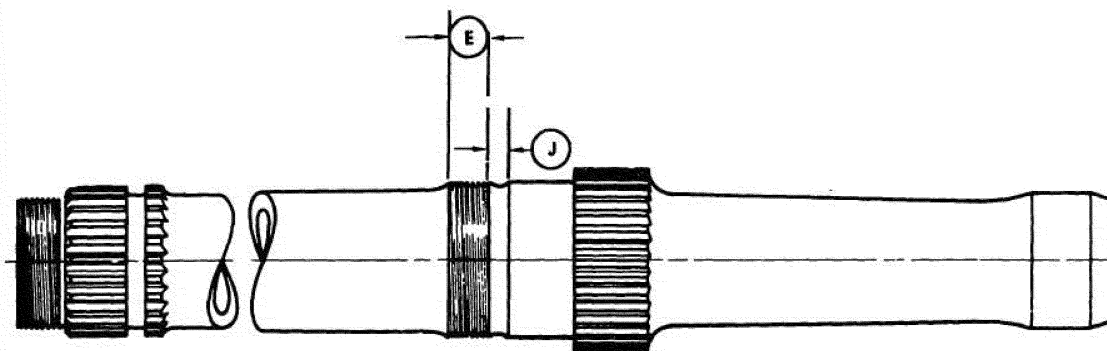
This AD defines the unsafe condition as a crack in the main rotor mast, which could result in failure of the mast and subsequent loss of control of the helicopter.

(i) Remove any surface rust with a wire brush or steel wool and, using a 10X or higher power magnifying glass, inspect the areas of the mast as shown in area E and area J of Figure 1 to Paragraph (f) of this AD for pitting, corrosion, or a crack.

- (2) If there is a crack, pitting, or corrosion, before further flight, replace the mast with an airworthy mast.
