Federal Register

Federal Aviation Administration

[Docket No. FAA–2015–0497; Directorate Identifier 2012–NM–192–AD; Amendment 39–18128; AD 2015–06–10]

Airworthiness Directives; ATR–GIE Avions de Transport Régional Airplanes

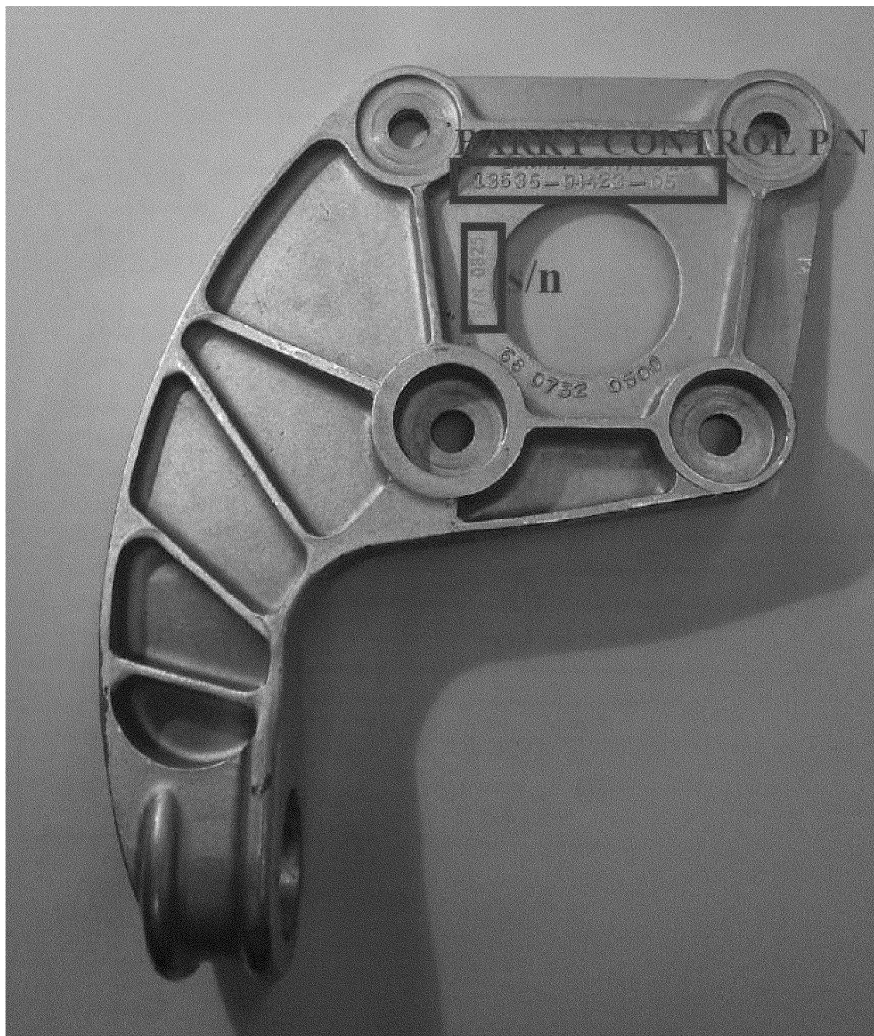
Figure 1 to paragraph (g)(1) of this AD - Location of Fitting Part Number and Serial Number

- (1) Identify the serial number (S/N) of the part number (P/N) S54210394200 (Barry Control P/N 94423-05) LH and right-hand (RH) shock mount pick-up fittings installed on both engine nacelles. Figure 1 to paragraph (g)(1) of this AD identifies the fitting part number and serial number locations.

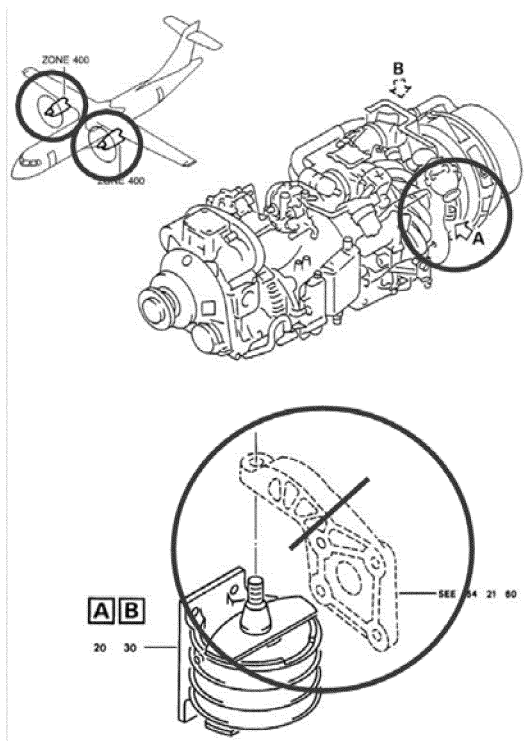
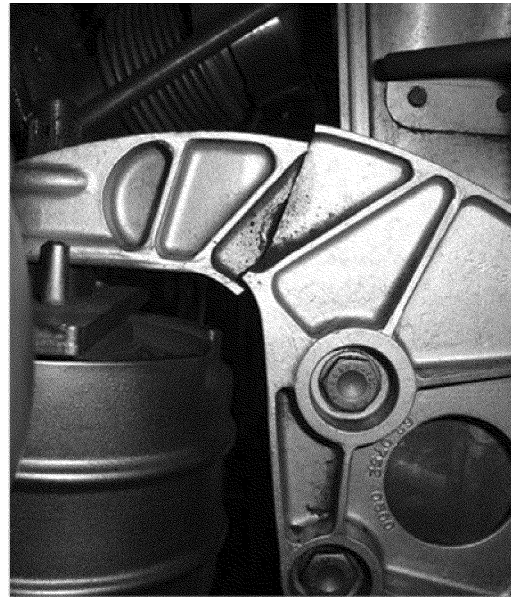
Figure 2 to Paragraph (g)(2) of this AD - Shock Mount Pick-up Fitting

(2) Do a detailed inspection of both LH and RH aft side isolator pick-up fittings on both engines to detect cracks, in accordance with

paragraph 004.1 of ATR ATR72 Aircraft Maintenance Manual (AMM) Job Instruction Card (JIC) 54-11-61 DVI 10000, dated March

1, 2012. Refer to figure 2 to paragraph (g)(2) of this AD for potential crack location.

(1) If any crack is found during any inspection required by paragraphs (g)(2) and (g)(3) of this AD: Before further flight, repair in accordance with a method approved by

the Manager, International Branch, ANM-116, Transport Airplane Directorate, FAA; or EASA; or ATR's EASA Design Organization Approval (DOA).
