[Docket No. FAA–2015–3989; Directorate Identifier 2014–NM–250–AD]

#### Airworthiness Directives; Airbus Airplanes

**ACTION:** Notice of proposed rulemaking (NPRM).

**SUMMARY:** We propose to adopt a new airworthiness directive (AD) for all Airbus Model A318; A319; A320; and A321 series airplanes. This proposed AD was prompted by reports of premature aging of certain passenger chemical oxygen generators that resulted in the generators failing to activate. This proposed AD would require an inspection to determine if certain passenger chemical oxygen generators are installed and replacement of affected passenger chemical oxygen generators. We are proposing this AD to prevent failure of the passenger chemical oxygen generator to activate and consequently not deliver oxygen during an emergency, possibly resulting in injury to the airplane occupants.

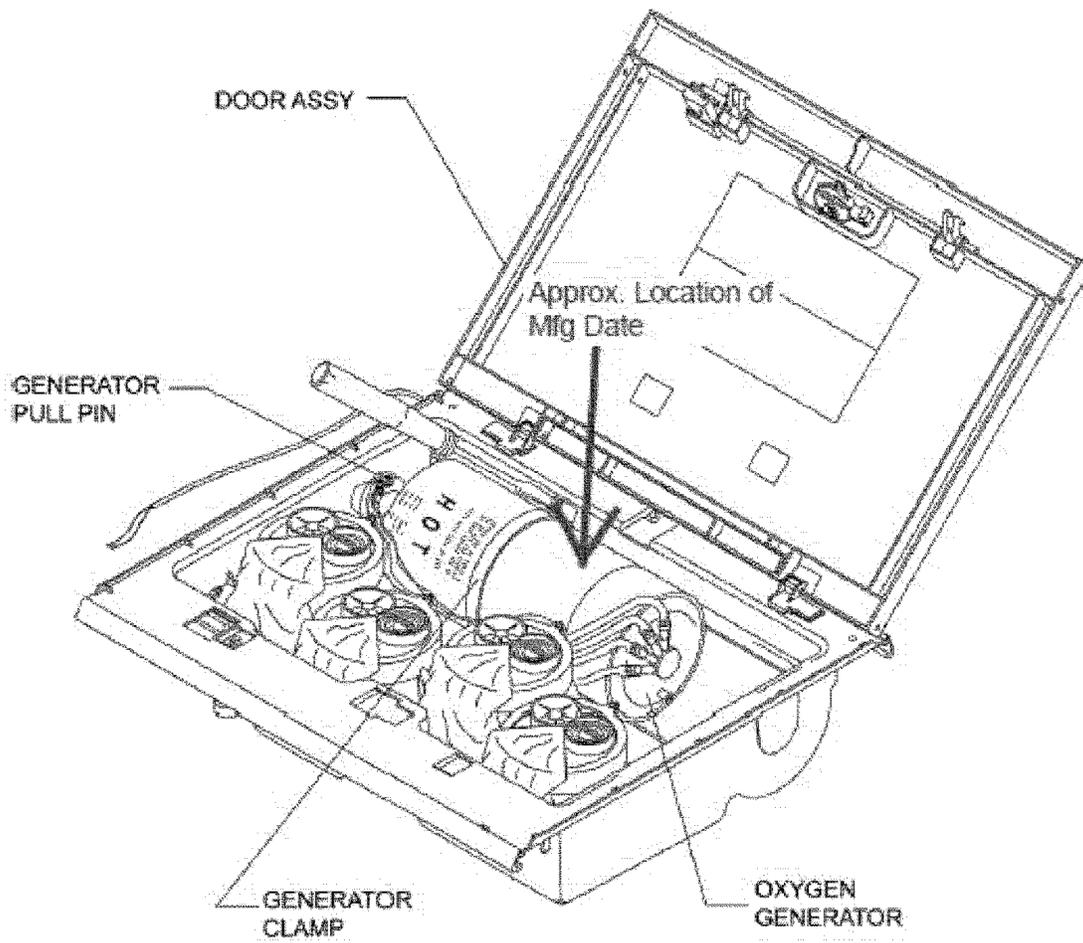
Figure 1 to paragraph (g) of this AD - location of date (MM-YY)

Within 30 days after the effective date of this AD, do a one-time inspection of passenger chemical oxygen generators, part numbers (P/N) 117042-02 (15 minutes (min)-2 masks), 117042-03 (15 min-3 masks), 117042-04 (15 min-4 masks), 117042-22 (22 min-2 masks), 117042-23 (22 min-3 masks), and 117042-24 (22 min-4 masks) to determine the date of manufacture as specified in Airbus Alert Operators Transmission (AOT) A35N006-14, dated December 10, 2014, including Appendix 01. Refer to figure 1 and figure 2 to paragraph (g) of this AD for the location of the date. A review of airplane maintenance records is acceptable for the inspection required by paragraph (g) of this AD, provided the date of manufacture can be conclusively determined by that review.

If, during any inspection required by paragraph (g) of this AD, any passenger chemical oxygen generator having a date of manufacture in 1999, 2000, or 2001 is found: At the applicable time specified in paragraph (h)(1), (h)(2), or (h)(3) of this AD, remove and replace the affected passenger chemical oxygen generator with a serviceable unit, in accordance with the Accomplishment Instructions of B/E Aerospace Service Bulletin 117042-35-001, dated December 10, 2014 (for 15 minute passenger chemical oxygen generators); and Airbus AOT A35N006-14, dated December 10, 2014, including Appendix 01 (for 22 minute passenger chemical oxygen generators).
