[Docket No. FAA-2016-4228; Directorate Identifier 2015-NM-107-AD]

## Airworthiness Directives; Airbus Airplanes

**SUMMARY:** We propose to supersede Airworthiness Directive (AD) 2014-13-12, for all Airbus Model A318, A319, A320, and A321 series airplanes. AD 2014-13-12 currently requires identifying the part number and serial number of each passenger oxygen container, replacing the oxygen generator manifold of any affected oxygen container with a serviceable manifold, and performing an operational check of the manual mask release, and doing corrective actions if necessary. Since we issued AD 2014-13–12, we have determined that affected containers have not only been marked with company name B/E Aerospace, as was specified, but also, for a brief period, with the former company name DAe Systems. This proposed AD would retain the requirements of AD 2014-13-12, and require replacing the oxygen generator manifold of any affected DAe oxygen container with a serviceable manifold. We are proposing this AD to detect and correct nonserviceable oxygen generator manifolds, which could reduce or block the oxygen supply and result in injury to passengers when oxygen supply is needed.

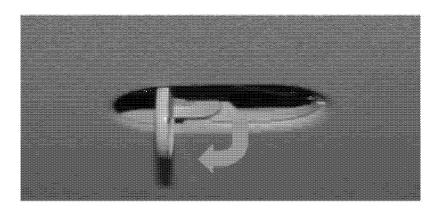
## Picture B:

**Design A:** The placard on the passenger oxygen container test button is as described in Picture A of Appendix 1 of this AD. The Mask configuration ("ZZ" in Picture A) is a number and the test button is as shown in Picture B.

described in "Picture A" in figure 1 to paragraph (i)(7) of this AD. The mask configuration ("ZZ" in "Picture A") is a number, and the test button is as shown in "Picture B."
