[Docket No. **FAA-2016-4674**; Directorate Identifier **2016-SW-001-AD**; Amendment **39-18835**; AD **2017-06-11**]

#### **Airworthiness Directives; Airbus Helicopters**

**SUMMARY:** We are superseding Emergency Airworthiness Directive (Emergency AD) 2015-24-51 for Airbus Helicopters Model EC120B. Emergency AD 2015-24-51 required inspections of the air conditioning system. This supersedure revises the applicability, some of the terminology, and the

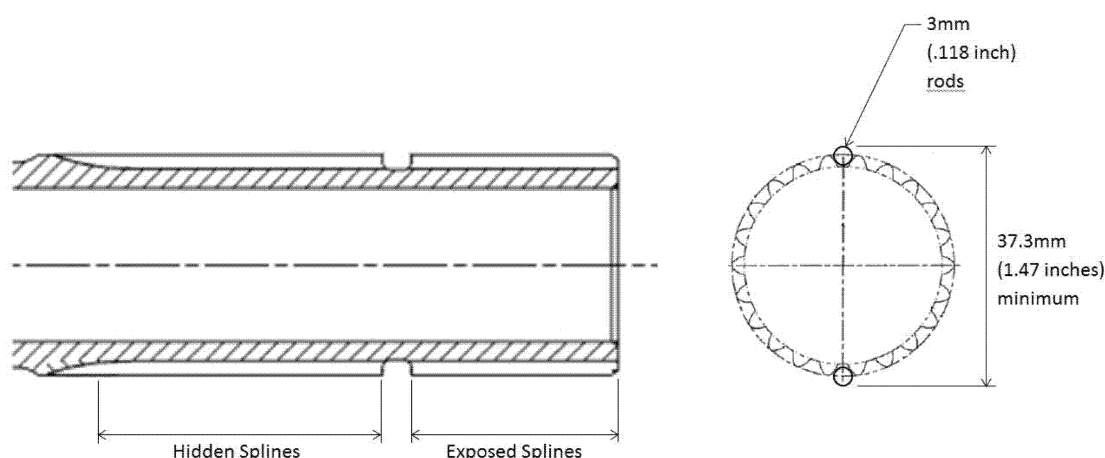
(ii) Inspect the exposed portion of each wheel spline for cracking, scoring, metal pick-up, and wear by using Figure 1 to paragraph (f)(1)(ii) of this AD. To inspect for wear, position two 3 mm (0.118 inch) rods in all diametrically opposed splines and measure to determine whether there is a minimum of 37.3 mm (1.47 inches) across the outside diameter of the rods. If there is any cracking, scoring or metal pick-up, or if a measurement is less than 37.3 mm, replace the wheel.
