[Docket No. FAA-2019-0715; Product Identifier 2019-NM-151-AD; Amendment 39-19760; AD 2019-20-07]

#### Airworthiness Directives; The Boeing Company Airplanes

**2019–20–07 The Boeing Company:**  
Amendment 39–19760; Docket No. FAA–2019–0715; Product Identifier 2019–NM–151–AD.

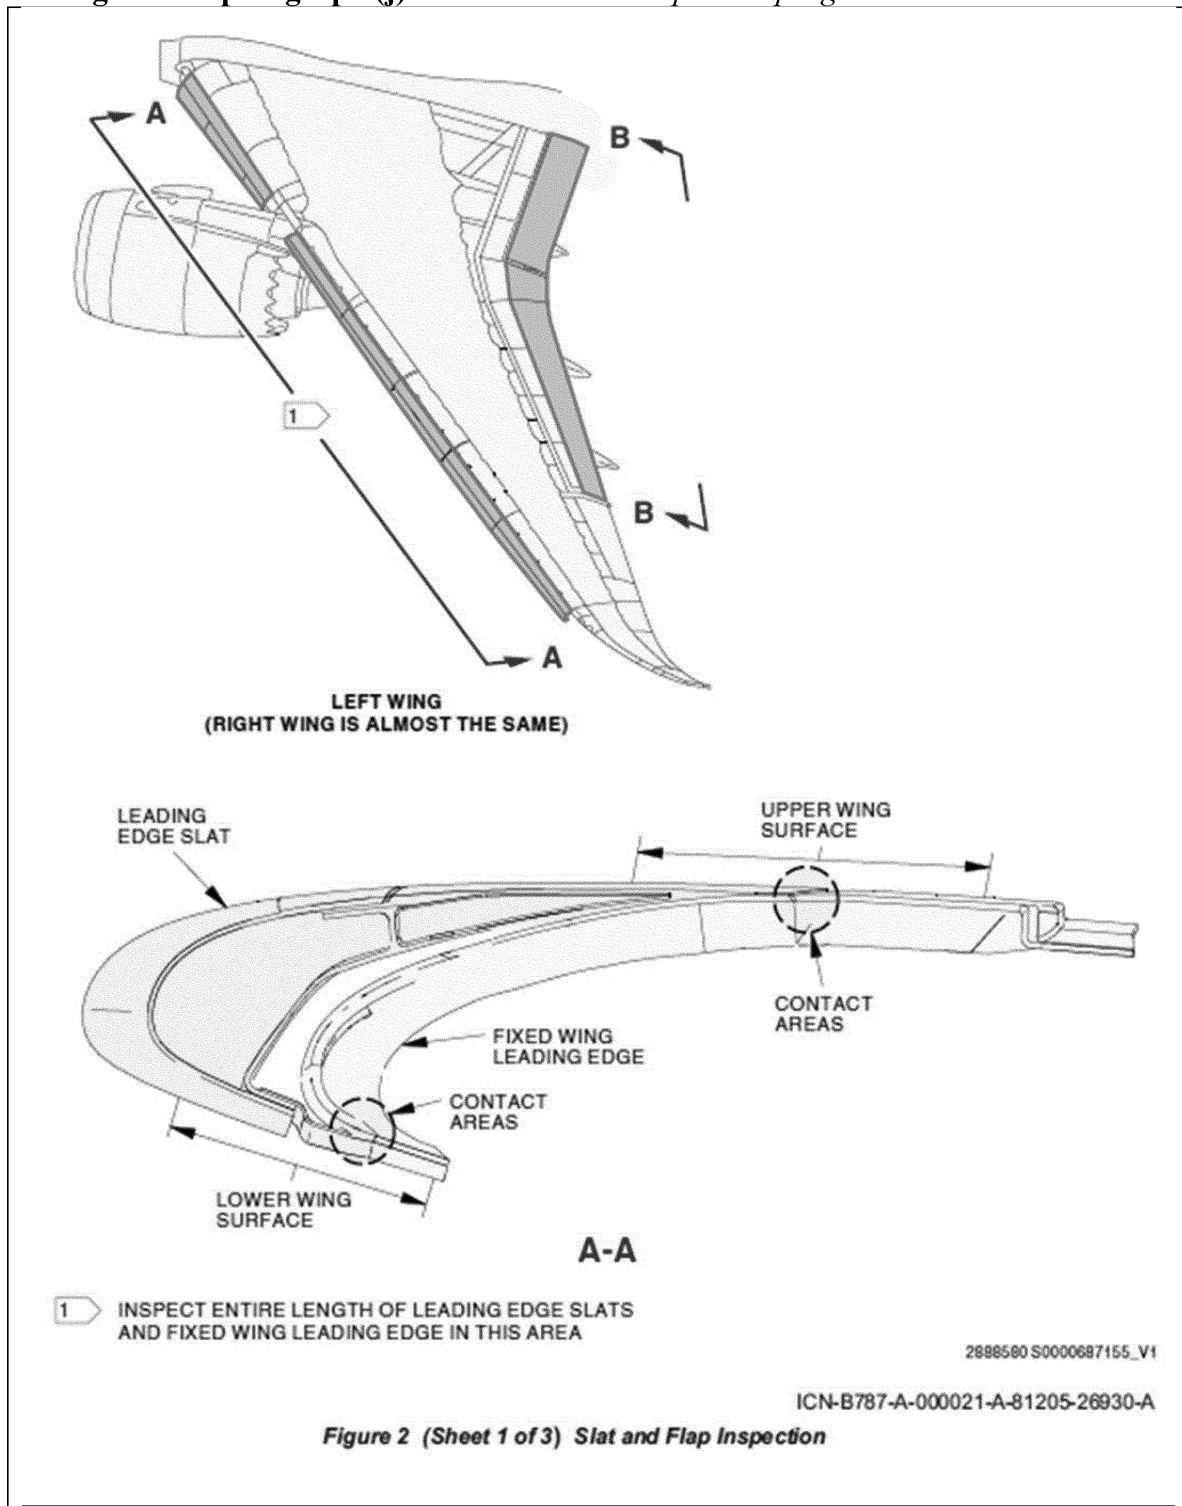
**Figure 2 (Sheet 1 of 3) Slat and Flap Inspection**

- (a) Do this inspection to make sure that contaminants (ice, snow, slush) are not present which can either obstruct retraction of the LE slats or TE flaps, or freeze the slats to the fixed leading edge after retraction.

- (a) Examine these areas for contaminants (ice, snow, slush):

- 1) Slats/flaps surfaces
- 2) Leading edge contact surfaces

- 3) Slat actuation areas, including exposed areas of the slat track cavity, and slat cove
- 4) Flap tracks, hinges, seals

- (b) Remove the contamination that you find.

- (c) Confirm a contaminant-free condition in these areas immediately prior to retraction of the slats/flaps surfaces.
- 1) Slats/flaps surfaces
  - 2) Leading edge contact surfaces

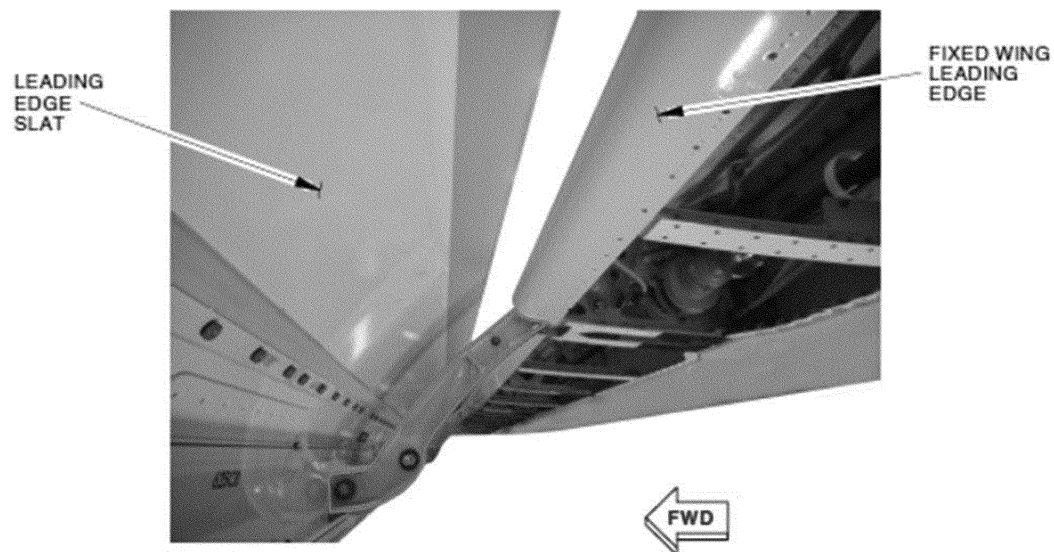
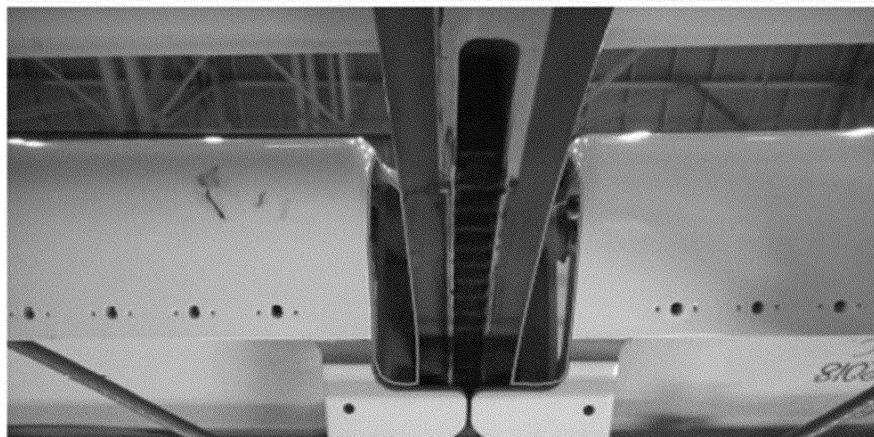
**Figure 2 (Sheet 2 of 3) Slat and Flap Inspection**

ACTUATION AREAS  
(TYPICAL)  
A-A

SLAT TRACK CAVITY  
(TYPICAL)  
(VIEW IN THE AFT DIRECTION)  
A-A
