[Docket No. 2001–SW–40–AD; Amendment 39–12793; AD 2002–13–05]

Airworthiness Directives; MD Helicopters, Inc. Model 369D, 369E, 369F, and 369FF Helicopters

ACTION: Final rule.

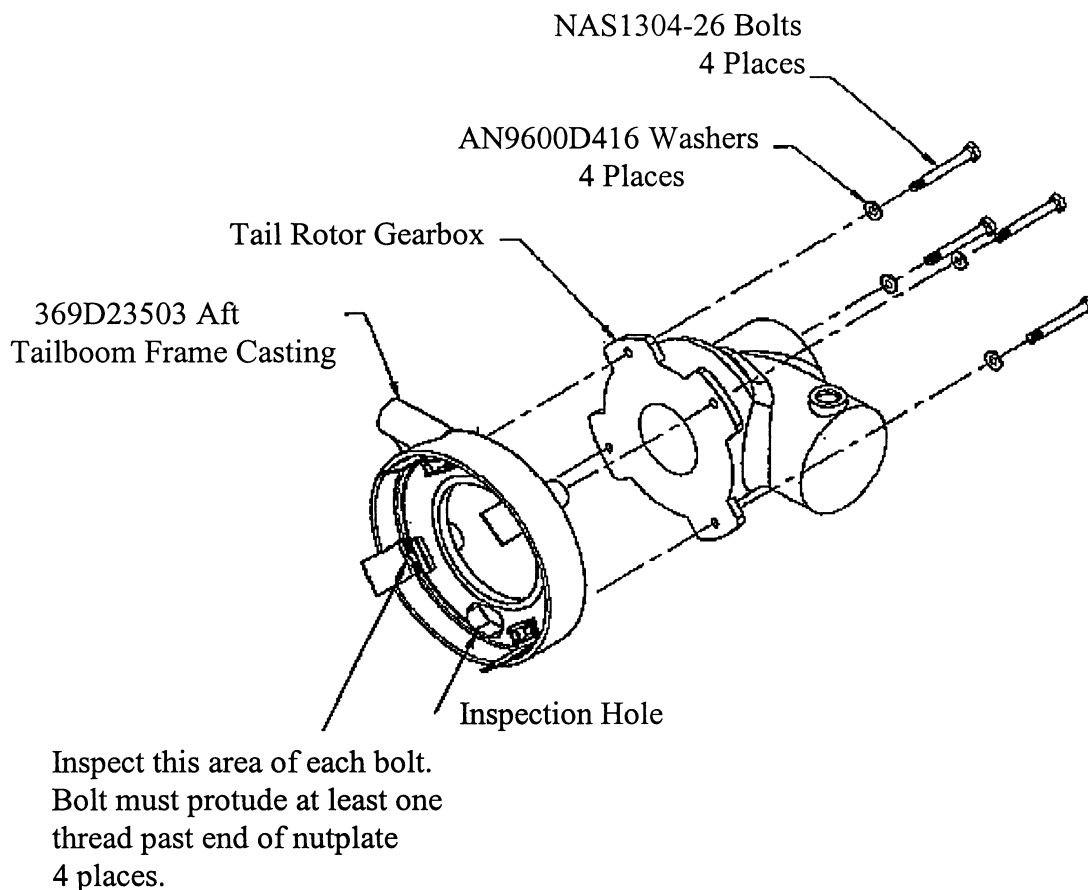
Figure 1 - Inspection Location

To prevent loss of the tail rotor gearbox due to attaching bolts of inadequate grip length and subsequent loss of helicopter control, accomplish the following:

(2) Remove the tailboom control rod and determine the number of bolt threads protruding from each nutplate on the internal surface of the aft tailboom frame casting, P/N 369D23503, as shown in Figure 1 of this AD. At least one thread must protrude. If more than four threads protrude, add an additional washer, P/N AN960D416, under the bolt head. Torque the bolt to 100-110 in-lbs, and reapply a slippage mark. See Figure 1:
