[Docket No. 99–CE–85–AD; Amendment 39–12917; AD 2002–21–11]

Airworthiness Directives; EXTRA Flugzeugbau GmbH Model EA–300S Airplanes

2002–21–11 Extra Flugzeugbau GmbH:
Amendment 39–12917; Docket No. 99–CE–85–AD.

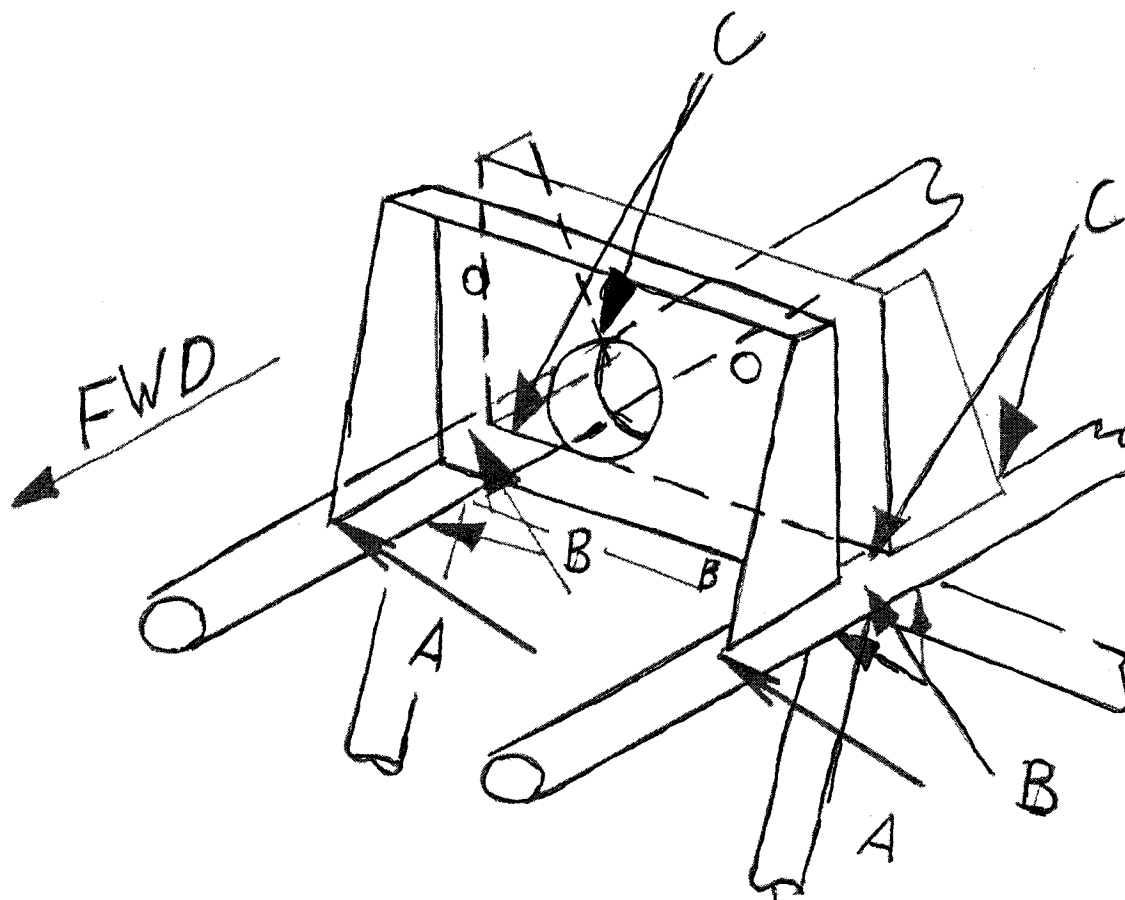
Actions	Compliance	Procedures
(1) For all affected airplanes, inspect, using a fluorescent dye penetrant method, the upper longeron at the horizontal stabilizer attachment for cracks in the areas depicted in Figure 1 of this AD.	Upon accumulating 250 hours time-in-service (TIS) or within the next 50 hours TIS after December 17, 2002 (the effective date of this AD), whichever occurs later.	In accordance with Part I of Extra Service Bulletin No. 300–2–95 (pages 2–6 at Issue: C, dated July 15, 1998; and pages 1 and 7 through 11 at Issue: D, dated January 30, 2001). No further action is required by this paragraph if the modification is already accomplished in accordance with Part II of Extra Service Bulletin No. 300–2–95 (all pages at Issue: C, dated July 15, stabilizer 1998).

(3) For all affected airplanes, if any crack is found during the inspection required by this AD and the crack(s) is (are) in Area A or Area B as depicted in Figure 1 of this AD, accomplish the following: (i) Repair and modify the upper longeron at the horizontal stabilizer attachment; and (ii) Weld the cracks tight during repair.	Prior to further flight after the inspection where any crack is found in Area A or Area B as depicted in Figure 1 of this AD.	In accordance with Part II of Extra Service Bulletin No. 300–2–95, Issue: D, dated January 30, 2001. No further action is required by this paragraph if already accomplished in accordance with Part II of Extra Service Bulletin No. 300–2–95 (all pages at Issue: C, dated July 15, 1998).

(4) For all affected airplanes, if any crack is found during the inspection and the crack(s) is (are) in Area C as depicted in Figure 1 of this AD, accomplish the following: (i) Obtain a repair scheme from the manufacturer; (ii) Incorporate this repair scheme; and (iii) Accomplish any follow-up actions as directed by the FAA.	Prior to further flight after the inspection where any crack is found.	In accordance with a repair scheme obtained from EXTRA Flugzeugbau GmbH, Flugplatz Dinslaken, D–46569 Hünxe, Federal Republic of Germany; telephone: (0 28 58) 91 37–00; facsimile: (0 28 58) 91 37–30. Obtain this repair scheme through the FAA at the address specified in paragraph (g) of this AD.

(2) For all affected airplanes, if no crack(s) is (are) found during the inspection required by this AD, modify the upper longeron at the horizontal stabilizer attachment.	Prior to further flight after the inspection required by paragraph (d)(1) of this AD.	In accordance with Part II of Extra Service Bulletin No. 300–2–95 (pages 2–6 at Issue: C, dated July 15, 1998; and pages 1 and 7 through 11 at Issue: D, dated January 30, 2001). No further action is required by this paragraph if already accomplished in accordance with Part II of Extra Service Bulletin No. 300–2–95 (all pages at Issue: C, dated July 15, 1998).
