[Docket No. FAA–2005–22534; Directorate Identifier 2005–NE–27–AD; Amendment 39–14305; AD 2005–20–11]

**Airworthiness Directives; Rolls-Royce Corporation (RRC) (formerly Allison Engine Company, Allison Gas Turbine Division, and Detroit Diesel Allison) Models 250–C28, –C28B, and –C28C Turbohaft Engines**

**2005–20–11 Rolls-Royce Corporation**  
(formerly Allison Engine Company,  
Allison Gas Turbine Division, and

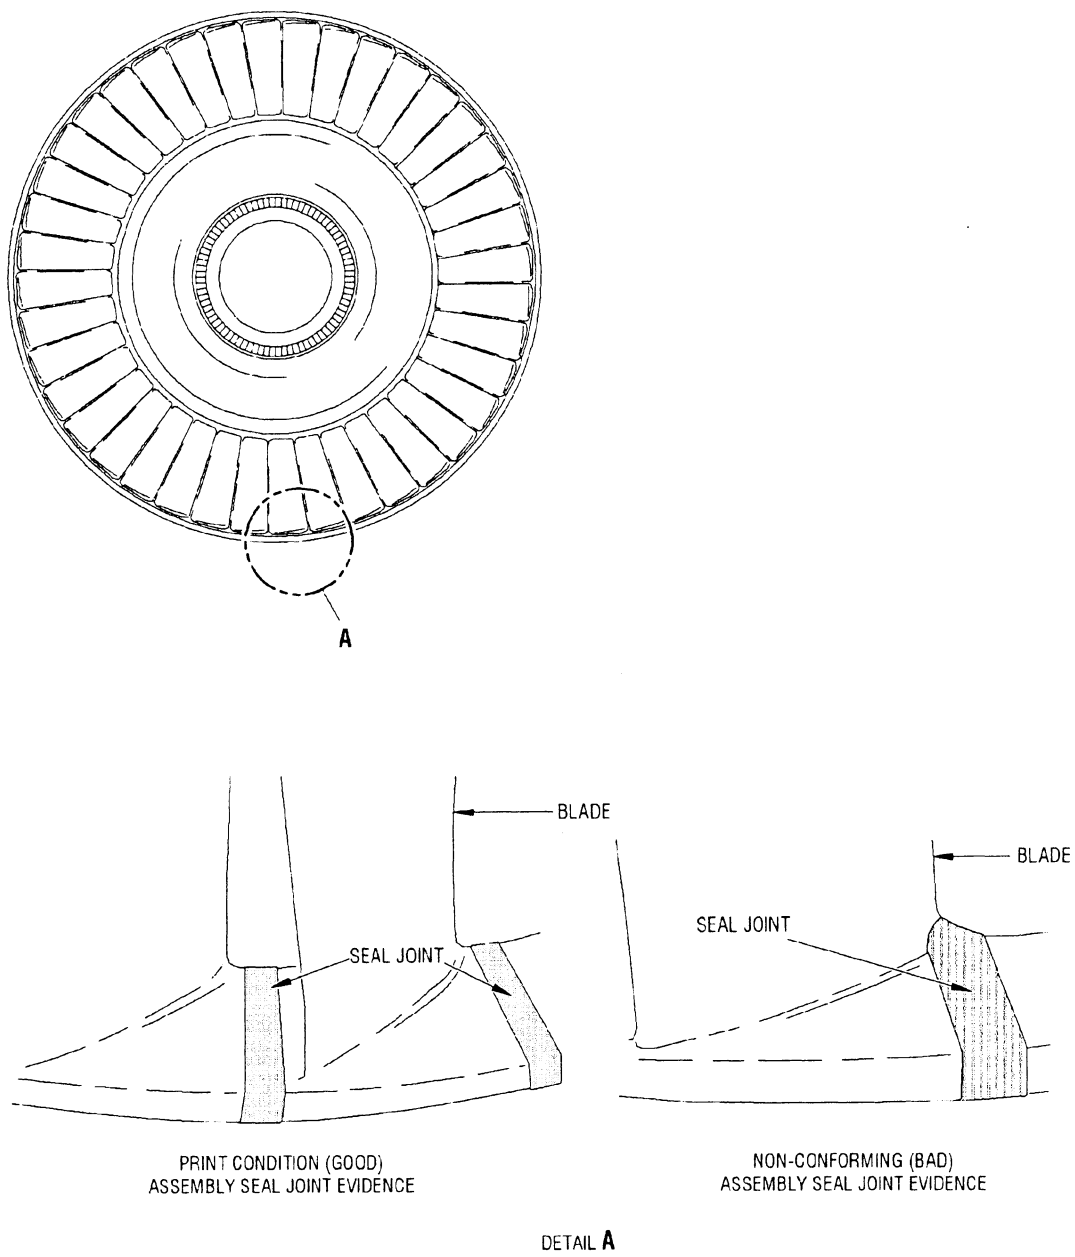
Figure 1.

**SUPPLEMENTARY INFORMATION:** In April 2005, we became aware of reports of three failed third-stage turbine wheels, P/N 6899383. The third-stage turbine wheels had partial loss of the blades and shroud. RRC conducted an analysis and found the failures were caused by compromised third-stage blade fillet radii, which led to increased stresses to the third-stage blades and shroud. RRC categorized this finding as a

(h) Remove the third-stage turbine wheel and perform a onetime visual inspection of the seal joint in each passage between airfoils at the hub and shroud. Seal joint evidence must not be present within blade fillet radii. See Figure 1 of this AD for reference.

(i) Remove from service any turbine wheel that has seal joint evidence present within blade fillet radii.
