Special Conditions: Boeing Model 747-8/-8F Airplanes; Additional Airframe Structural Design Requirements Related to Sudden Engine Stoppage Due to Fan Blade Failures

[Docket No. FAA-2009-0464; Directorate Identifier 2008-NM-189-AD; Amendment 39-15992; AD 2008-16-09 R1]

Airworthiness Directives; Short Brothers Model SD3-60 Airplanes

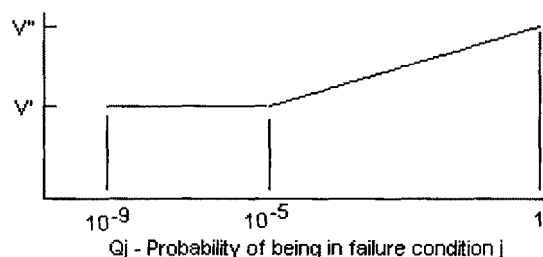
Clearance speed

V' = Clearance speed as defined by § 25.629(b)(2).

V'' = Clearance speed as defined by § 25.629(b)(1).

Note: If P_j is greater than 10^{-3} per flight hour, then the flutter clearance speed must not be less than V'' .

(6) Freedom from aeroelastic instability must also be shown up to V' in Figure 3 above, for any probable system failure condition combined with any damage required or selected for investigation by § 25.571(b).
