[Docket No. FAA-2018-0181; Product Identifier 2017-SW-085-AD; Amendment 39-19219; AD 2018-05-10]

Airworthiness Directives; Agusta S.p.A. Helicopters

2018–05–10 Agusta S.p.A.: Amendment 39–19219; Docket No. FAA–2018–0181; Product Identifier 2017–SW–085–AD.

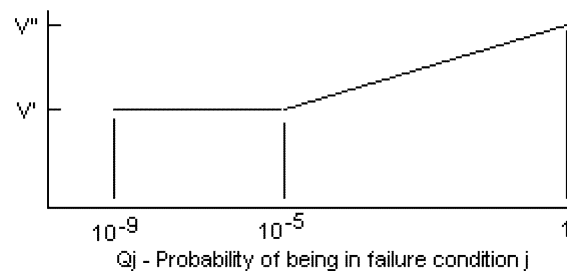
Figure 3: Clearance speed

vi. Freedom from aeroelastic instability must also be shown up to V' in Figure 3, above, for any probable system-failure condition, combined with any damage required or selected for investigation by § 25.571(b).
