[Docket No. FAA-2018-0454; Product Identifier 2017-NM-056-AD; Amendment 39-19387; AD 2018-18-08]

Airworthiness Directives; Airbus SAS Airplanes

2018-18-08 Airbus SAS: Amendment 39-19387; Docket No. FAA-2018-0454; Product Identifier 2017-NM-056-AD.

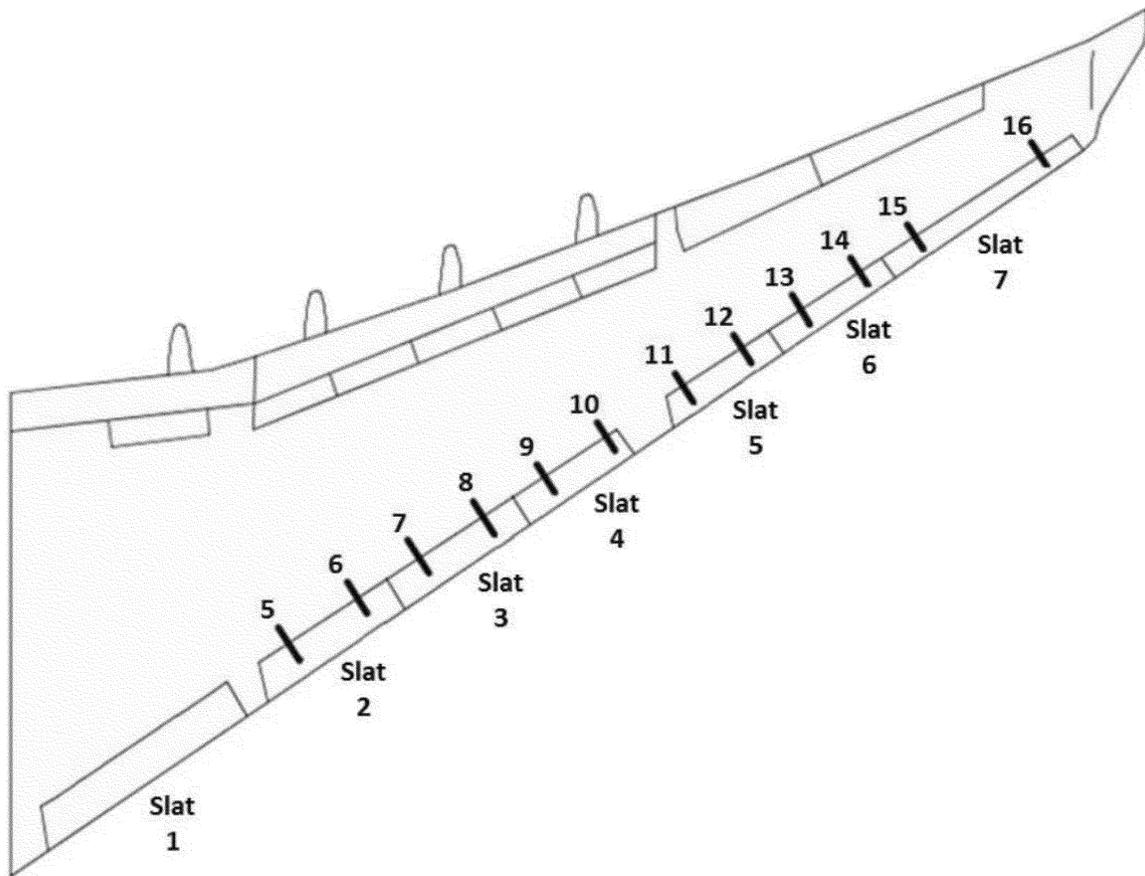
Figure 1 to paragraph (g) of this AD – Positions of Affected Slat Tracks

This AD was prompted by reports of cracked slat tracks at the location of the front stop attachment to the track. We are issuing this AD to detect and correct cracked slat tracks which could affect the structural integrity of the slat surface, possibly leading to detachment of an outer or inner slat surface, and resulting in reduced control of the airplane.

(1) For the purpose of this AD, "affected slat track" is defined as a pre-modification 45967 slat track, located at the wing positions as indicated in figure 1 to paragraph (g) of this AD, and having a part number specified in figure 2 to paragraph (g) of this AD. In case the part number identification (ID) plate is missing or cannot be read, the slat track can be identified by the ink marking. If the operator cannot determine the part number, then that airplane is in Group 1.

For Group 1 airplanes: At the applicable times specified in figure 3 to paragraph (h) of this AD, do a detailed inspection of the front stop lateral and aft surfaces, and do a special detailed inspection of the front stop
