14 CFR Part 39

[Docket No. FAA–2018–0479; Product Identifier 2016–NE–23–AD; Amendment 39–19369; AD 2018–17–15]

Airworthiness Directives; Honeywell International Inc. Turboprop and Turboshaft Engines

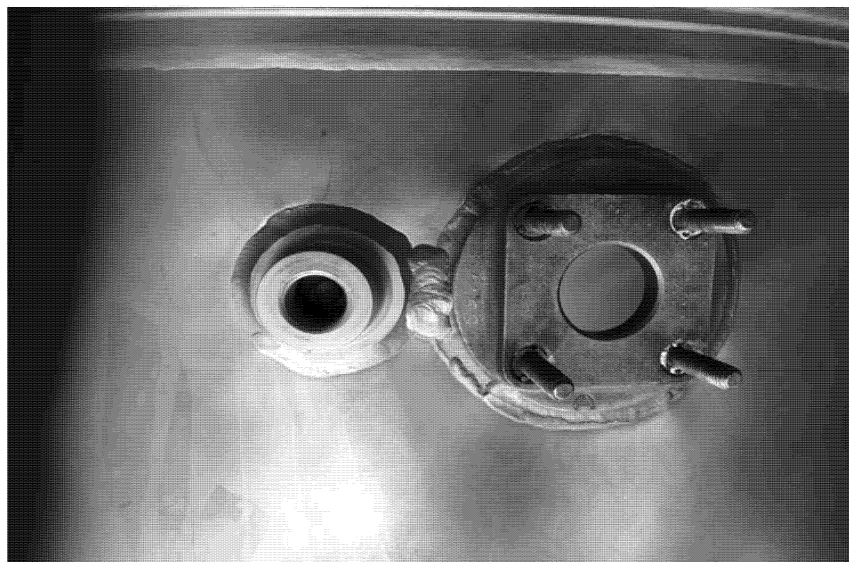
Figure 1 to Paragraph (h) of this AD. Combustion Chamber Case Assembly Without the One-Piece Bleed Pad with P3 Boss

(2) Figures 1 and 2 to paragraph (h) of this AD illustrate the appearance of combustion chamber case assembly, P/N 893973–5, without and with, respectively, the one-piece bleed pad with the P3 boss.

After the effective date of this AD, do not install a combustion chamber case assembly, P/N 869728-1, 869728-3, or 893973-5, in TPE331-3U, -3UW, -5, -5A, -5AB, -5B, -6, and -6A engine models or in TPE331-1, -2, and -2UA engine models modified by National Flight Services, Inc., STC SE383CH, unless the combustion chamber case assembly has a one-piece bleed pad with P3 boss.
