**DEPARTMENT OF TRANSPORTATION****Federal Aviation Administration****14 CFR Part 39**

[Docket No. 97-SW-46-AD; Amendment 39-10240; AD 97-20-13]

**Airworthiness Directives; Eurocopter Deutschland Model EC135 P1 and T1 Helicopters**

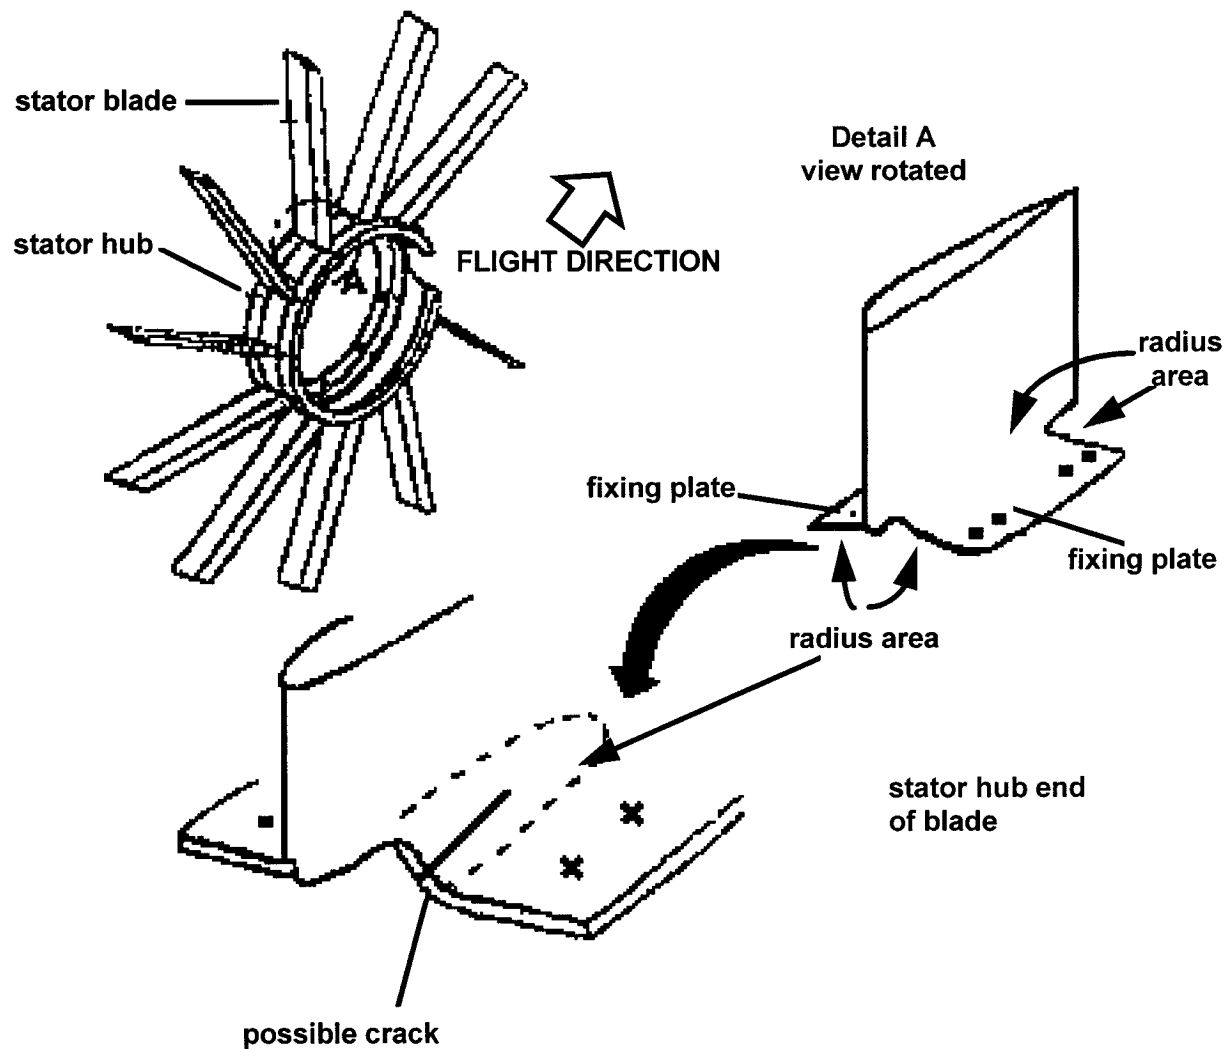
**Inspection of the stator blades  
Figure 1**

EC135 P1 and T1 helicopters, which requires immediate and daily repetitive inspections of the stator blades for cracks in the stator hub area. If this visual inspection reveals a crack, a dye-penetrant inspection is required. Also, within 400 hours time-in-service (TIS) after the effective date of this AD, and thereafter, at intervals not to exceed 400 hours TIS, a dye-penetrant inspection for cracks is required. If any of the inspections reveal cracked stator blades, each crack must be stop-drilled. If any of the inspections reveal cracks on a stator blade with a total crack length of 15mm or longer, or if cracks are found on more than 3 stator blades, the affected blades must be replaced with airworthy blades prior to further flight. That action was prompted by the discovery of cracks on the stator blades of the tail rotor. This condition, if not corrected, could result in failure of the tail rotor and subsequent loss of control of the helicopter.

(a) Before further flight, and thereafter before the first flight of each day, visually inspect all stator blades in the stator hub area for cracks (see Figure 1). Inspect the stator blades in the areas where they are riveted to

the stator hub. Pay particular attention to the radius areas where the stator blade base attaches to the stator hub.

1. Maximum 3 stator blades with cracks allowed.
2. The total length of all cracks on each blade must not exceed 15 mm.

(1) If the inspection reveals a crack at the base of a stator blade, remove the paint from

the area and perform a dye-penetrant inspection.

(2) If the inspection reveals 3 or less cracked stator blades and a total crack length

per stator blade of less than 15mm, stop-drill each crack with a 2mm diameter drill.

(b) Within 400 hours time-in-service (TIS), and thereafter, at intervals not to exceed 400 hours TIS, remove the paint from all stator blades in the stator hub area and perform a dye-penetrant inspection for cracks.

(c) If the inspections reveal cracks on any stator blade with a total crack length of 15mm or longer, or if more than 3 stator blades are cracked, remove the affected stator blades and replace them with airworthy stator blades before further flight. The inspections required by this AD must continue to be performed on all stator blades including replacement stator blades.
