[Docket No. 98-SW-23-AD; Amendment 39-10725; AD 98-10-09]

**Airworthiness Directives; Eurocopter France Model SA.315B, SA.316B, SA.316C, SA.319B, and SE.3160 Helicopters**

#### AD 98-10-09 Eurocopter France:

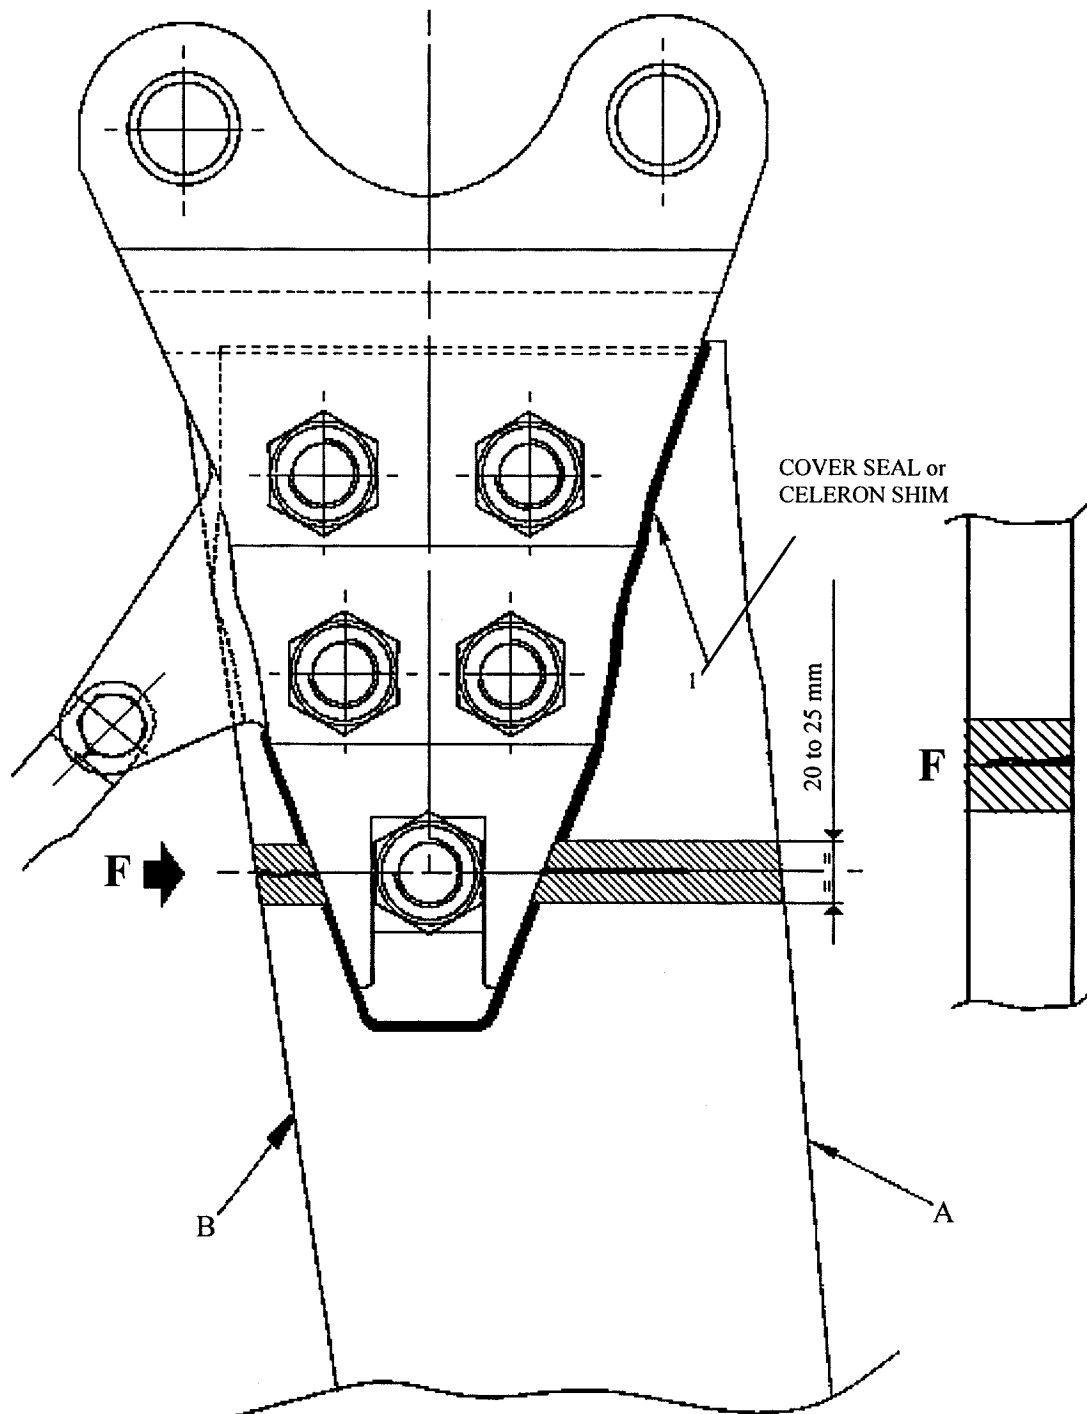
Figure 1

(c) Within 25 hours TIS from the last required inspection of each blade spar for cracks in the area indicated in Figure 1, and thereafter at intervals not to exceed 25 hours TIS:

(3) Visually inspect each blade spar with a 10-power or higher magnifying glass along the hatched area indicated in Figure 1, beginning on the blade lower surface, then on the flat section of the trailing edge (B), on the blade upper surface, and then on the flat section of the leading edge (A).

(4) Before returning the blades to service, confirm that there is a sealing bead (1) around the edge of the blade cuff.

(d) If more than 25 hours TIS have elapsed since the last required inspection of each blade spar for cracks in the area indicated in Figure 1, before further flight, conduct the inspections required by paragraph (c) of this AD.

(e) If a crack is found in a blade spar or cuff, remove the blade and replace it with an airworthy blade prior to further flight.
