Federal Aviation Administration

[Docket No. 96–CE–09–AD; Amendment 39–10864; AD 97–01–01 R1]

Airworthiness Directives; The New Piper Aircraft, Inc. PA–24, PA–28R, PA–30, PA–32R, PA–34, and PA–39 Series Airplanes

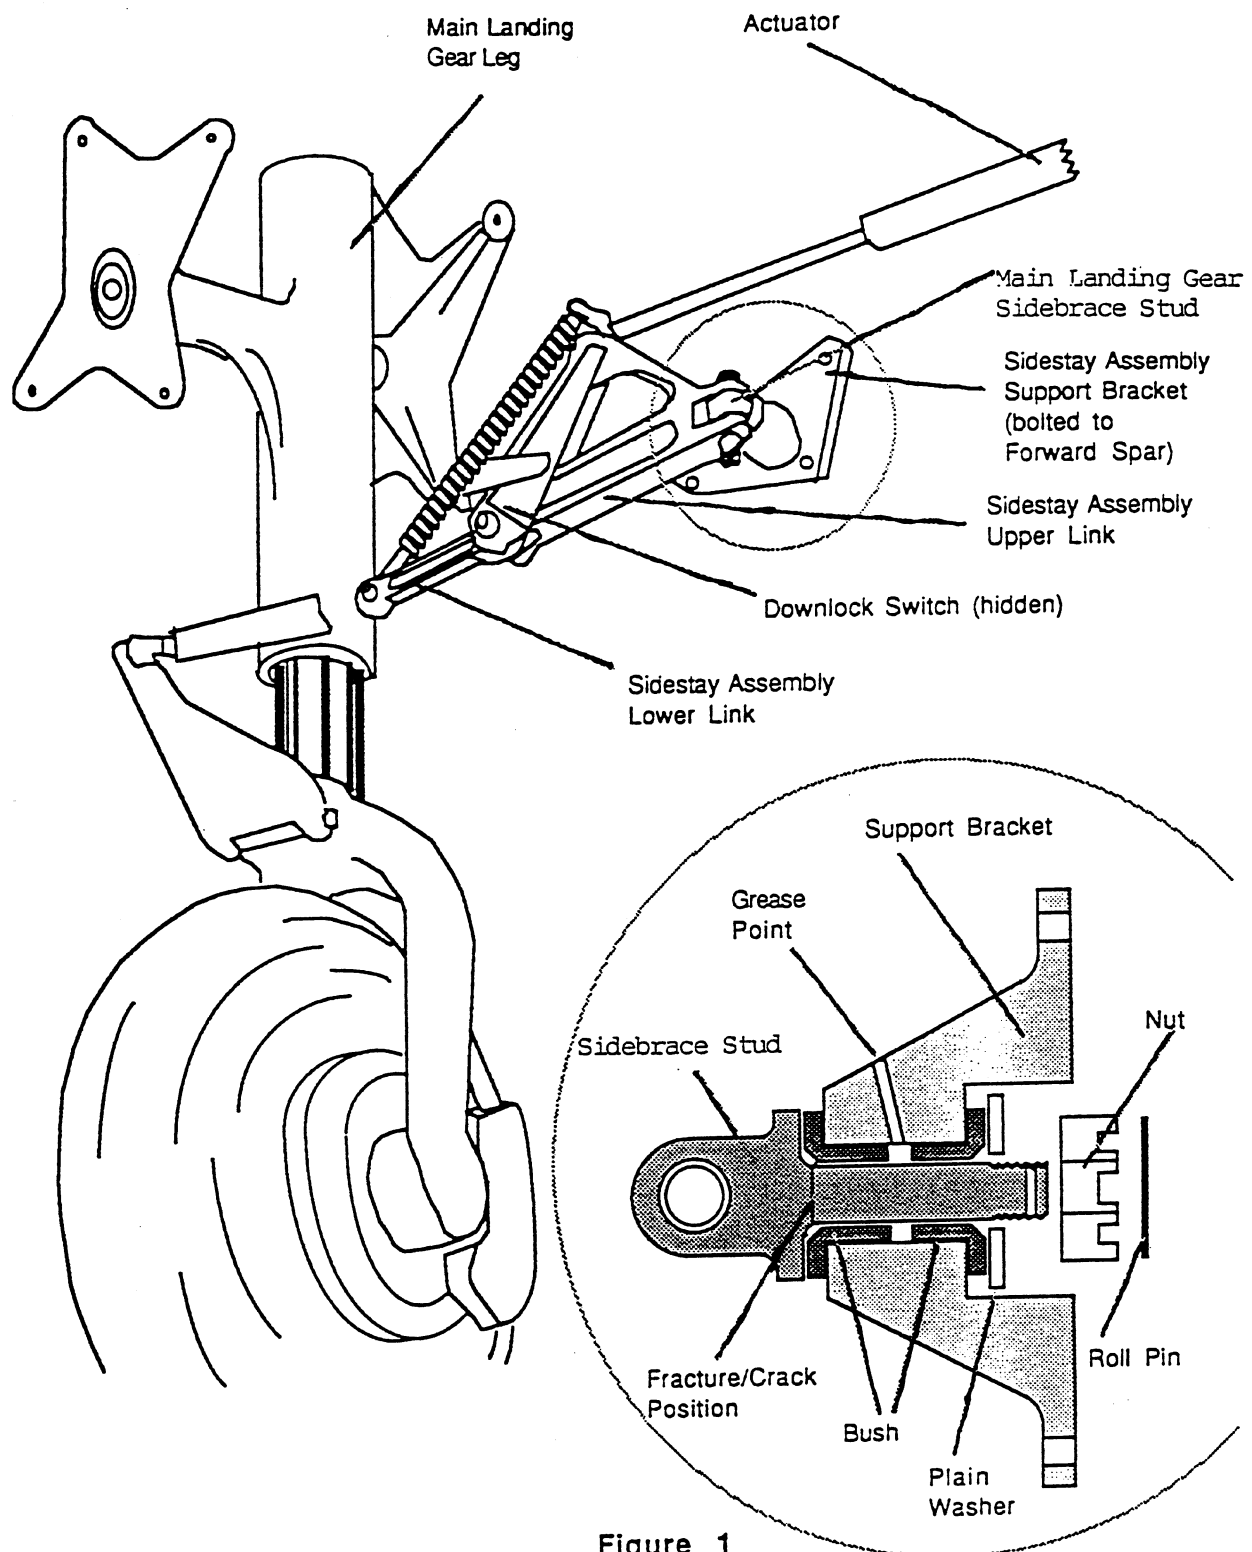
(a) Remove both the left and right main gear sidebrace studs from the airplane in accordance with the instructions contained in the Landing Gear section of the maintenance manual, and inspect each main gear sidebrace stud for cracks, using Type I (fluorescent) liquid penetrant or magnetic particle inspection methods. Figure 1 of this AD depicts the area of the sidebrace stud shank where the sidebrace stud is to be inspected.

Note: This figure is provided to depict the area of the sidebrace stud to be inspected. This is not intended to represent the configuration of all models affected.

(1) For any main gear sidebrace stud found cracked, prior to further flight, replace the cracked stud with an FAA-approved serviceable part (part numbers referenced in the table in paragraph (b) of this AD or FAA-approved equivalent part number) in accordance with the instructions contained in the Landing Gear section of the applicable maintenance manual, and accomplish one of the following, as applicable:
