[Docket No. 98-SW-56-AD; Amendment 39-10874; AD 98-22-16]

#### Airworthiness Directives; Robinson Helicopter Company (RHC) Model R44 Helicopters

**AD 98-22-16 Robinson Helicopter**

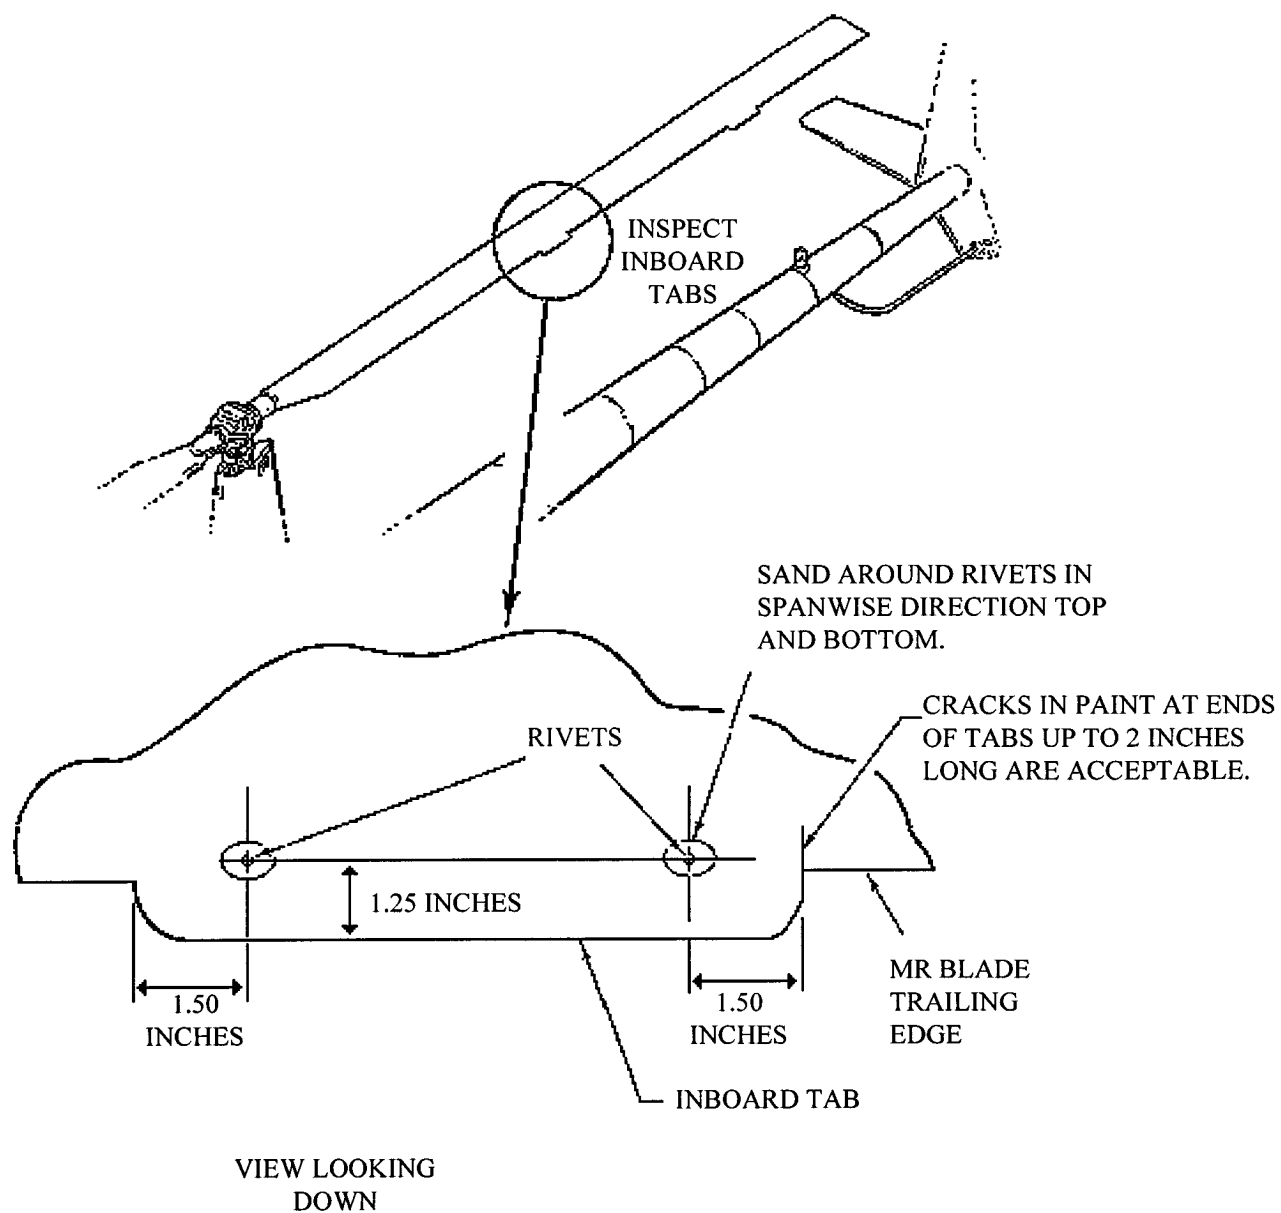
Figure 1

(a) Within the next 5 hours time-in-service (TIS), perform a dye-penetrant inspection of the main rotor blade skin around both inboard trim tab alignment rivets as follows, referring to Figure 1.

(1) Remove all paint around both rivets, exposing an area of approximately 3/4" in diameter, at the inboard trim tab on the top and bottom of each main rotor blade (4 places per main rotor blade). Use 180 grit or finer abrasive paper, followed by 600 grit or finer paper to eliminate course sanding marks. Sand only in a spanwise direction. Do not use chemical paint strippers.

(2) Inspect the main rotor blade skin around the rivets on the upper and lower surfaces (4 locations) using a dye-penetrant inspection method.

**Note 2:** Chordwise cracks in the paint up to 2 inches long which are located along either inboard or outboard edge of the trim tab are acceptable.

(b) Clean the sanded areas prepared in accordance with paragraph (a) of this AD with 111-Trichloroethane or methyl ethyl ketone (MEK) and then apply clear lacquer to seal the unpainted areas.

(c) Thereafter, prior to the first flight of each day, or at intervals not to exceed 5 hours TIS, whichever occurs first, using a 5-power or higher magnifying glass, visually inspect both upper and lower main rotor blade skin surfaces around the inboard trim tab rivets (4 locations) for cracks.

(d) If a crack is found, replace the main rotor blade with an airworthy main rotor blade before further flight.

(e) Prior to further flight after November 15, 1998, install a set of main rotor blades, main rotor blade P/N C016-2. This constitutes terminating action for the inspections required by this AD.
