[Docket No. 96-CE-35-AD; Amendment 39-10213; AD 97-24-06]

Airworthiness Directives; Glasflugel Models Standard Libelle and Standard Libelle 201 B Sailplanes

Appendix to AD 97-24-06—Aileron Actuating Shaft

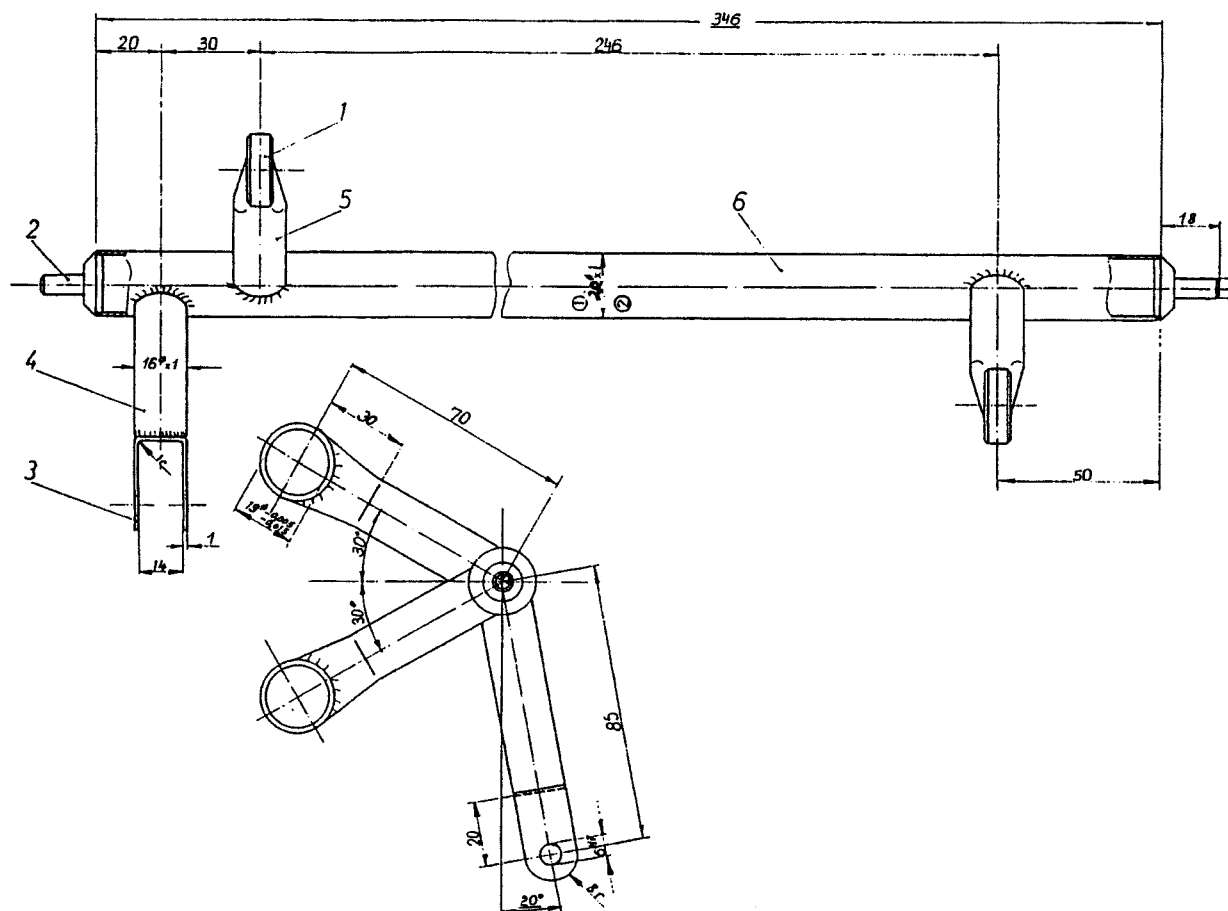
FIGURE 1

Using a magnifying glass (2x minimum) and a flashlight, inspect the aileron actuating shaft in the fuselage (see Figure 1) near the welding seams for cracks in the paint. If there is any cracked paint on the actuating shaft, prior to further flight, remove the actuating shaft and inspect for cracks in the shaft and welding seams using a dye-penetrant method. If there are no cracks or any other damage, flying operation can continue until the accumulation of 8 calendar months after the initial inspection required by this AD, at which time Method 2 or Method 3 shall be accomplished. If cracks are found, prior to further flight, accomplish Method 2 or Method 3.

Remove all paint. Weld (groove welding) all cracks. Weld the joints with the WIG-inert protective atmosphere welding system (wolfram inert gas welding system) with welding material 1.7734.2. Weld the plates (position 7) to the actuating shaft according to Figure 2. Finish the actuating shaft with primer and paint (paint type RAL 7003). Reinstall the aileron actuating shaft.

As an alternative to Method 2, replace the original actuating shaft with a new reinforced shaft according to Figure 1.
