[Docket No. 99–NM–100–AD; Amendment 39–11154; AD 99–09–51]

Airworthiness Directives; McDonnell Douglas Model MD–11 Series Airplanes

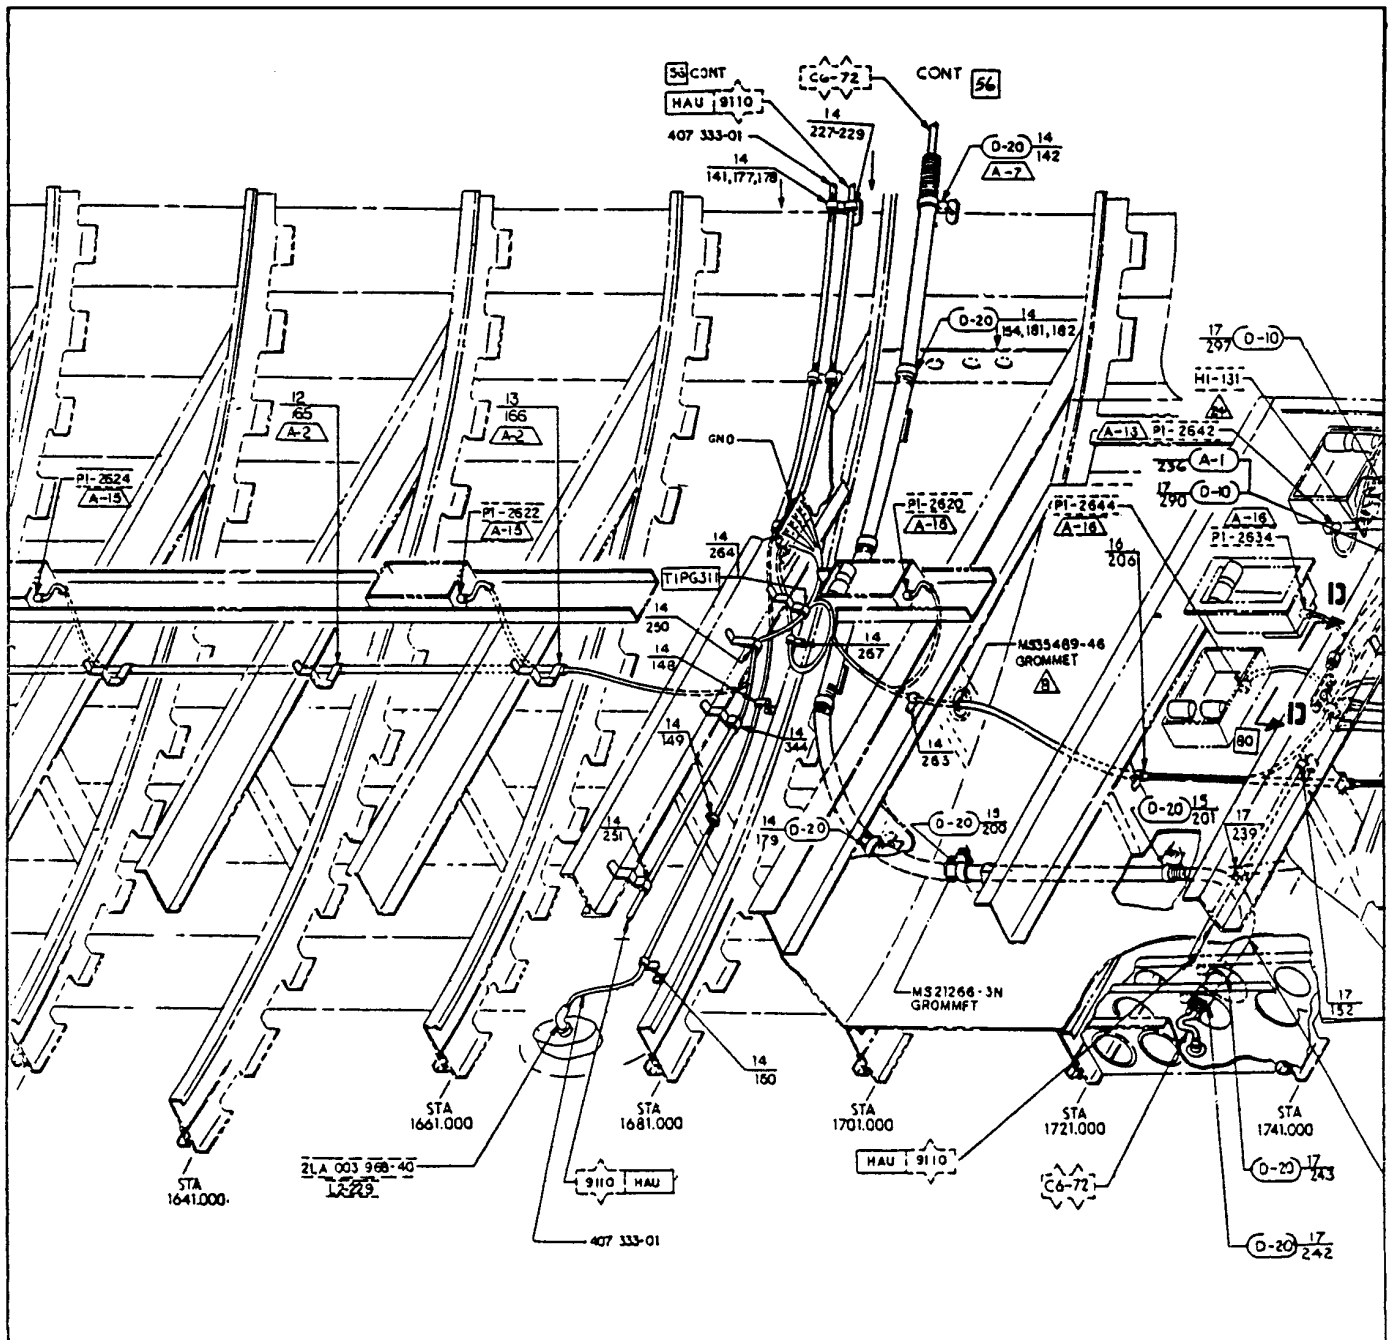
Figure 1

Investigation revealed that a wiring harness (including wires with a 115 volt alternating current) of the aft cargo loader control unit was contacting the insulation blanket and rubbing against frame 1681 above stringer R46. A wire

was cut, and three other wires were missing insulation. In addition, frame 1681 had signs of arcing damage. Furthermore, the exposed moisture barrier material of the insulation blanket was burnt, and a hole was detected on the insulation blanket where the wiring harness was chafing against frame 1681. Further investigation revealed that a wiring harness support bracket/clamp on the wire bundle at frame 1681 may not have been installed during production of the airplane.

A missing wiring harness support bracket/clamp on the wire bundle at frame 1681 could cause the wire bundle to chafe against the frame, which could result in sparks, smoke, and possible fire in the lower center cargo compartment.

(a) Within 5 days after the effective date of this AD: Perform a one-time visual inspection under the floorboards in the lower center cargo compartment at frame 1681 (approximately one inch outboard of longeron R46) to verify that a bracket having part number P/N 9D0062-3-16-24 (or equivalent), and an open face nylon clamp having P/N NMC1001-1 or 383-1 (see Figure 1, Item 14/267), are installed to support wire bundle No. AGS9110. (The nylon clamp specified in this paragraph may be a larger size, depending on the size of the wire bundle.)

(1) If the bracket and clamp are installed: Prior to further flight, perform a visual inspection to detect damage of the subject wire bundle. If any damage is detected, prior to further flight, accomplish paragraphs (a)(1)(i) and (a)(1)(ii) of this AD.

(ii) Install a silicone rubber coated with a glass cloth protective wrap [Douglas Material Specification (DMS) 2109 or equivalent] around the wire bundle(s) in the area over frame 1681 above stringer R46 in accordance with Chapter 20-10-01 of the McDonnell Douglas MD-11 Wiring Diagram Manual.

(i) If no damage is detected: Prior to further flight, install a silicone rubber coated with a glass cloth protective wrap (DMS 2109 or equivalent) around the wire bundle(s) in the area over frame 1681 above stringer R46 in accordance with Chapter 20-10-01 of the McDonnell Douglas MD-11 Wiring Diagram Manual.
