## DEPARTMENT OF TRANSPORTATION

[Docket No. 99-SW-80-AD]

#### **Airworthiness Directives; Bell Helicopter Textron Canada Model 206L, L-1, L-3 and L-4 Helicopters**

**ACTION:** Supplemental notice of proposed rulemaking; reopening of comment period.

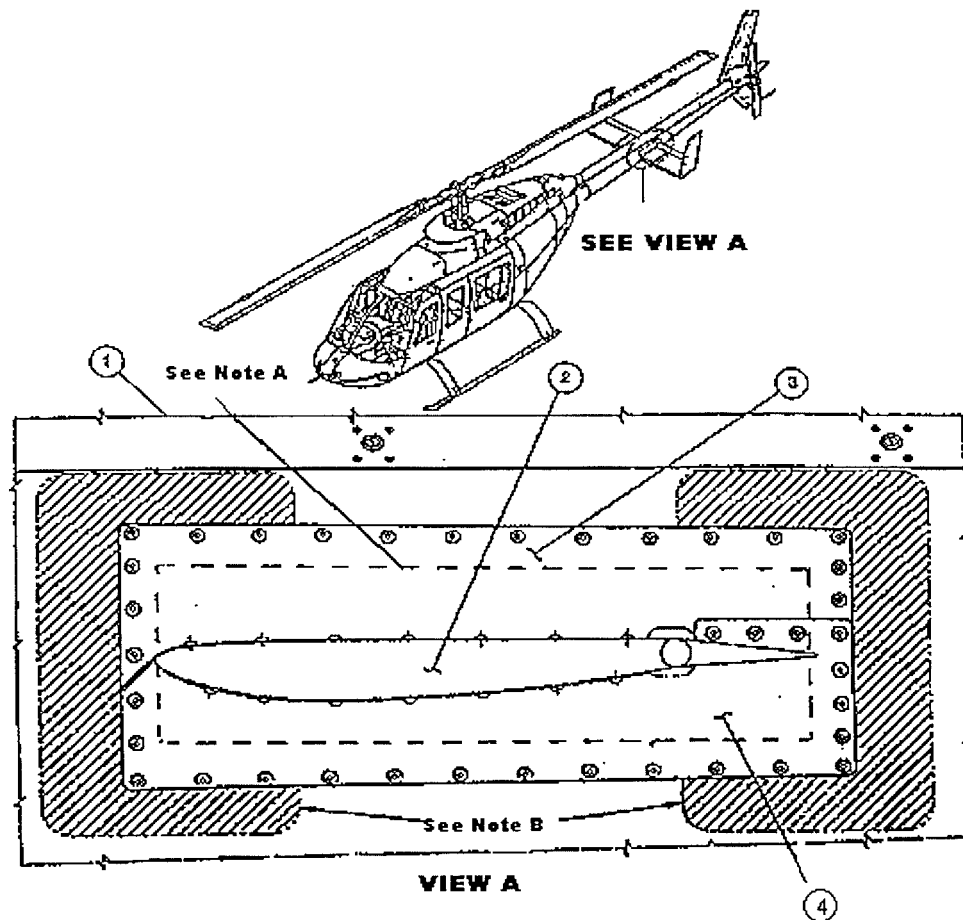
**Figure 1**

(a) Before further flight and thereafter at intervals not to exceed 10 hours time-in-service (TIS) until accomplishing a one-time fluorescent-penetrant inspection (FPI) required by paragraph (c)(2) of this AD, visually inspect for a crack in the tailboom using a 10-power or higher magnifying glass in the shaded areas as depicted in Figure 1 of this AD:

- A. Inspect entire edge of stabilizer opening on both sides of the tailboom.
- B. Inspect for a crack in these two areas on both sides of the tailboom

(2) Perform a one-time FPI of the edges of the tailboom skins for any crack around the left and right horizontal stabilizer openings as shown in Figure 1 of this AD. Remove paint and primer to inspect the edges and exterior skin surface in the skin area at least 3/4 inch around the edges of the horizontal stabilizer openings as shown in Figure 1 of this AD.

(2) Visually inspect the entire edge of the horizontal stabilizer opening on both sides of the tailboom for any crack using a 10-power or higher magnifying glass.

(e) Within 600 hours TIS, inspect and modify the tailboom in accordance with the Accomplishment Instructions, Parts I, II, and III of Bell Helicopter Textron Canada (BHTC) Alert Service Bulletin 206L-99-115, Revision F, dated April 14, 2001 (ASB).

(g) If a crack is found during any check or inspection required by this AD, before further flight, replace the cracked tailboom with an airworthy tailboom modified according to the requirements of paragraph (e) of this AD or with an airworthy tailboom, P/N 206-033-004-181.
