## DEPARTMENT OF TRANSPORTATION

### National Highway Traffic Safety Administration

#### Denial of Motor Vehicle Defect Petition

## Appendix—Petition Analysis—DP15–005

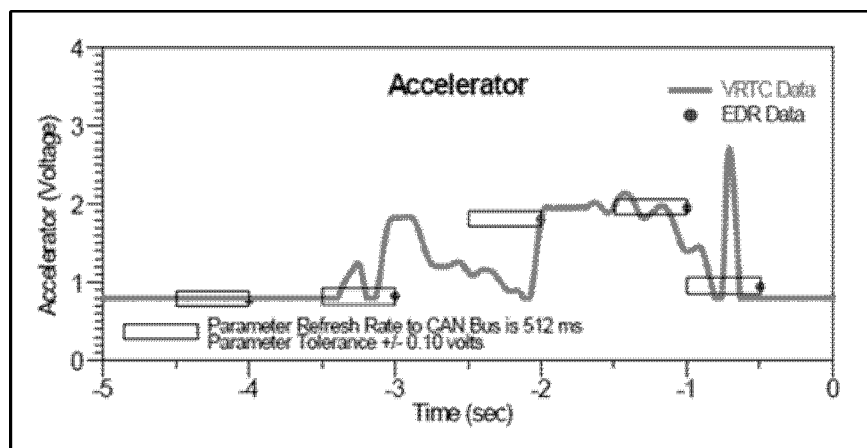
In 2010, NHTSA's Vehicle Research and Test Center (VRTC) conducted testing to validate the EDR pre-crash data used in NHTSA field investigations.<sup>4</sup> Figure 1 shows

accelerator pedal sensor voltage data from one test performed by VRTC in the validation testing.<sup>5</sup> As the figure shows, the EDR does not necessarily capture all accelerator pedal applications during an event and the accelerator pedal voltage recorded at each EDR time interval may not be the actual accelerator pedal voltage at that interval.

Figure 1. VRTC validation testing of EDR accelerator pedal sensor voltage from simulated collisions in a 2007 Toyota Camry.
