**SUMMARY:** This amendment supersedes Airworthiness Directive (AD) 75-23-08 R5, which currently requires repetitively inspecting and replacing or repairing the exhaust system on certain Cessna Aircraft Company (Cessna) 300 and 400 series airplanes. The requirements of this AD replace the inspections and replacements that are required by AD 75-23-08 R5 with inspections and replacements containing new simplified procedures for all 300 and 400 series airplanes (models affected by the current AD plus additional models). This AD also revises the inspection intervals and requires replacing certain unserviceable parts and removing the exhaust system for a detailed inspection. This AD is the result of numerous incidents and accidents relating to the exhaust systems on Cessna 300 and 400 series airplanes dating from the middle 1970's to the present, including six incidents since issuance of AD 75-23-08 R5 where exhaust problems were cited. The actions specified by this AD are intended to detect and correct cracks and corrosion in the exhaust system, which could result in exhaust system failure and a possible uncontrollable in-flight fire with pilot and/or passenger injury.

Appendix to Doc

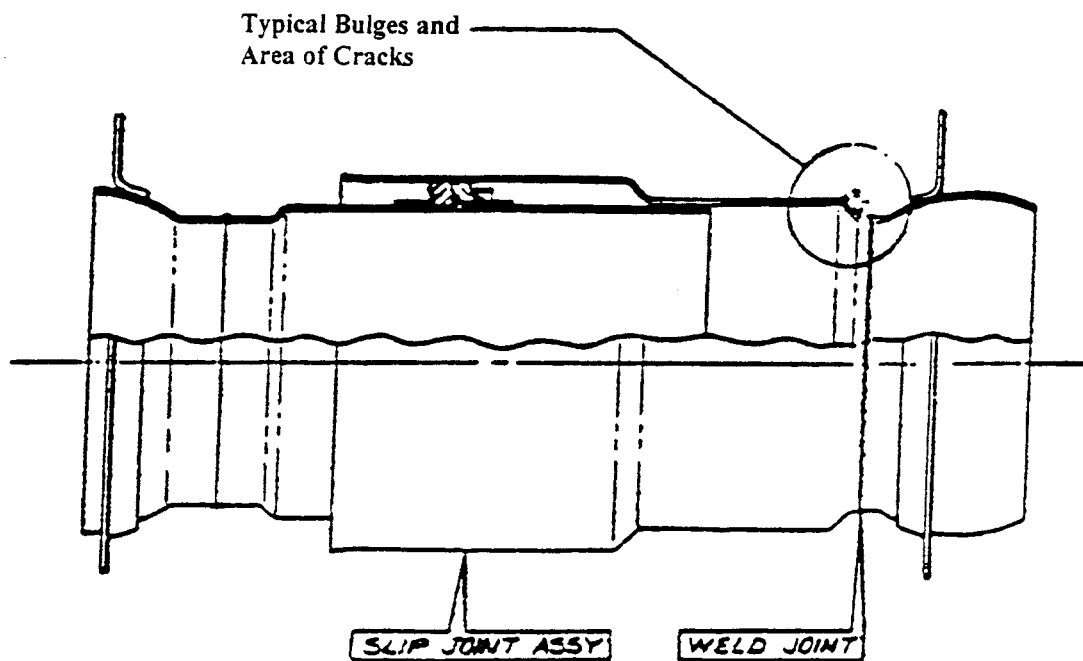
FIGURE 1 to the Appendix

(3) Visually inspect the exhaust joint springs for correct compression. If the joint is disturbed or if the springs are obviously loose or frozen, proceed with the following inspection (see Figure 1 of this Appendix).
