[Docket No. 99-NM-200-AD]

Airworthiness Directives; Sab Model SAAB SF340A and SAAB 340B Series Airplanes

ACTION: Notice of proposed rulemaking (NPRM).

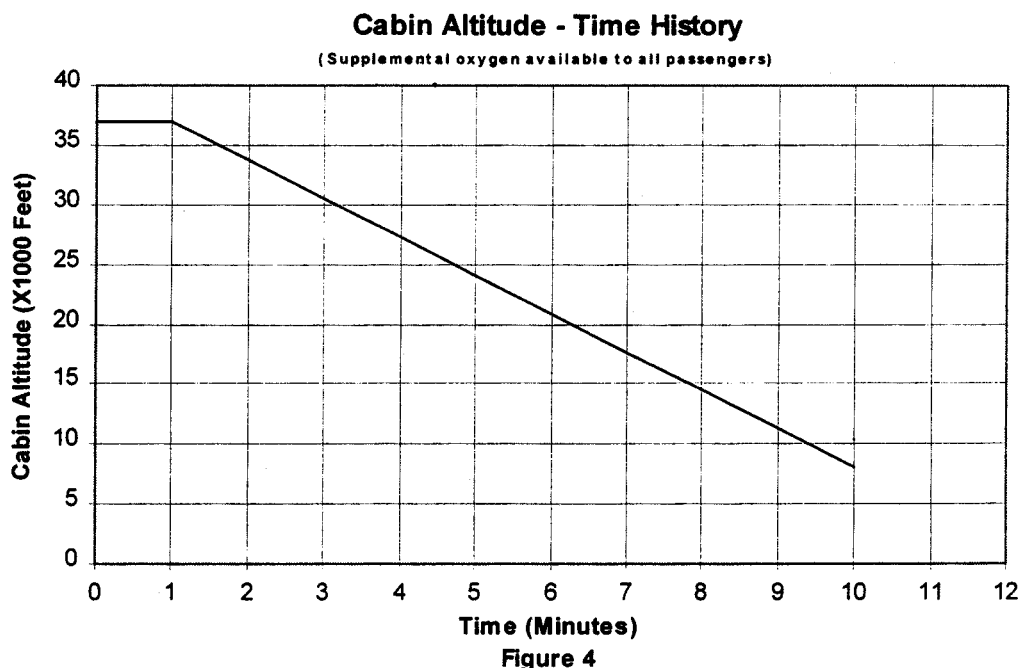
NOTE: For figure 4, time starts at the moment cabin altitude exceeds 8,000 feet during depressurization. If depressurization analysis shows that the cabin altitude limit of this curve is exceeded, the following alternate limitations apply: After depressurization, the maximum cabin altitude exceedance is limited to 40,000 feet. The maximum time the cabin altitude may exceed 25,000 feet is 2 minutes; time starting when the cabin altitude exceeds 25,000 feet and ending when it returns to 25,000 feet.
