[Docket No. 96-NM-209-AD; Amendment 39-11372; AD 99-21-26]

Airworthiness Directives; Raytheon (Beech) Model 400, 400A, 400T, and MU-300-10 Airplanes

ACTION: Final rule.

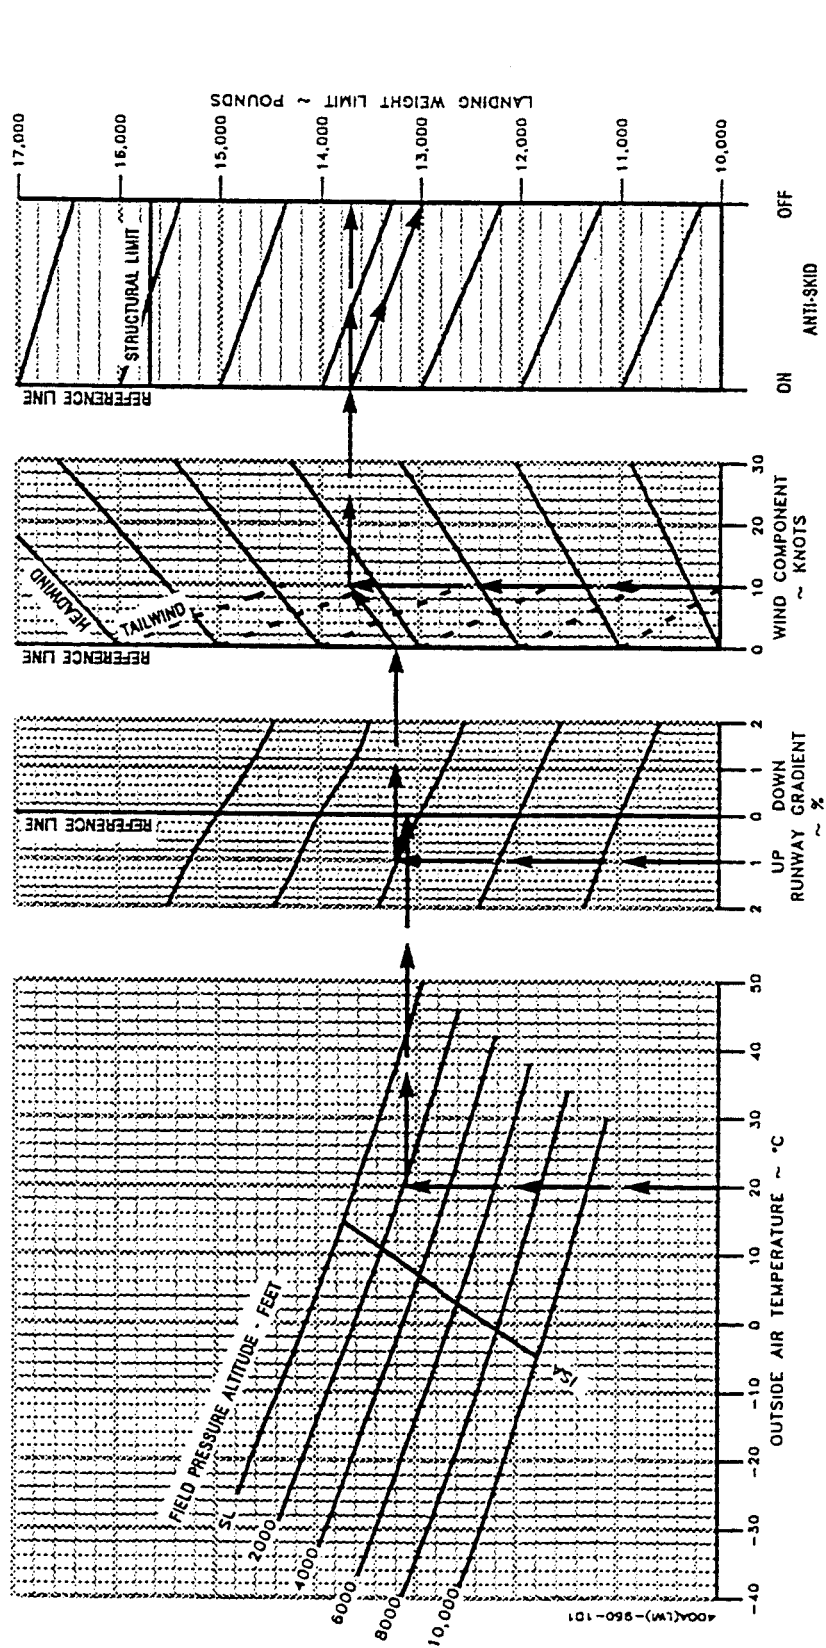
ASSOCIATED CONDITIONS:
BRAKING . . . MAXIMUM

EXAMPLE:

OAT 20°C
FIELD PRESSURE ALTITUDE 2000 FT
RUNWAY GRADIENT 1% UP
HEADWIND 10 KTS
LANDING WEIGHT LIMIT:
ANTI-SKID (ON) 13,715 LBS
ANTI-SKID (OFF) 13,000 LBS

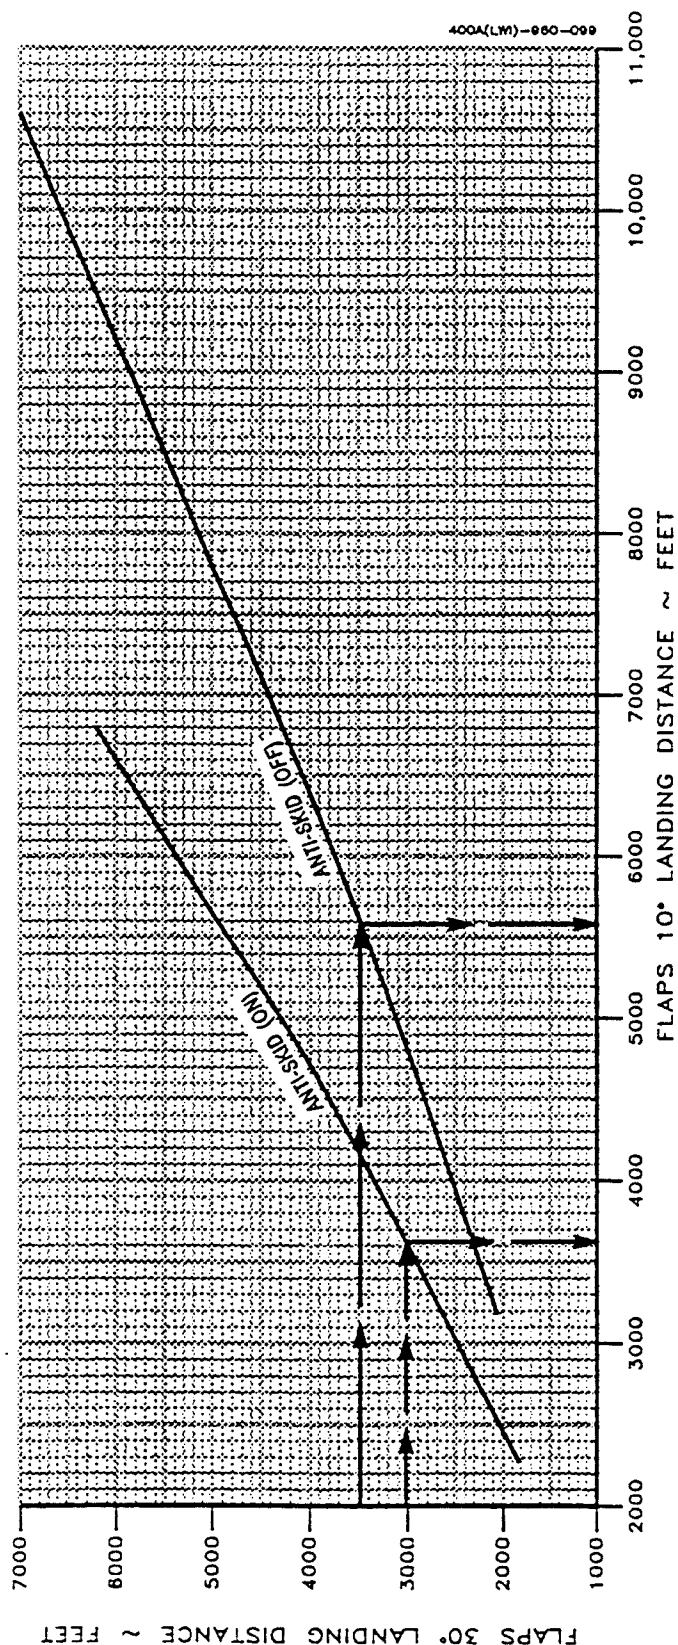
MODEL 400A (RK-24 AND AFTER) AND 400T

ASSOCIATED CONDITIONS:

THRUST RETARDED TO MAINTAIN 3°
APPROACH ANGLE TO 50 FT.

ANTI-SKID (OFF) 5580 FT

V_{REF} 119 KTS

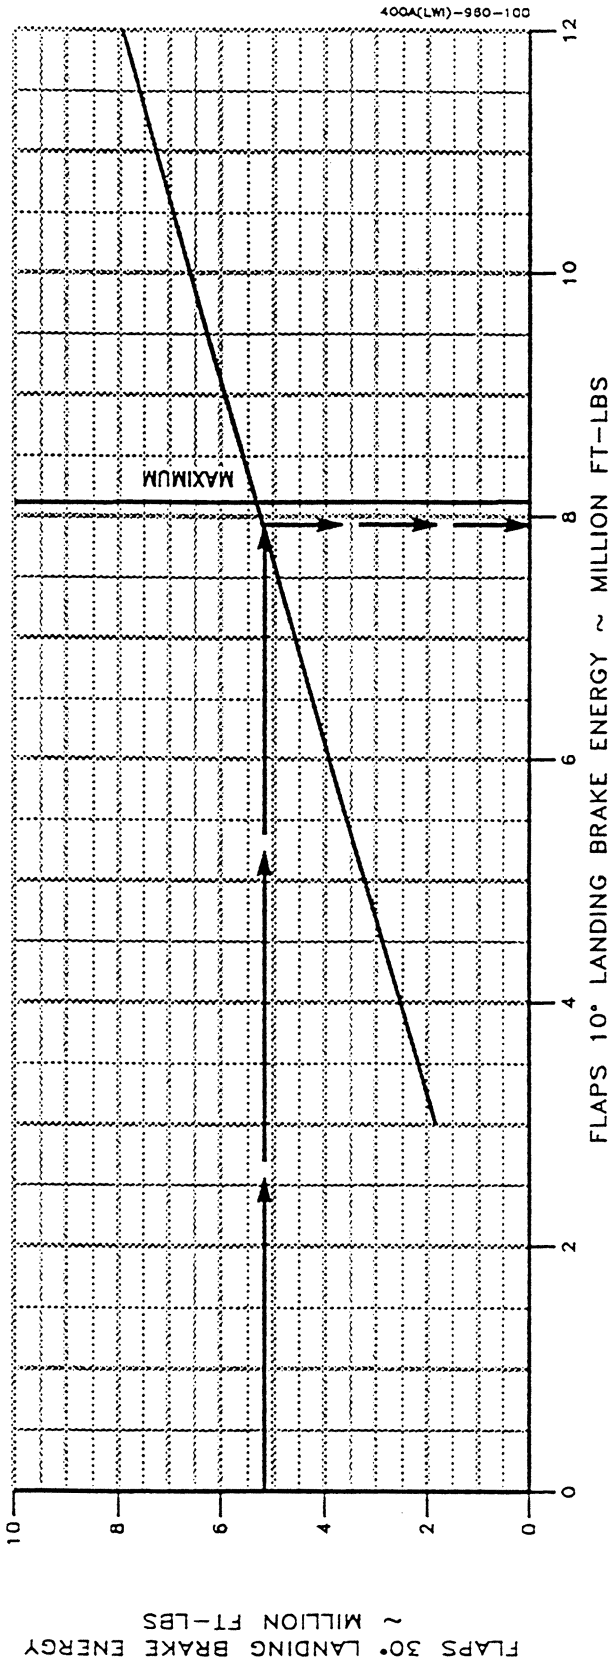
LANDING BRAKE ENERGY - FLAPS 10°

MODEL 400A (RK-24 AND AFTER) AND 400T

ASSOCIATED CONDITIONS:

- NOTES: 1. MAXIMUM LANDING BRAKE ENERGY = 8.12 MILLION FT-LBS.
2. TO DETERMINE THE FLAPS 10° LANDING BRAKE ENERGY, READ
FROM THE "LANDING BRAKE ENERGY" GRAPH FOR THE APPROPRIATE
FLAP 30° LANDING BRAKE ENERGY. THEN ENTER THE GRAPH
BELOW WITH THAT VALUE, AND READ THE FLAPS 10° LANDING
BRAKE ENERGY.

EXAMPLE:
LANDING BRAKE ENERGY
ANTI-SKID (ON) 5.18 MIL FT-LBS
FLAPS 10° LANDING BRAKE ENERGY
ANTI-SKID (ON) 7.93 MIL FT-LBS

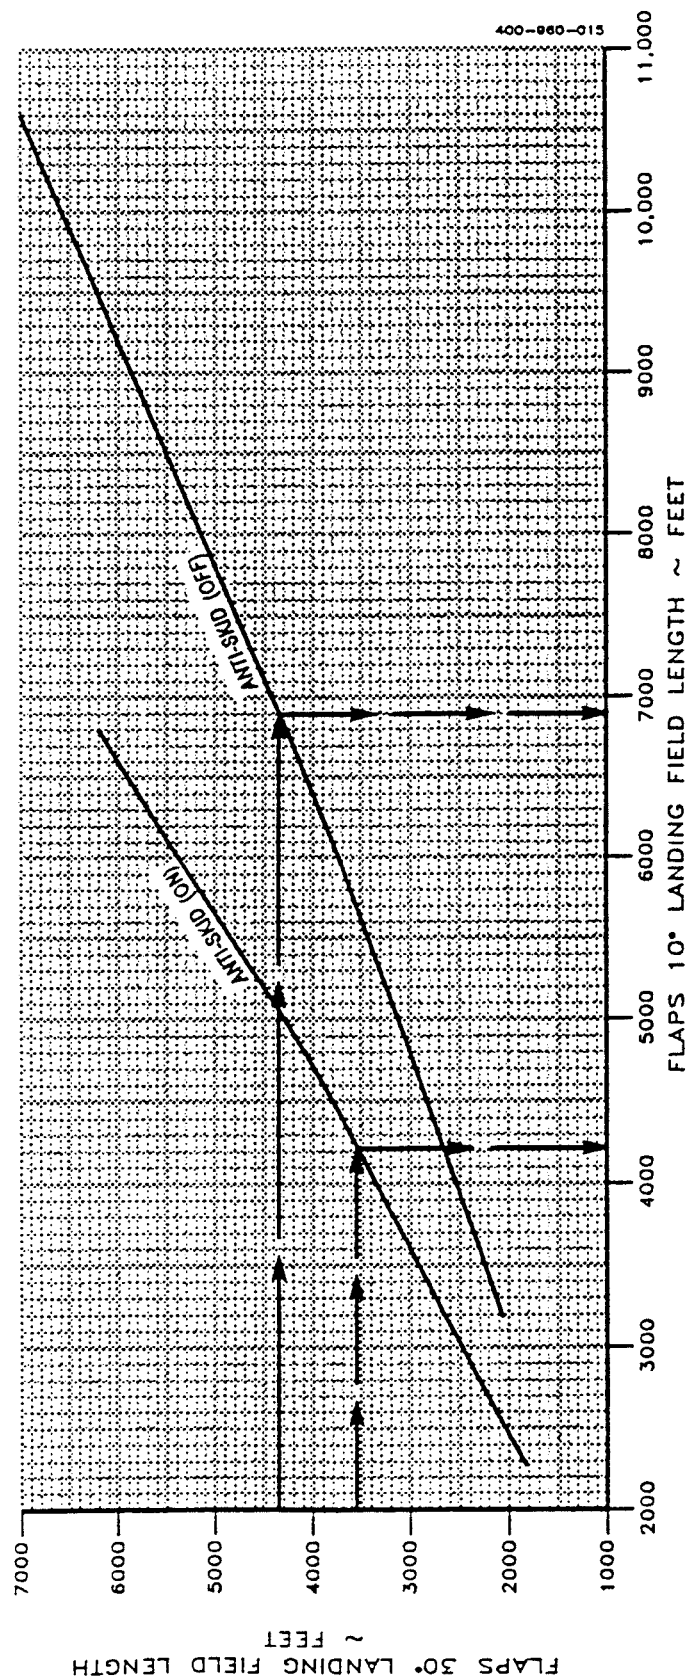
LANDING FIELD LENGTH - FLAPS 10°

MODEL 400A (RK-1 THRU RK-23), 400, AND MU-300-10

ASSOCIATED CONDITIONS:

EXAMPLE:

FLAPS 30° LANDING FIELD LENGTH	
ANTI-SKID (ON)	3550 FT
ANTI-SKID (OFF)	4350 FT
LANDING WEIGHT	13,700 LBS
FLAPS 10° LANDING FIELD LENGTH	
ANTI-SKID (ON)	4214 FT
ANTI-SKID (OFF)	6892 FT
V _{REF}	124 KTS

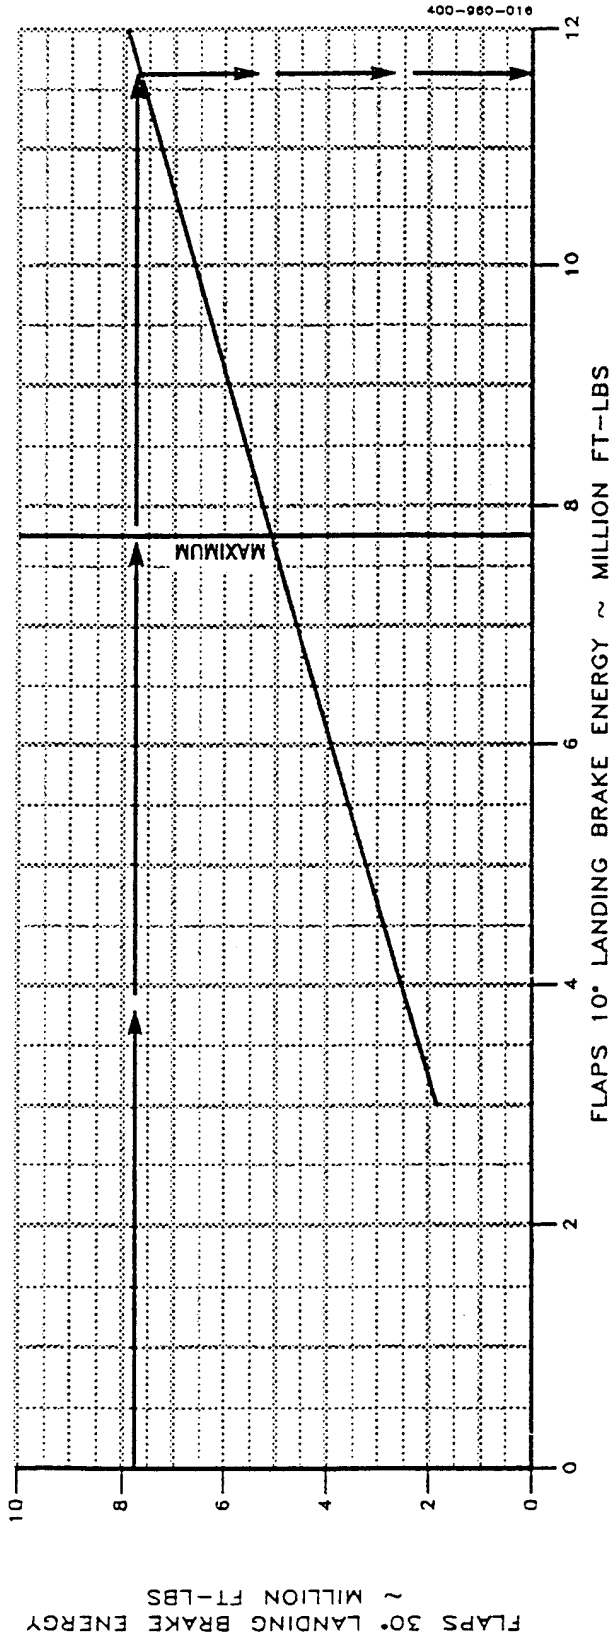
LANDING BRAKE ENERGY - FLAPS 10°

MODEL 400A (RK-1 THRU RK-23), 400, AND MU-300-10

ASSOCIATED CONDITIONS:

EXAMPLE:

LANDING BRAKE ENERGY	
ANTI-SKID (ON).....	7.75 MIL FT-LBS
FLAPS 10° LANDING BRAKE ENERGY	
ANTI-SKID (ON).....	EXCEEDS MAXIMUM
