To prevent asymmetric flaps, jammed flaps, and/or possible interference between the flap and the aileron, which could inhibit aileron travel and result in possible loss of roll control of the airplane, accomplish the following:

(a) Initially at whichever of the compliance times in paragraphs (a)(1), (a)(2), and (a)(3) of this AD that occurs later, and thereafter at intervals not to exceed 600 ground-air-ground (GAG) cycles, inspect the outboard flap attachment brackets and roller bearings on both wings for visible wear and elongation of the bracket holes, in accordance with the Accomplishment Instructions section of Raytheon Aircraft Safety Communiqué No. 137, Revision 1, dated December, 1997.

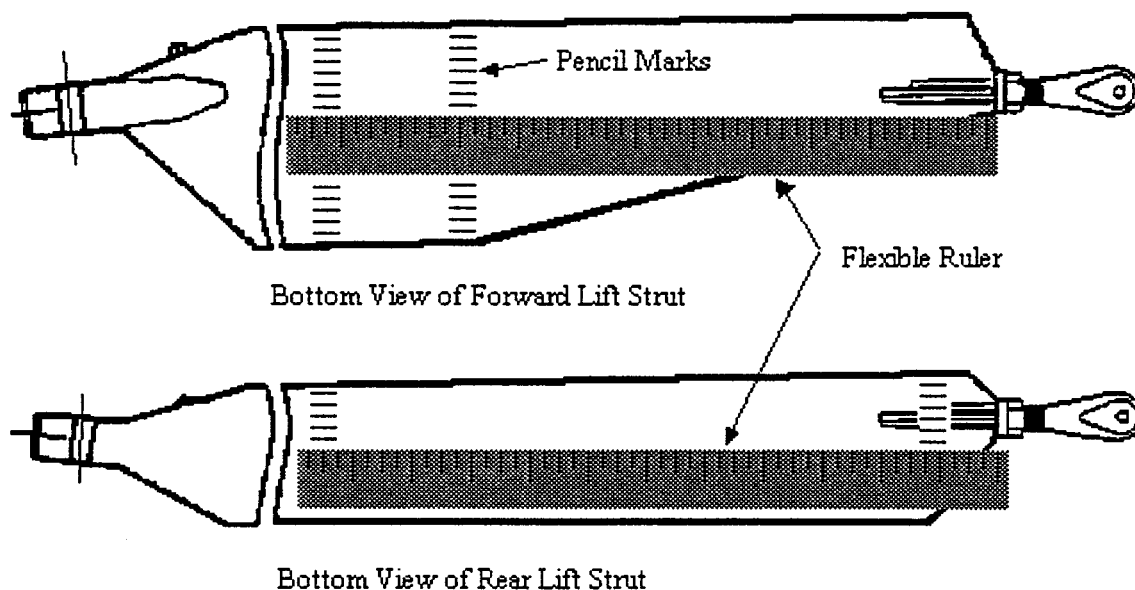
Figure 1

2. Using a flexible ruler, draw a $\frac{1}{4}$ -inch grid on the surface of the first 11 inches from the lower end of the strut as shown in Piper Service Bulletin No. 528D or 910A, as applicable. This can be done using a soft (#2) pencil and should be done on both faces of the strut. As an alternative to drawing a complete grid, make two rows of marks spaced every $\frac{1}{4}$ -inch across the width of the strut. One row of marks should be about 11 inches from the lower end of the strut, and the second row should be several inches away where the strut starts to narrow. Lay the flexible ruler between respective tick marks of the two rows and use tape or a rubber band to keep the ruler in place. See Figure 1.
