DEPARTMENT OF TRANSPORTATION**Federal Aviation Administration****14 CFR Part 39**

[Docket No. 99-NM-161-AD; Amendment 39-11749; AD 2000-11-01]

Airworthiness Directives; McDonnell Douglas Model DC-9-80 and MD-90-30 Series Airplanes, and Model MD-88 Airplanes

ACTION: Final rule.

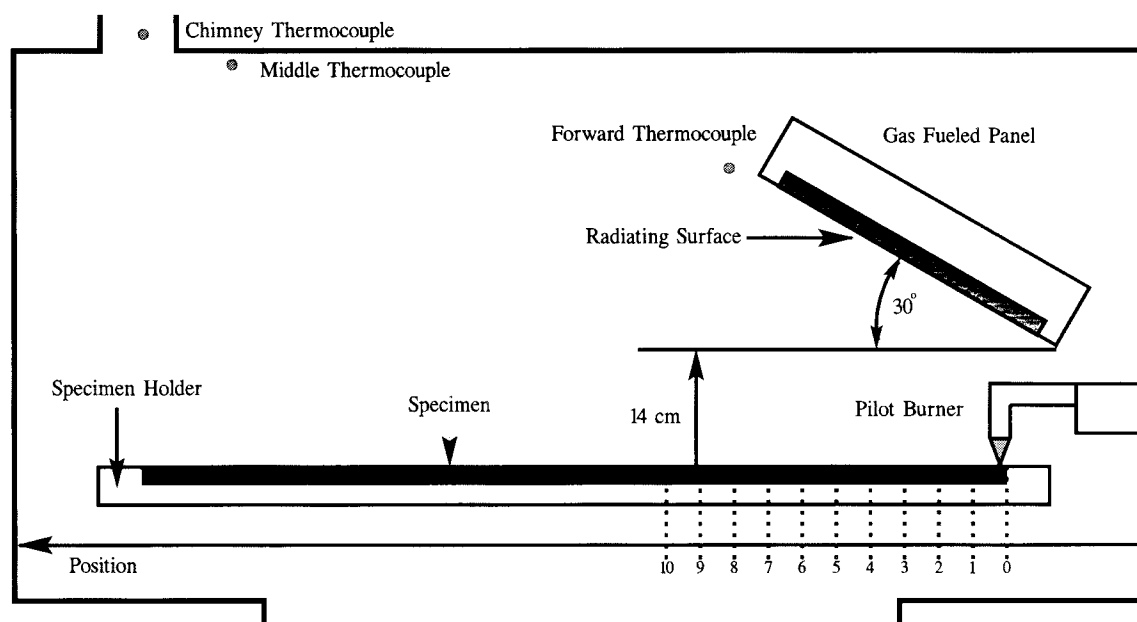
Figure 1.

(b) *Test Apparatus* (as schematically shown in figure 1).

(2) *Radiant Heat Source.* The radiant heat energy source will be a panel of porous refractory material mounted in a cast iron frame, with a radiation surface of 12 by 18 inches (305 by 457mm). It shall be capable of operating at temperatures up to 1500°F (816°C (Figure 1).

(ii) Radiant Panel Placement. The panel will be mounted in the chamber at 30 degrees to the horizontal specimen plane.

(1) During burner application, no flaming is allowed to propagate more than 2 inches (50.8mm) along the sample (to the left in figure 1) of the centerline of the flame.

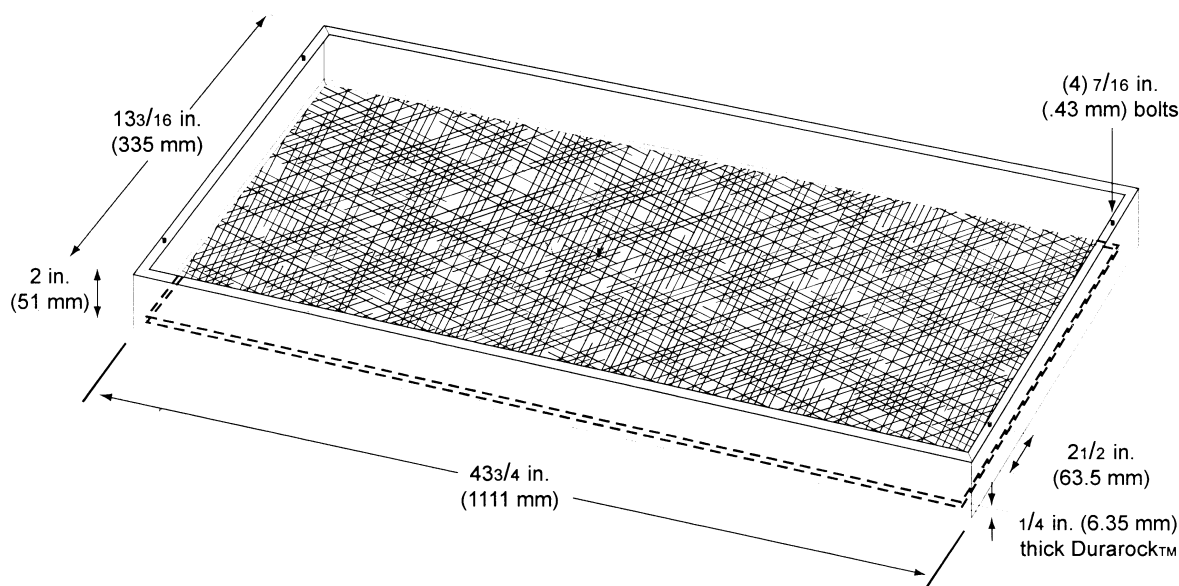
(19.1mm) lip that extends around the bottom of the platform base. It is suggested that the shortest piece be placed at the end furthest from the radiant panel (figure 2). A $\frac{1}{2}$ inch (13mm) piece of Kaowool™ board or other high temperature material measuring $41\frac{1}{2}$ by $8\frac{1}{4}$ inches (1054 by 210mm) will be attached to the back side of the platform. This board will serve as a heat retainer and will protect the test specimen from excessive preheating. The height of this board must not be too high such that it will impede the sliding platform movement (in and out) of the test chamber.

Figure 2: Sliding Platform

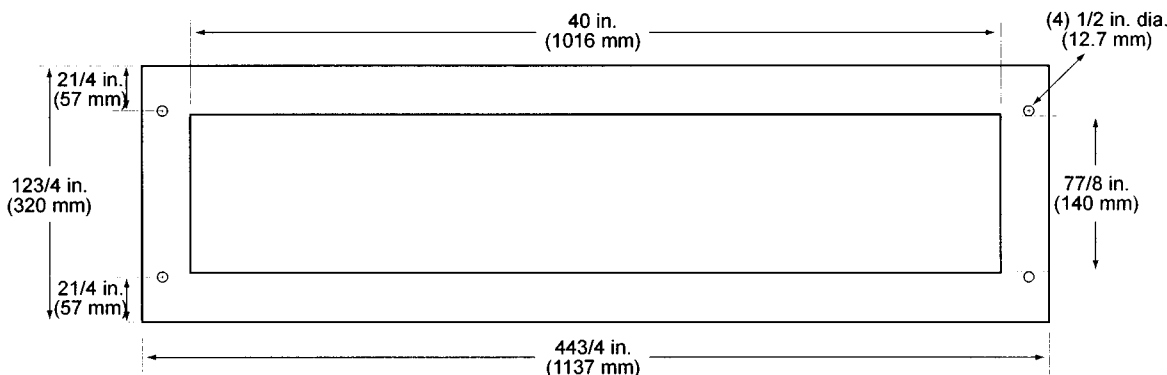
(ii) The test specimen will be placed horizontally on the non-combustible base. A stainless steel retaining frame (AISI Type 300 UNA–NO8330), or equivalent, having a thickness of 0.078 inches (1.98mm) and

overall dimensions of $44\frac{3}{4}$ by $12\frac{3}{4}$ inches (1137 by 320mm) with a specimen opening of 40 by $7\frac{7}{8}$ (1016 by 140mm) will be placed on top of the test specimen. The retaining frame will have two $\frac{1}{2}$ inch (12.7mm) holes

drilled at each end for positioning the frame to the two stud bolts at each end of the sliding platform (figure 3).

Figure 3: Stainless Steel Retaining Frame

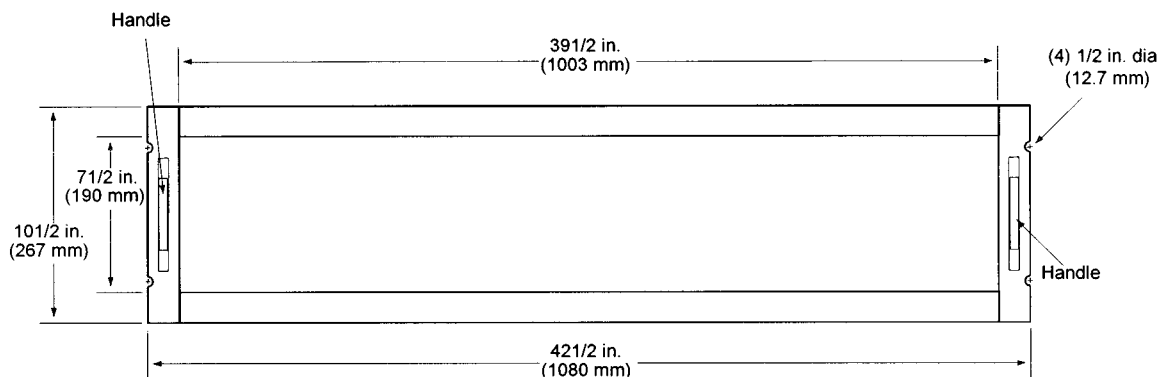
(iii) A securing frame (acting as a clamping mechanism) constructed of mild steel will be placed over the test specimen. The securing frame overall dimensions are $42\frac{1}{2}$ by $10\frac{1}{2}$ inches (1080 by 267mm) with a specimen opening of $39\frac{1}{2}$ by $7\frac{1}{2}$ inches (1003 by 190mm). Hence, the exposed area of test specimen exposed to the radiant panel is $39\frac{1}{4}$ by $7\frac{1}{4}$ inches (996 by 184mm). See figure 4. It is not necessary to physically fasten the securing frame over the test specimen due to the weight of the frame itself.

Figure 4: Angle Iron (1.5x1.5) Securing Frame
*NOTE: All Seams Welded

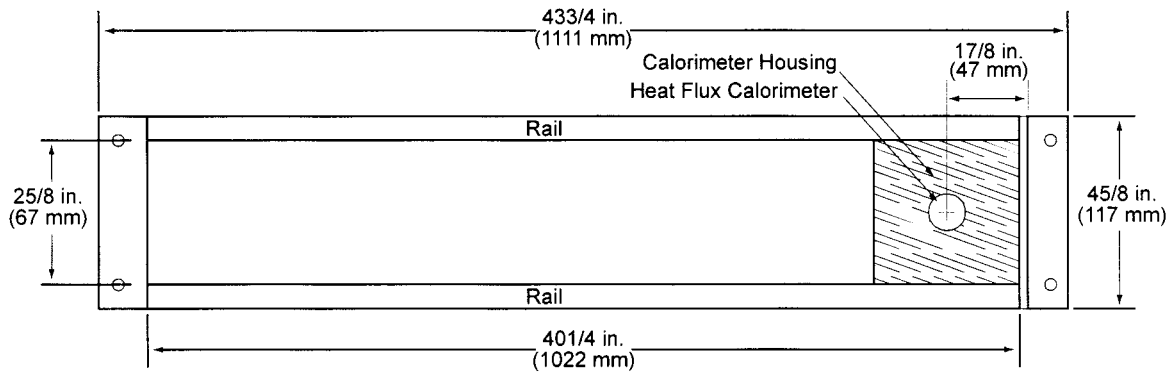
(8) *Calorimeter Fixture.* With the sliding platform pulled out of the chamber, install a 2-rail fixture that has a travel range of 40 3/4 inches (1022mm) over the sliding platform. The dimension between the 2 rails is 2 11/16 inches (68mm). The rail fixture is screwed into the sliding panel, such that it is always directly under the geometric center of the radiant panel (figure 4). Push the platform into the chamber and insert the calorimeter. The calorimeter, which is mounted in an insulated housing, fits in the rail opening but has enough clearance such that it may be moved along the rail for heat flux readings. The top surface of the calorimeter must be level with the rails.

(1) With the sliding platform out of the chamber, install the rail fixture. Push the platform back into the chamber, install the calorimeter (in its housing), and move the calorimeter to the "zero" position (figure 5). Close the bottom door located below the

Figure 5: Calorimeter Rail

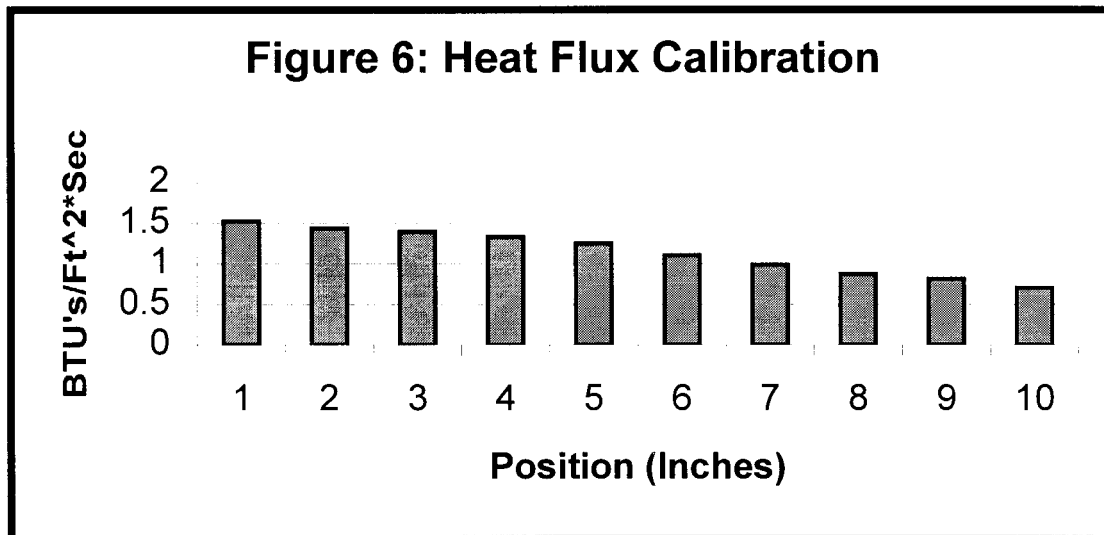
(3) After steady-state conditions have been reached, move the calorimeter 2 inches (51mm) from the "zero" position and record

the heat flux. Allow a minimum of 30 seconds at each position for the calorimeter

to stabilize. Record at least 10 positions. (Figure 6 depicts a calibration profile.)
